**Bat Survey Report** Trenance, Townshend, Hayle, TR27 6AQ

Mark Tunmore was instructed by Caroline Robinson in May 2023 to carry out a programme of bat surveys at a semi-detached house known as Trenance, located at Townshend, Hayle, TR27 6AQ. The survey was requested in preparation for a planning application to extend the house at the back (PA23/01558). This followed an initial assessment by Cove Ecological Surveys on 16 March 2023, which identified the building as holding moderate potential for roosting bats using the national survey guidelines and found approximately 100 bat droppings in the loft area, confirming its use as a bat roost. Two emergence surveys and a period of remote monitoring in the loft were recommended, in keeping with the survey guidelines. This report summarises the results of the further surveys and offers advice on mitigation and licensing.

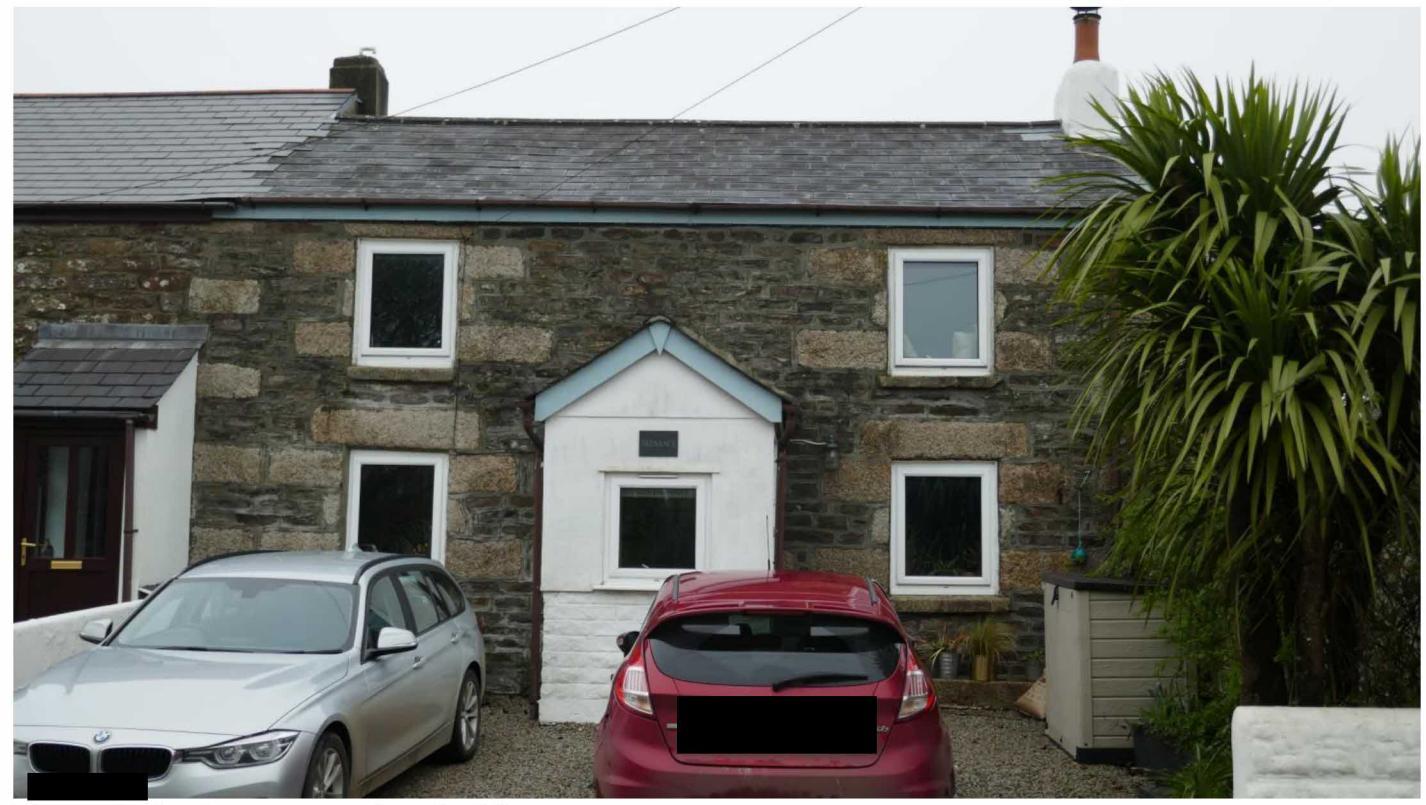
Figure 1. Southern aspect of the building.

The house was built of stone and the walls were tightly pointed; the eastern gable of the building was rendered (Figure 2). The pitched roof was composed of slate; some slates were lifting in places and there was a large gap beneath a section of the ridgeline (Figure 4); a single chimney was present on the eastern end of the building and lead flashing around the base of this was lifting (Figure 5). A wooden fascia was present at the front of the house, which had a large gap behind it. These features provided potential roost features and access points for bats. A small porch was also present on the front of the house (Figure 1), which had a pitched slate roof.

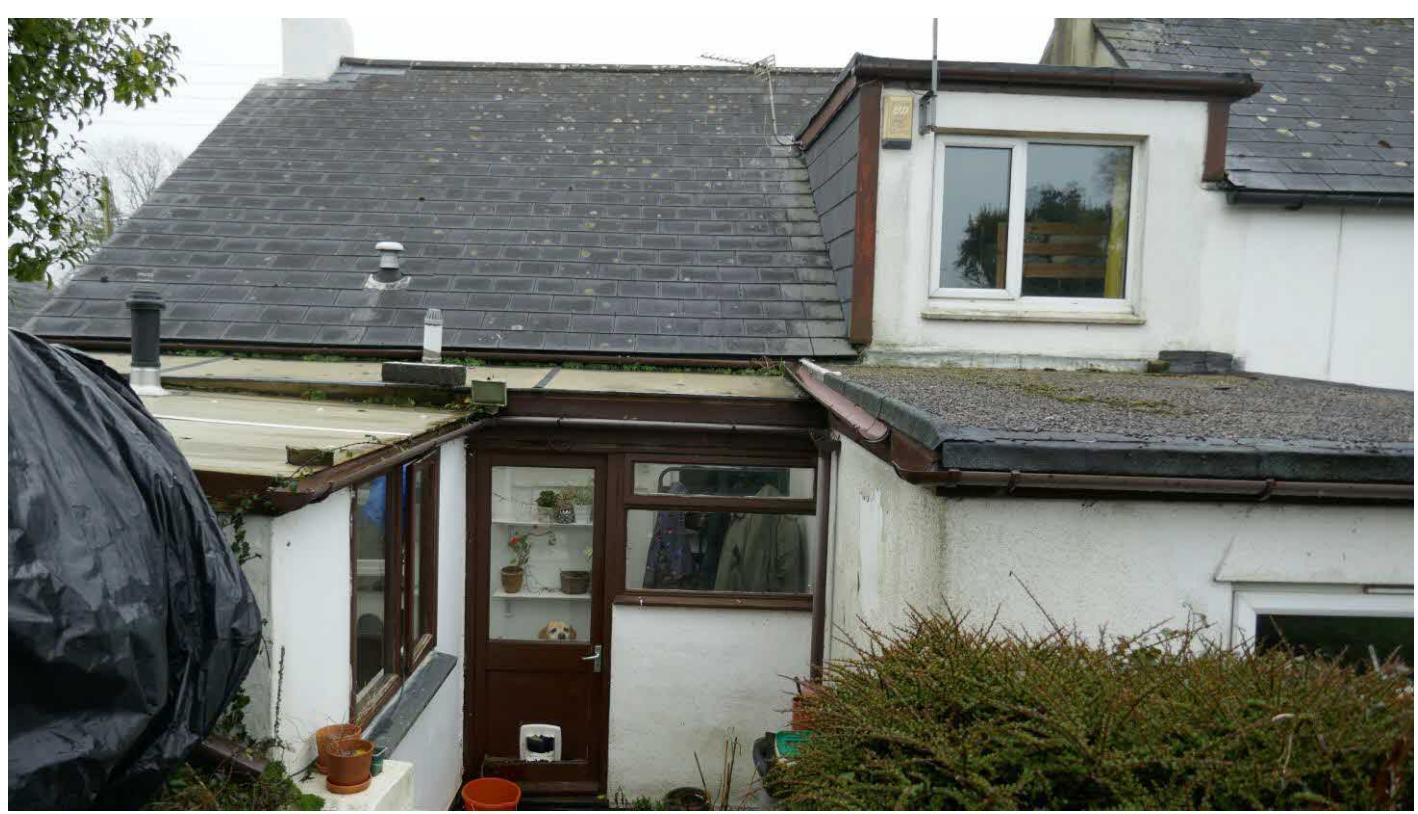
Figure 3. Northern aspect of the building.

At the back of the house a dorma was built into the roof, which had a section of vertical slates on one side and a wooden fascia with a gap behind it, which was suitable for roosting bats (Figure 3). Beneath the dorma a flat roofed extension projected north (Figure 7), which was bitumen felted with a layer of gravel on top. The wooden fascia here also held suitable gaps for roosting bats.

Also at the back of the house was a single storey conservatory and joined on utility room with a flat corrugated perspex roof (Figure 3).

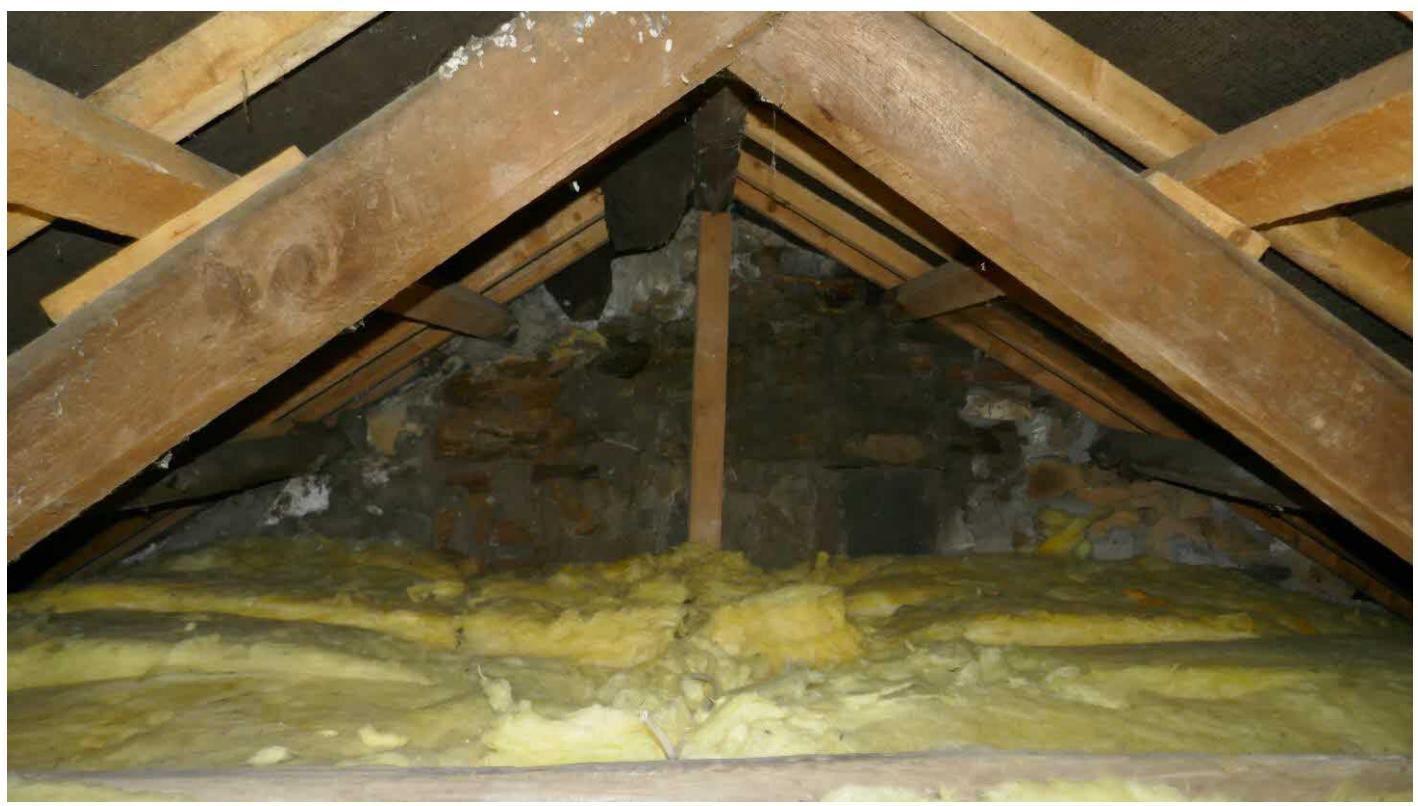
Figure 6. Roof void.

A roof void of approximately 1.25m internal height was present above the top floor (Figure 6), which had a layer of fibreglass insulation on the floor and the roof was lined with bitumen felt (this was torn in places and could allow access for bats). The roof void was being used for light storage purposes. A second void was present on the lower part of the roof on the north side of the building (Figure 8), above the bathroom with space at the top of this void potentially allowing bat access to the main roof void above.

- The main roof void where Brown Long-eared Bat is roosting will not be developed and will remain available for use by bats with no loss of space. Repairs will be carried out to the roof and loft insulation/roof lining may be replaced. The roof will remain lined with 1F Bitumen felt and no breathable membranes will be used in this area, which are known to be harmful to bats. It is possible that in carrying out roof repairs that the bat access point may be lost. Therefore two bat slates will be fitted to the roof at the front of the house and slits of approximately 15cm long x 2cm wide will be cut in the roof lining below to allow bats access to the roof void.

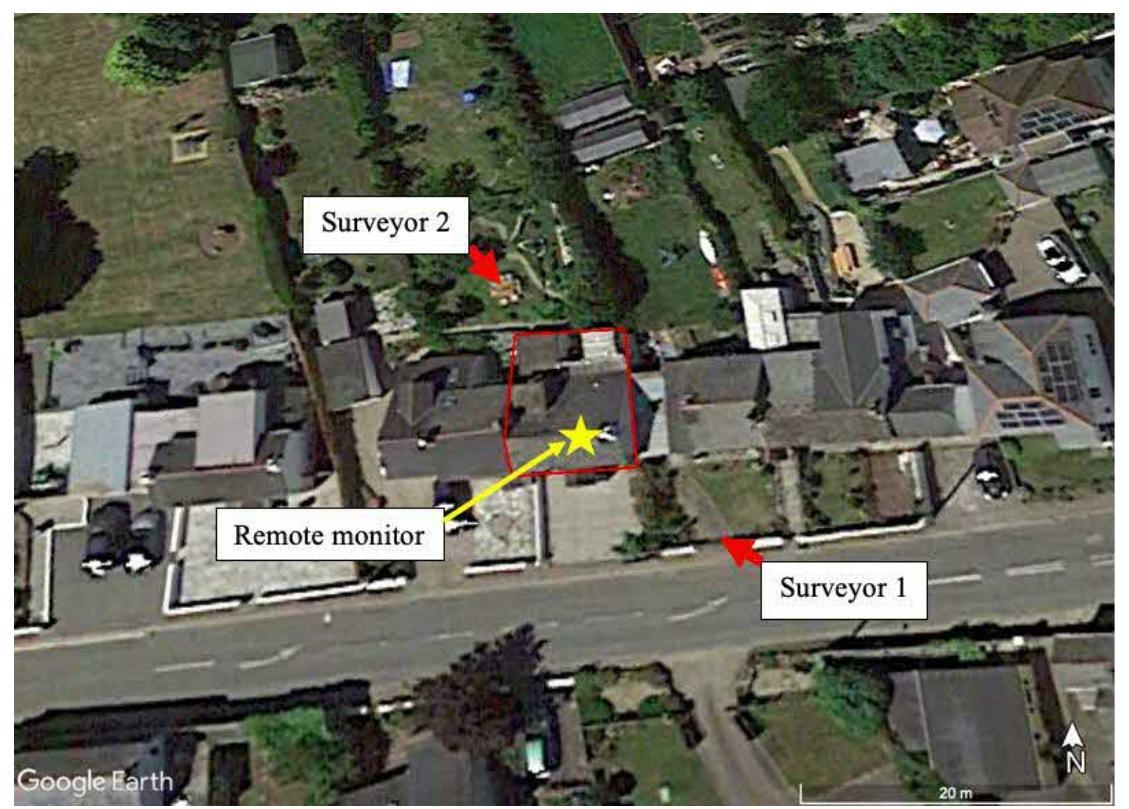
**Figure 9**. Surveyor and equipment locations. www.coveecologicalsurveys.co.uk

Two surveyors were present on each survey supported with 'night vision aids' (NVA). Surveyor one was located in the street at the front of the property viewing the southern and western aspects and roof, with surveyor two in the back garden viewing the northern aspect and roof. This strategy enabled all aspects of the property containing potential bat roosting features to be viewed. Table 1 summarises the personnel and equipment used, Figure 9 shows the surveyor and equipment locations and Figure 10 shows infrared illumination at the darkest part of the surveys.

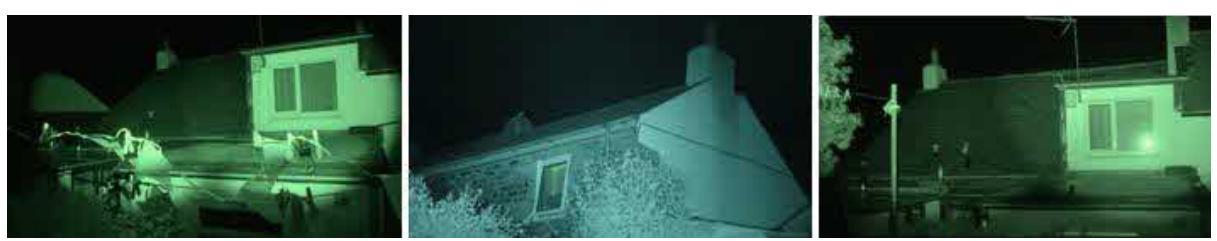
**Figure 10.** Infrared illumination. Left: Surveyor 2 (18 May). Middle: Surveyor 1 (23 June). Right: Surveyor 2 (23 June).

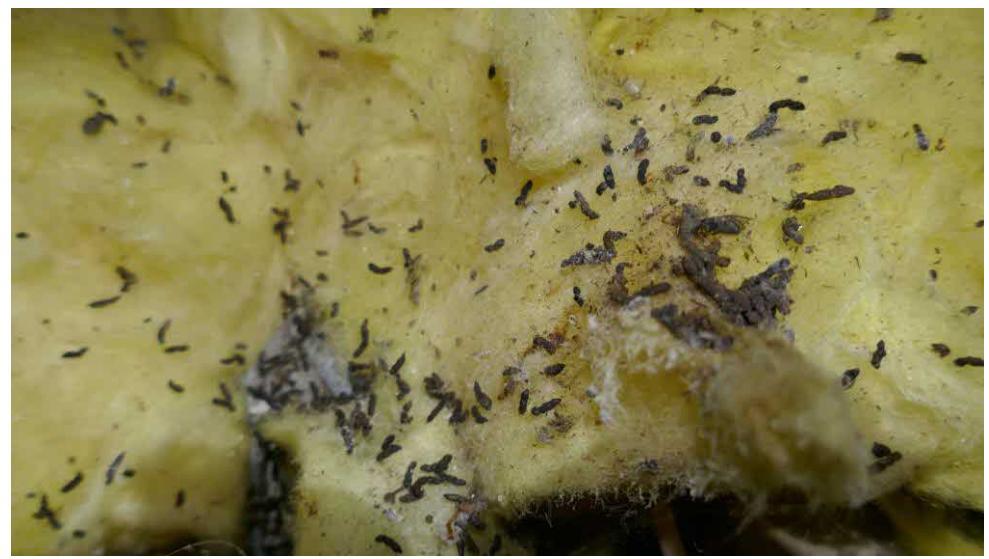
Figure 11. Bat droppings found in the roof void.

On 16 March 2023 a scattering of bat droppings was found on the fibreglass insulation in the roof void (Figure 11) with a concentration of 100 droppings found close to the gable wall. A sample of the droppings was taken for DNA analysis, which confirmed the presence of two species—Common Pipistrelle *Pipistrellus pipistrellus* and Brown Long-eared Bat *Plecotus auritus*.

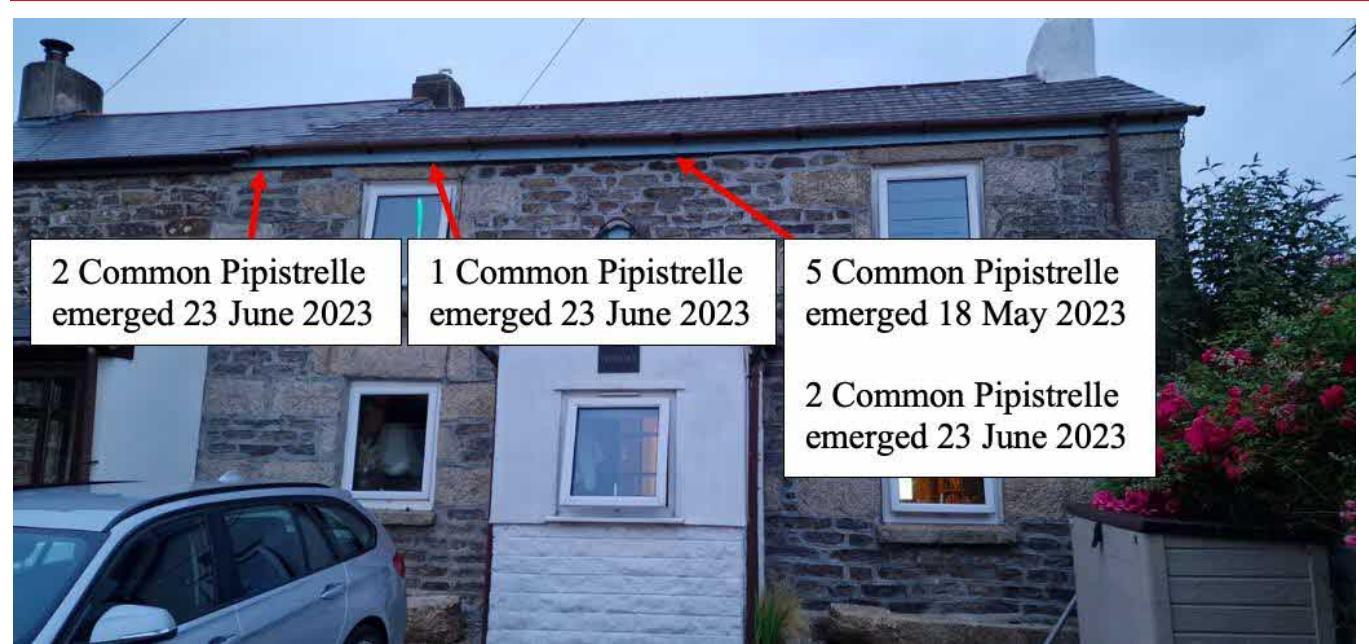
Figure 12. Common Pipistrelle emergence locations on the southern aspect of the building.

During the first emergence survey on 18 May five **Common Pipistrelle** emerged from one location beneath the fascia board on the southern facing aspect between 21.12 and 21.16 (see Figure 12). Common Pipistrelle activity was recorded regularly throughout the survey from 21.06 B.S.T. onwards, with Noctule *Nyctalus noctula* heard high overhead on three occasions.

The surveys have shown that five Common Pipistrelles are day-roosting behind the gap along the length of the fascia at the front of the building. The presence of droppings from this species in the roof void indicates that they are also using this space on occasion. A single Brown Long-eared Bat is day-roosting within the

- The existing fascia at the front of the house will remain unchanged so it will be possible to return the Common Pipistrelle roost where it is; 20mm gaps will additionally be left behind all new fascias and barge boards throughout.
