Postlebury, Withiam Friary

Bat & Bird Inspection Report Prepared for: Lewis Sheppard Date: May 2023

BAT & BIRD SCOPING REPORT MAY 2023

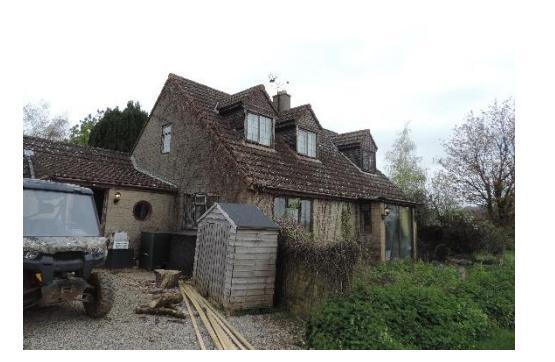
Plate 1: Postlebury Viewed from the East

Postlebury was a two-storey house with single-storey extensions to the south and east (Plates 1 & 2). The walls were constructed from stone and were in a good condition, lacking any cracks or crevices. Intact, single-glazed doors and windows were present throughout. Ivy (*Hedera helix*) was growing up northern and southern aspects. Wooden weather boarding present on the single-storey extension to the south; this boarding was damaged and included several gaps (Plate 3). The wall tops were covered by overlapping tiles that were flush. Intact wooden soffit boxes were present in the east and west. Fascia boards were present in the south and were flush with the wall.

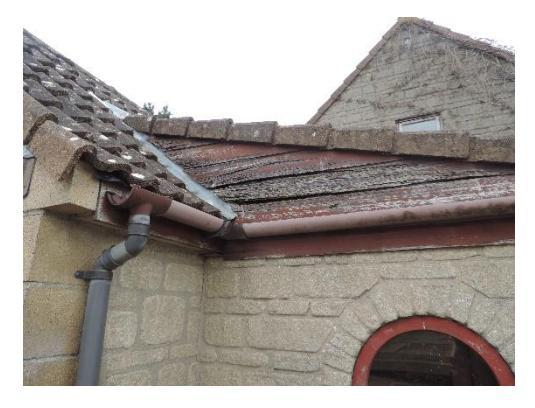
Plate 4: Damaged Soffit Box

The main roof was pitched roof with sloping and flat sections over the single-storey extensions. The pitched and sloping roofs were clad in pan tiles whilst the flat section was covered in bitumen felt. The roofs were in a good condition, lacking any raised, slipped or missing tiles. Three dormer windows were present, all of which were clad in wooden weather boards and included soffit boxes. A section of soffit box on the southernmost of the dormers was damaged and included gaps (Plate 4).

Based on the presence of suitable roost features that could not be accessed for inspection coupled with the property's location within suitable habitat, Postlebury was assessed as having Moderate BRP. All of the identified potential roost features were only suitable for crevice-dwelling species of bats. As such, the property did not afford any roosting opportunities for greater horseshoe bat.

Postlebury was assessed as having Moderate BRP. This assessment was based on the presence of potential roost features that could not be accessed for inspection. Further survey will be required to establish whether bats are present.

All bat roosts are protected from damage by domestic law (see Section 1.2.1) and it will be necessary to establish whether bat are present prior to submitting the planning application. Indeed, if a bat roost is present and likely to be adversely affected by the works, a EPSML will be required. To inform both the planning and EPSML (if required) applications, further surveys will be required. In accordance with published guidance (BCT, 2016 & 2022), a minimum of two emergence surveys will be needed to assess the property. If bats are recorded emerging from Postlebury, a third visit will be required. Emergence surveys are seasonally constrained and can only be undertaken during the active season for bats. The surveys should be undertaken between May and August and ideally spaced apart by a minimum of two weeks.

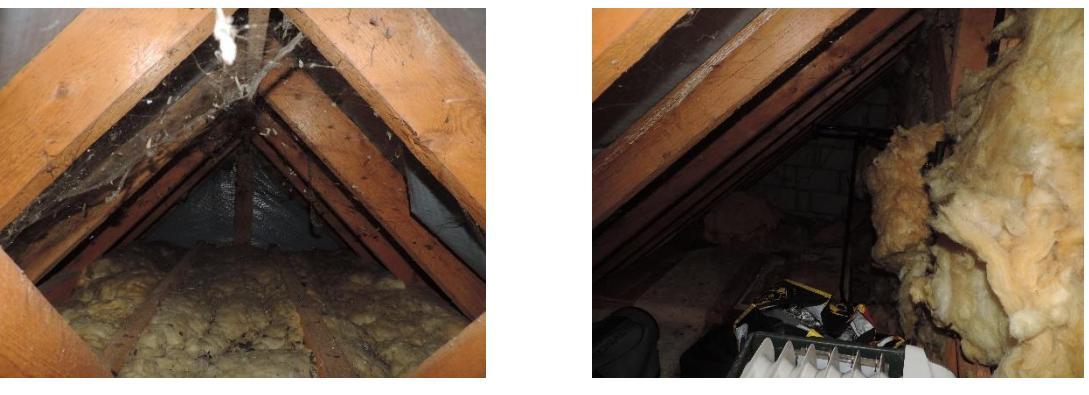
Plate 5: Loft Space 1

Loft Space 1 measured c. 15 m (L) x 2 m (W) x 1 m (H) (Plate 5). The roof was lined with plastic and coated in dense cobwebs. The gable walls were constructed from block and the floor was covered in fibreglass insulation. Three smaller loft spaces projected northwards (2 m x 1 m x 0.5 m) into the dormers. No signs of bats were recorded; however, there was extensive evidence of rats.

Loft Space 2 comprised eaves loft spaces on the first floor (15 m x 2 m x 2 m). The walls were constructed from block and the roof was lined in plastic. Cobwebs lined the roof.
