# Ecological Impact Assessment at

## Denver House

Acton Burnell Shrewsbury Shropshire SY5 7PQ

By Churton Ecology (Mr. R.G. Thorne BA [Hons] MRSB and Dr A.K. Thorne MCIEEM | Contact 01743718270) *Commissioned by Batch Valley Design Ltd* September 2023

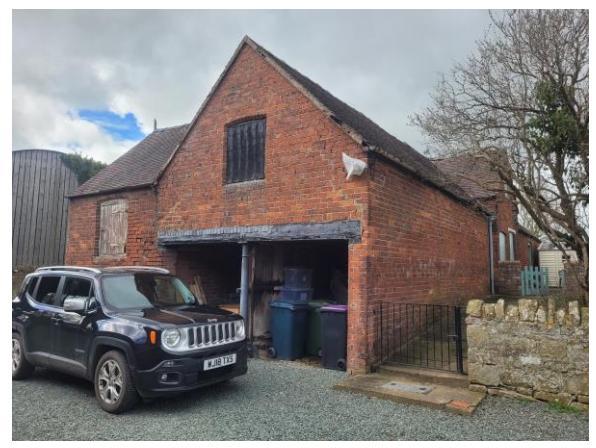
**P1:** Building A: viewed from the NE, looking WSW

The building comprises a central-wing and two smaller perpendicular wings to the east and west. The roof of the west-wing is badly damaged and only the tiles on the west roof slope remain. Large sections of the roof of the central-wing (south roof slope) have also lost their tiles, although the bitumen felt remains. The east-wing supports ground and first-floor levels and is separated from the central-wing by a full height brick partition wall. The central and west wings are single-storey and divided into rooms by a number of full height brick partition walls. With the exception of the east-wing, which is dark and enclosed, the interior is light and draughty and roosting opportunities are limited in these areas.

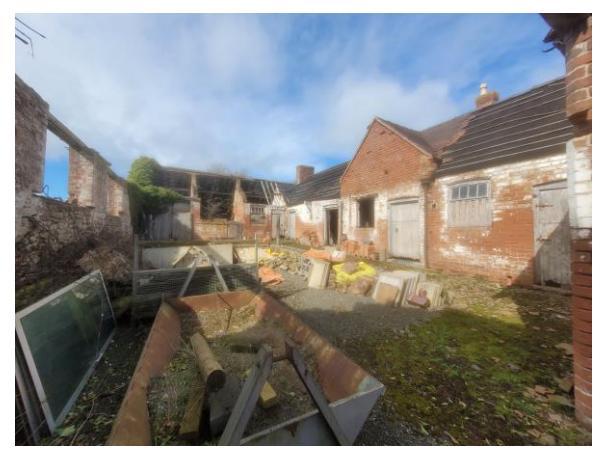
**P2:** Building A: viewed from the SE, looking NW

The building is pre-cavity-era brick construction and there are various cracks and crevices present throughout, particularly around the lintel and joists bearings. The roof-verges are close-verge construction; however, two of these are slightly damaged providing potential access to the gable wall tops in these areas.

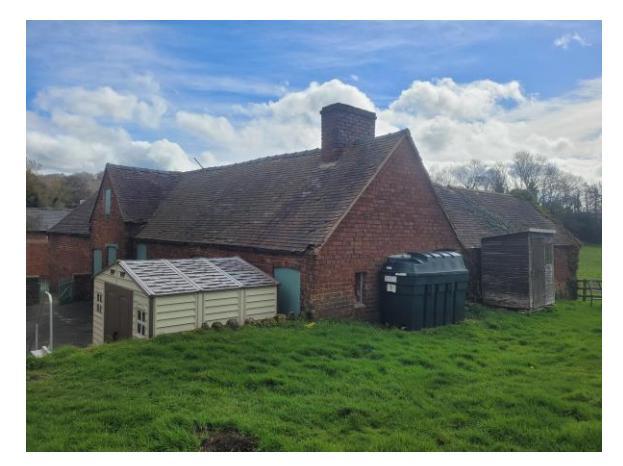
P4: Building A: viewed from the NW, looking ESE

Potential roost sites are limited to occasional holes and crevices in the wall masonry. Additionally there is access to the gable end and partition wall tops, ridge cavities, roofverges and access to the building interior is possible via occasional open or damaged window and doorway openings.

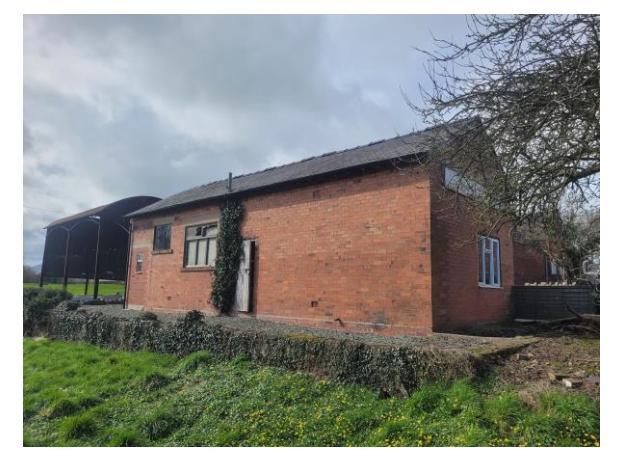
P6: Building B: viewed from the NE, looking SW

The building is small and rectangular and was formerly used as a butchers shop. The walls are cavity-era brick construction and there is potential access to the wall cavity in two or three locations. The roof is lined with bitumen felt and covered with flush slate and overlapping, angled clay ridge-tiles. Some of the vented ridge-tiles have the potential to be occupied by roosting bats.

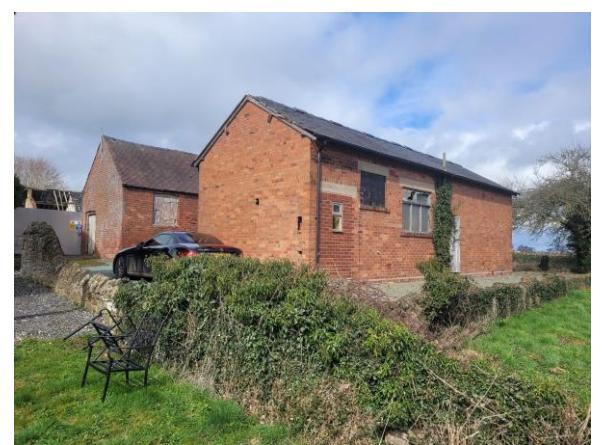
P7: Building B: viewed from the SE, looking NW

The roof-verges are mortared and intact; however, there is some potential for bats to access the gable wall tops under the end rafters. Internally the building is single-storey with a rudimentary loft space - the mdf ceiling panels are badly damaged centrally which provides uninterrupted access to the building interior from the loft space.

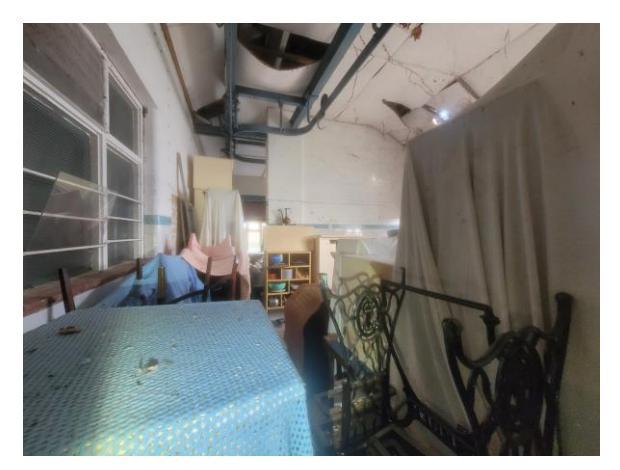
**P8:** Building B: Example of the interior

No bats, droppings or other field signs were noted in Building B; however, the building does have some moderate potential to support roosting bats in areas that could not be accessed (e.g. under the vented ridge-tiles).

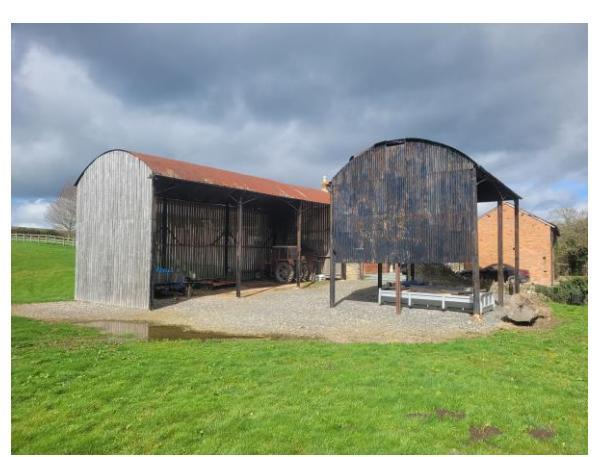
**P9:** Buildings C + D: viewed from the SE, looking NW

These are two steel framed Dutch barns, partially covered in corrugated tin sheeting. Neither building has the potential to support roosting bats.

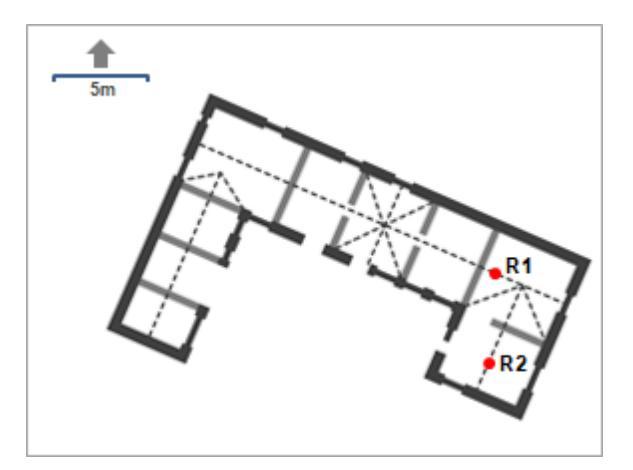
Fig 3: Roost location plan

Several hundred recent and mixed aged Brown Long-eared bat droppings were recorded on the floor in Building A under roost R1. The roost is either used by free-hanging individuals or the droppings could have been deposited by bats aggregating prior to full emergence with the roost located nearby in a more secluded location (e.g. in the ridge cavity or on top of the nearby partition wall). A single Brown Long-eared bat was also recorded roosting against the ridge-beam at roost R2.

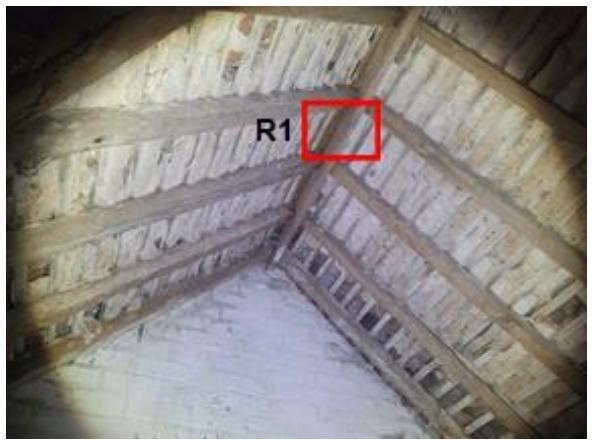
P13: Roost R1 location detail

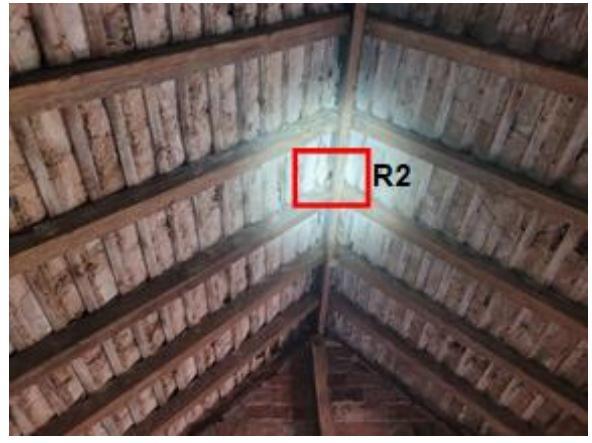
P14: Roost R2 (a single BLE bat) location detail

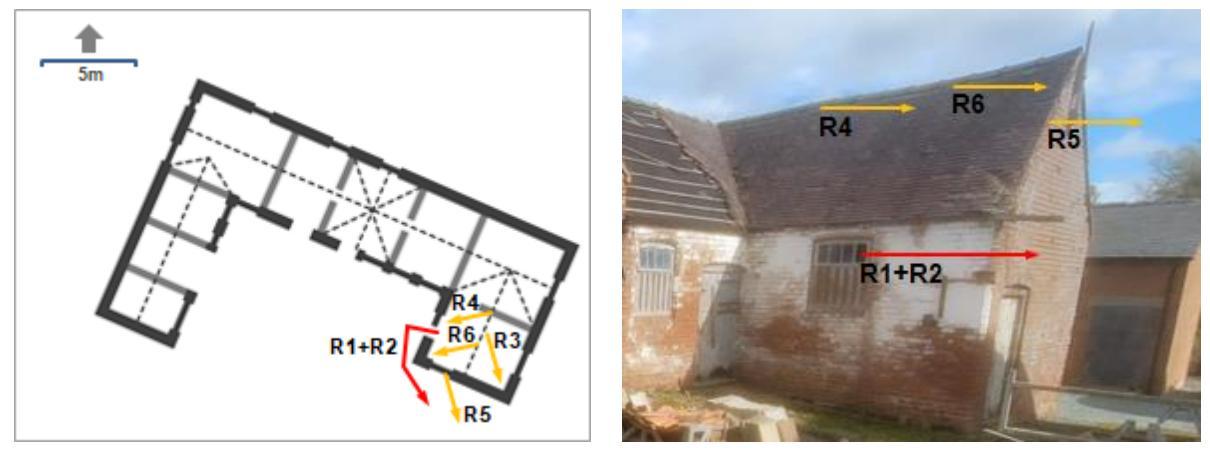
Fig 4: Roost and flightpath location plan

On arrival individual Brown Long-eared bats were recorded at Roosts R1 and R2. These emerged from a broken window pane on the west elevation of the east-wing between 22.04 and 22.09. The first bat flew around the yard and in and out of the open-fronted buildings before commuting to the stream (presumably) to the south-east. The second bat commuted directly to the stream.

A total of four Common Pipistrelle bats emerged from four different roost locations at R3 (counted six ridge-tiles along from the south gable, east roof slope, at 21.47), R4 (counted eight ridge-tiles along from the south gable, west roof slope, at 21.47), R5 (a damaged roof-verge approximately 1.25m down from the ridge, west roof slope, at 21.54) and R6 (counted four ridge-tiles along from the south gable, west roof slope, at 21.55).Two of the bats foraged around the yard and meadow to the south for most of the survey.

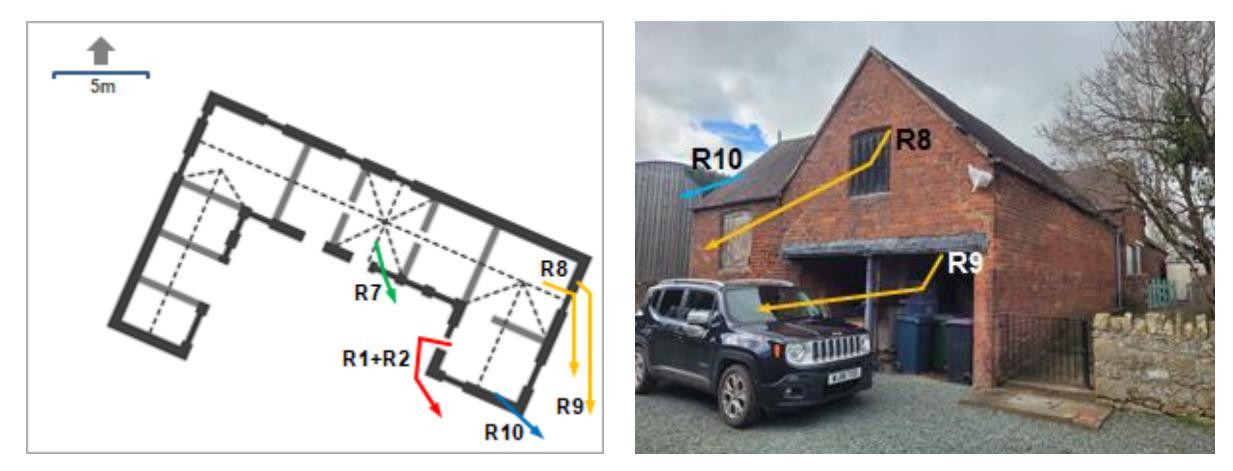
Fig 5: Roost and flightpath location plan

At 20.58 a single Whiskered bat emerged from under a ridge-tile on the central cross-wing at R7 (counted four ridge-tiles along from the south gable, east roof slope). The bat commuted to the south-east and was then recorded foraging around the Dutch barn (close to one of the bat detectors) for approximately twenty minutes (aiding species identification).

A total of two Common Pipistrelle bats emerged from two different roost locations at R8 (a crevice above the window hatch on the south-east gable, at 20.59) and R9 (a crevice behind the door lintel on the south-east gable, at 21.03).

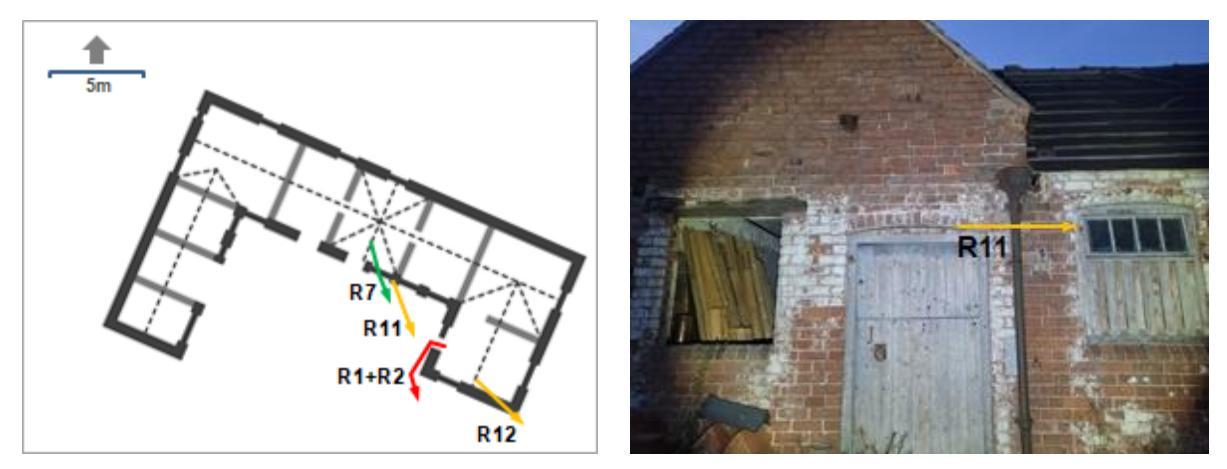
Fig 6: Roost and flightpath location plan

A total of two Common Pipistrelle bats emerged from two different roost locations at R11 (a masonry crevice above a door lintel on the cross-wing [south] gable, at 20.14) and R12 (a loose ridge-tile counted two tiles along from the south gable, east roof slope, at 20.19).

At 20.16 a single Whiskered bat emerged from the same ridge-tile roost (at R7) where it was recorded during the previous survey. The bat was then recorded foraging around the Dutch barn on and off for the majority of the survey (as during the previous survey).
