ARBORICULTURAL IMPLICATIONS ASSESSMENT

PROPOSED DEVELOPMENT

SUMMERSHADES GRASSCROFT OLDHAM

> Author: C. Salisbury Date: 06 November 2023 Ref: TRE/SGO

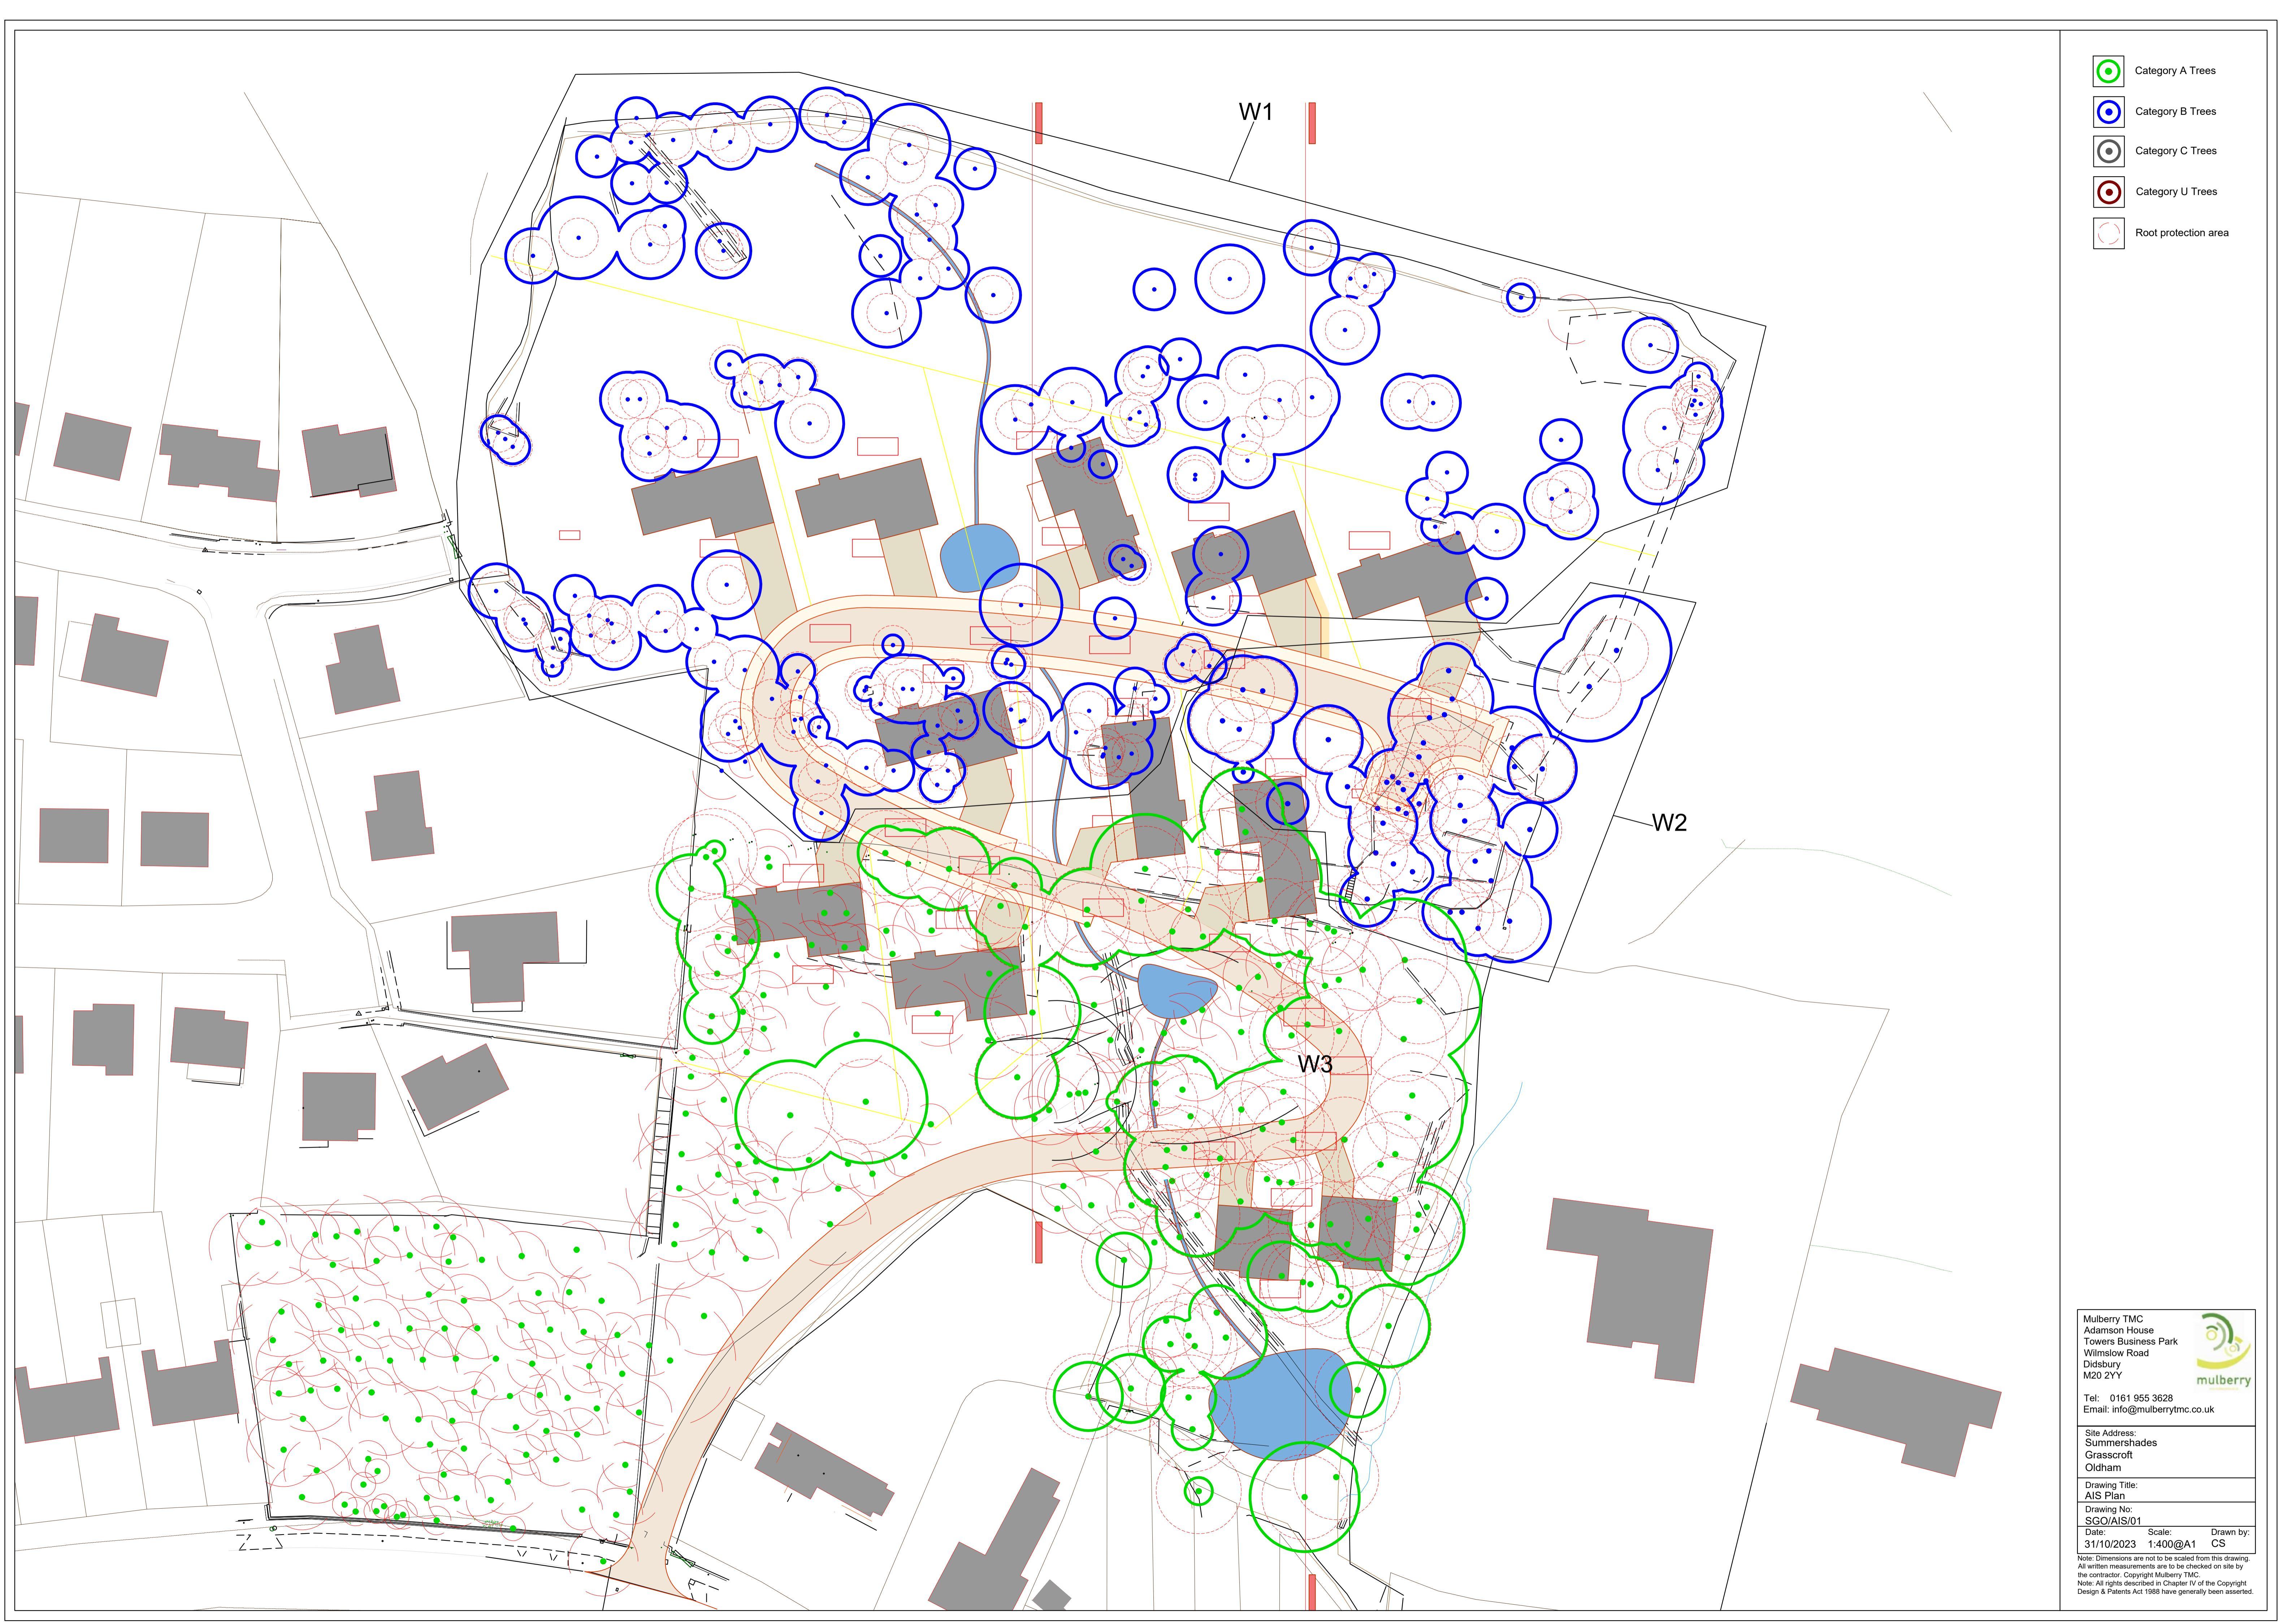
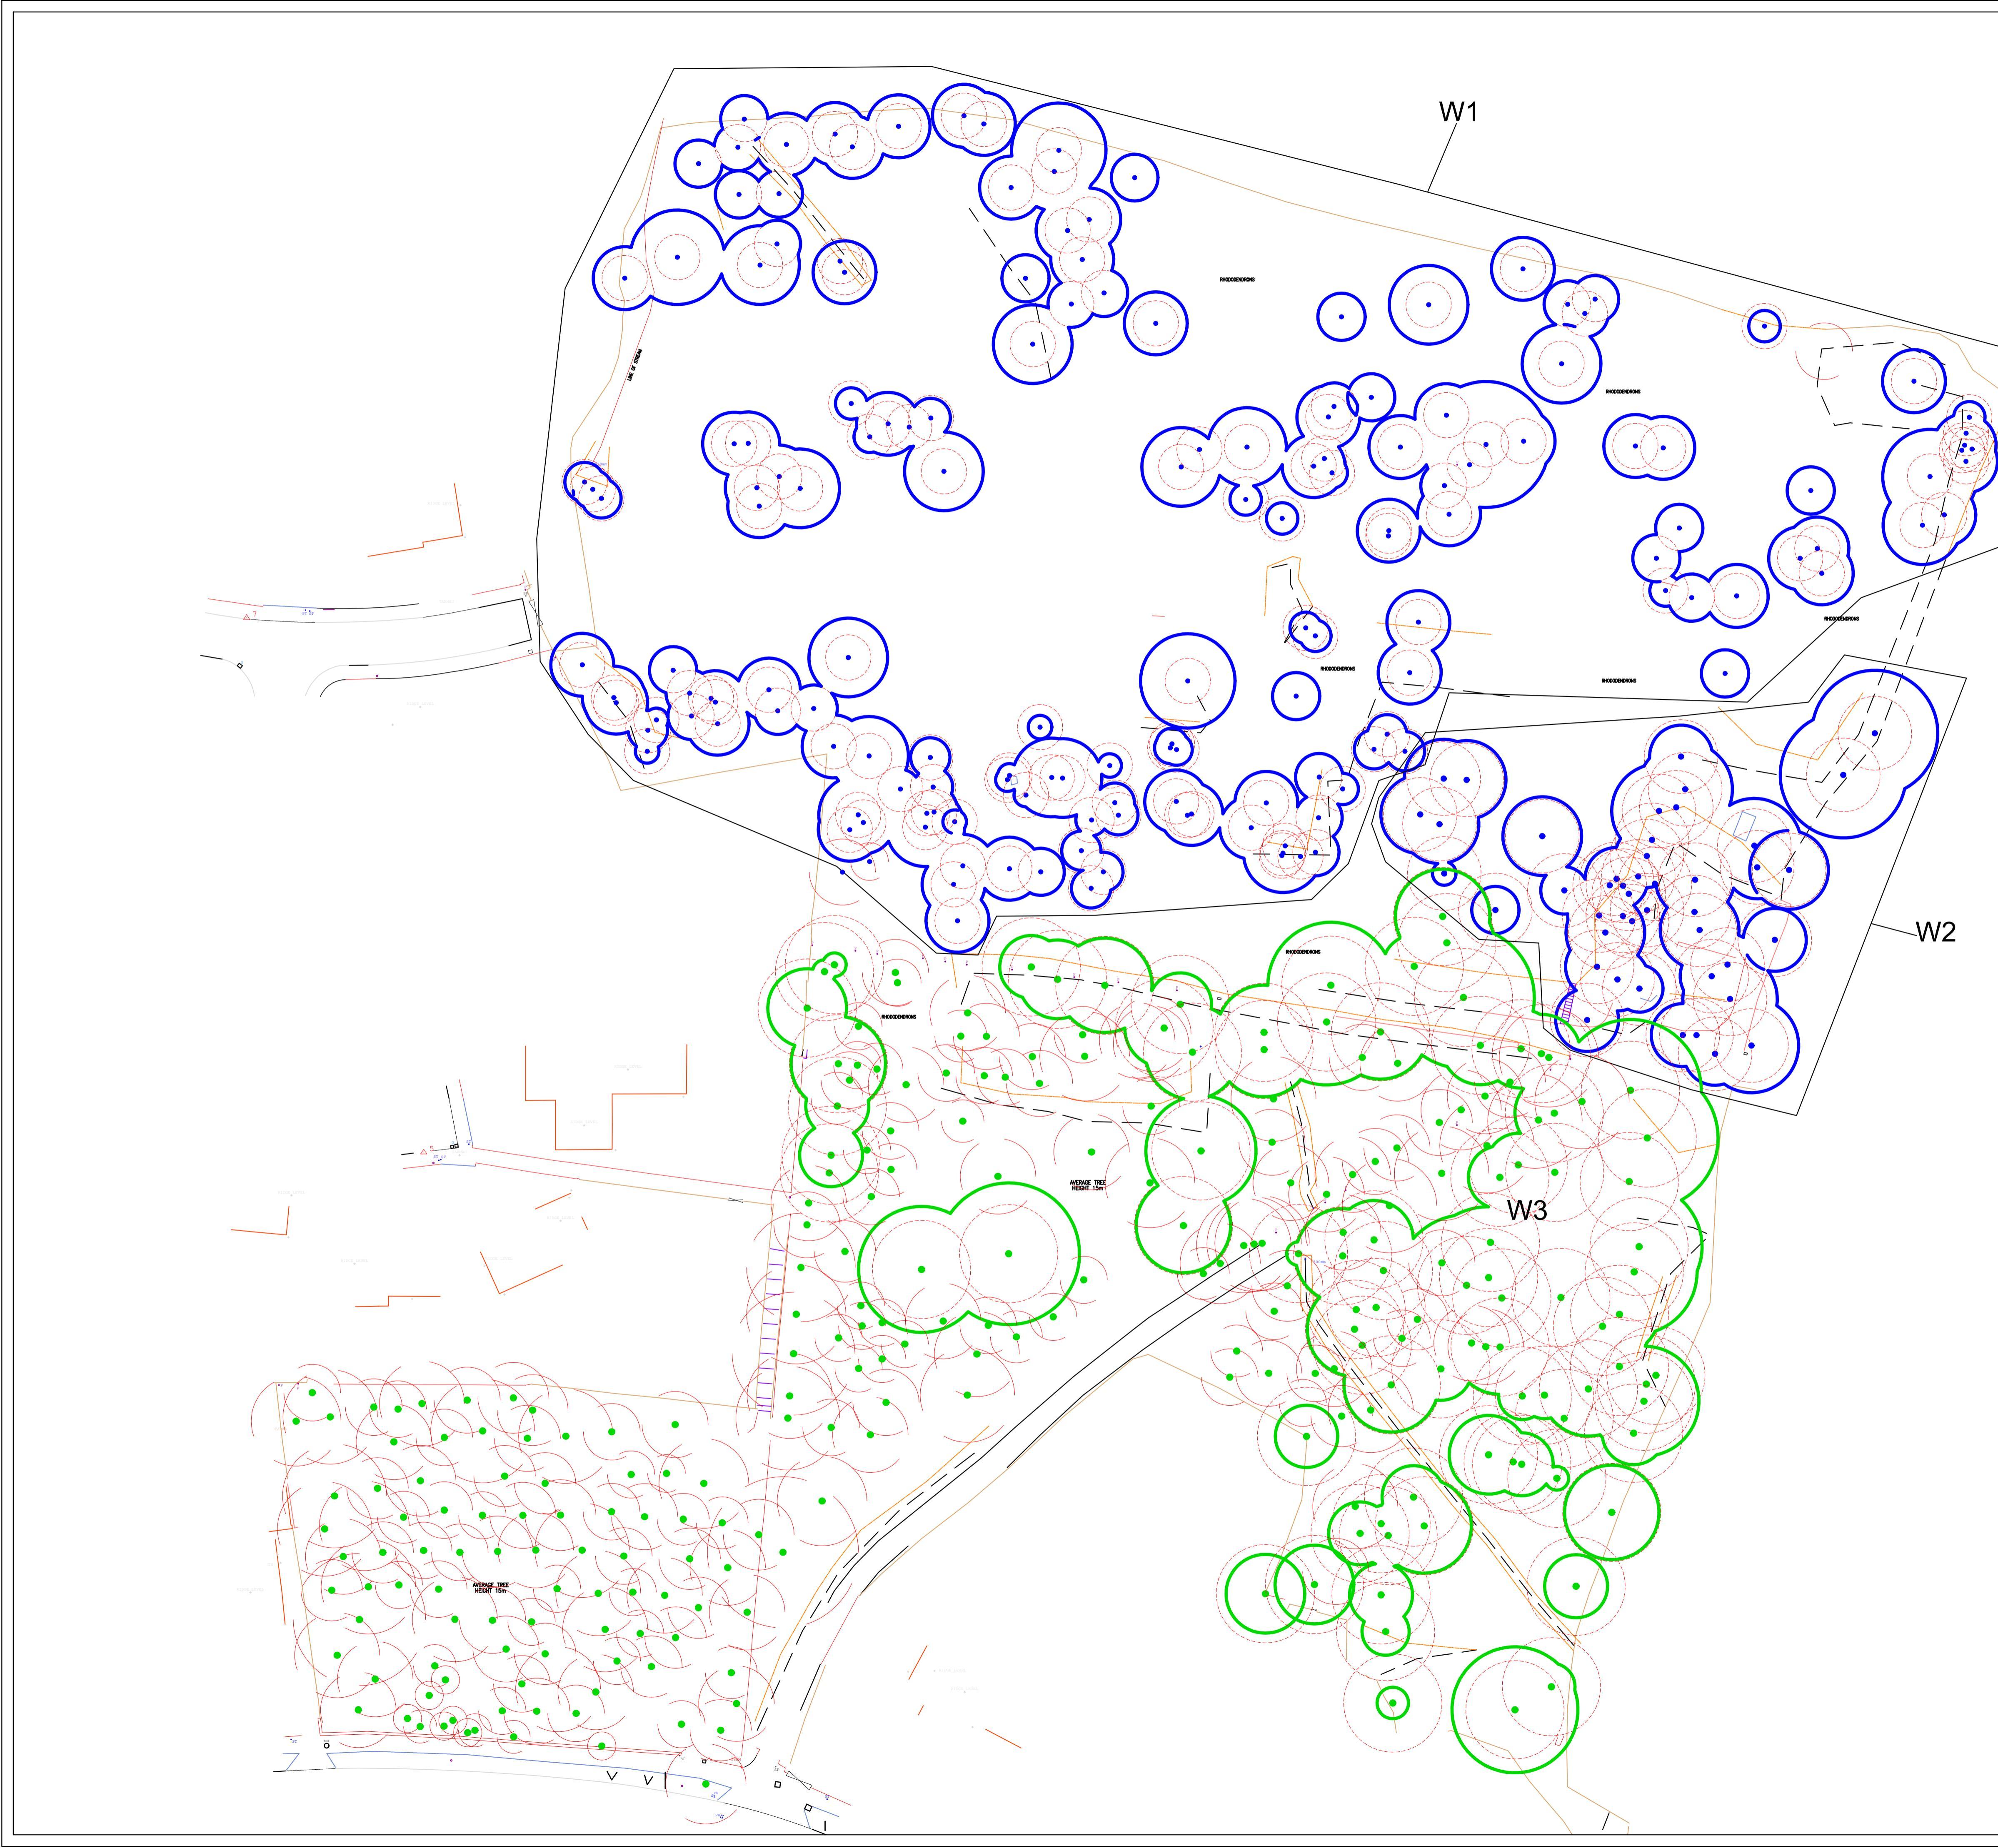
Plans

- 3.1 Due to the proposed development and its associated infrastructure there are a number of locations where the proposals are in close proximity to the trees surveyed. The Site Layout Plan within appendix three identifies the trees in relation to the proposed development.
- 3.2 In order to fully assess the impact of the proposals an Impact Table has been created detailing each tree, which shows the proximity of the associated works to the tree.
- 3.3 This can then be assessed in accordance with BS 5837:2012 to determine whether the development will have a detrimental impact on the health of each tree. Once this has been determined remedial measures can be detailed to reduce the impact the proposals will have on the treescape.
