# **GROUND GAS RISK ASSESSMENT**

# 25 Porter Street, Staveley M23-006/GAS

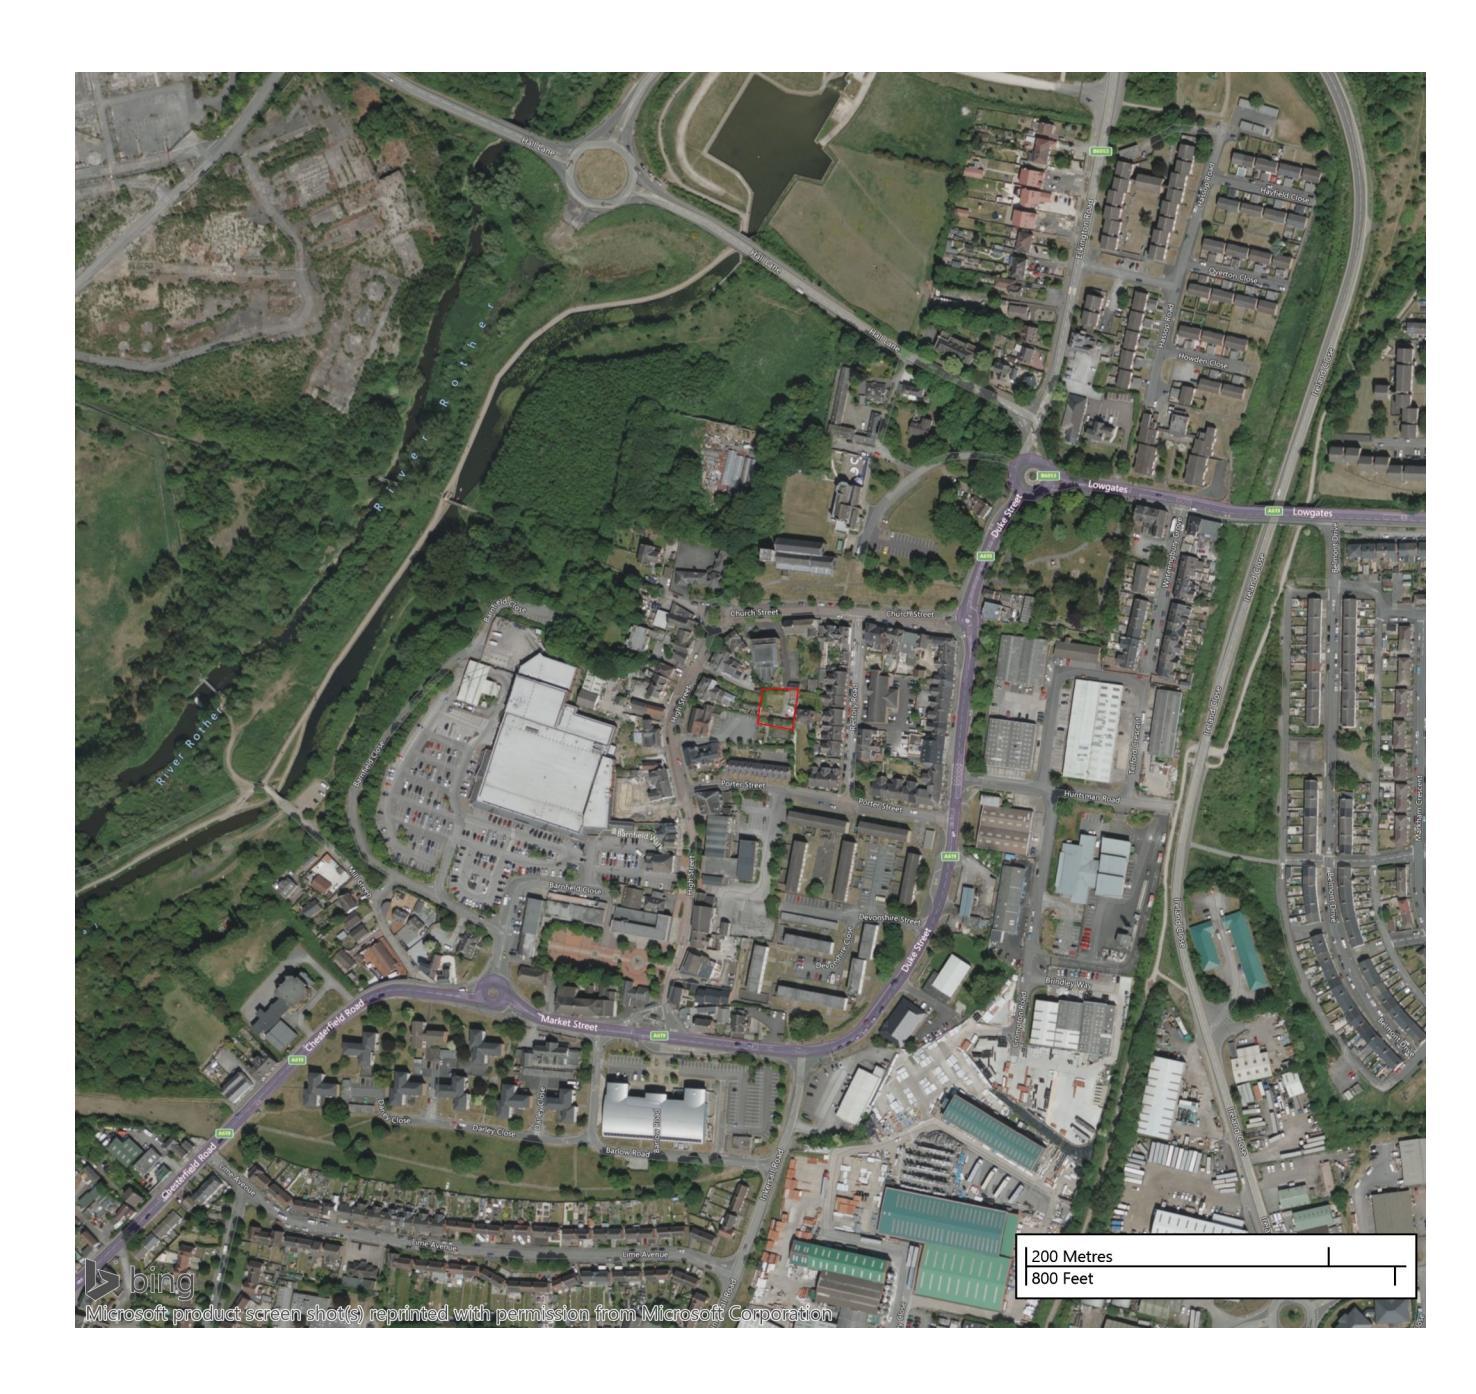
12-16 Yarm Road, Stockton on Tees, TS18 3NA Tel: 01642 607083 Email: info@solmek.com
Figure Title
Exploratory Hole Location Plan
Project Number
M23-006
Project Name
25 Porter Street, Staveley, Chesterfield
Client
David & Hilary Mateer
Date
September 2023
DRG Number
Figure 2
Scale
1:500 @ A4 [DO NOT SCALE]
Legend Key          Locations By Type - Empty         Locations By Type - RO         Project Bounds - Project Bounds

The gas was monitored by measuring emissions from a monitoring point installed into RBH03 during the fieldwork. Figure 2, appended to this letter report, shows the borehole locations.
