Ref: Construction of extension at 15 Wyndham Road, Petworth GU28 0EB.

The Ecology Co-op undertook a bat scoping assessment at 15 Wyndham Road on the 12th of February 2024 at the request of Richard Harris. This assessment was undertaken further to a proposal to construct a two-storey extension to the rear of the property. The survey was undertaken in accordance with best practice guidance produced by the Bat Conservation Trust¹.

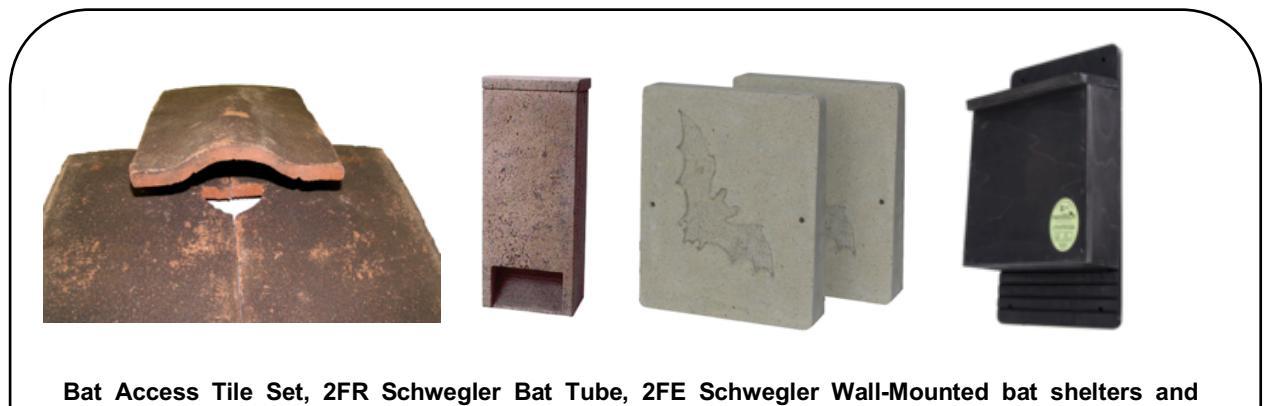
Bat Access Tile Set, 2FR Schwegler Bat Tube, 2FE Schwegler Wall-Mounted bat shelters and Improved Crevice Bat Box.

Additionally, the site can be enhanced for bats by incorporating the features below into the fabric of the building. Where bat access tiles are used, only a Type 1F bitumen lining must be used instead of modern breathable membranes such as Tyvec, which over time fray and entangle bats. The bat boxes and features should be installed under the instruction of a suitably licensed ecologist to ensure that the positioning is optimal, but generally, locations above 3.5m in the most southeasterly facing aspect of the building would be best.

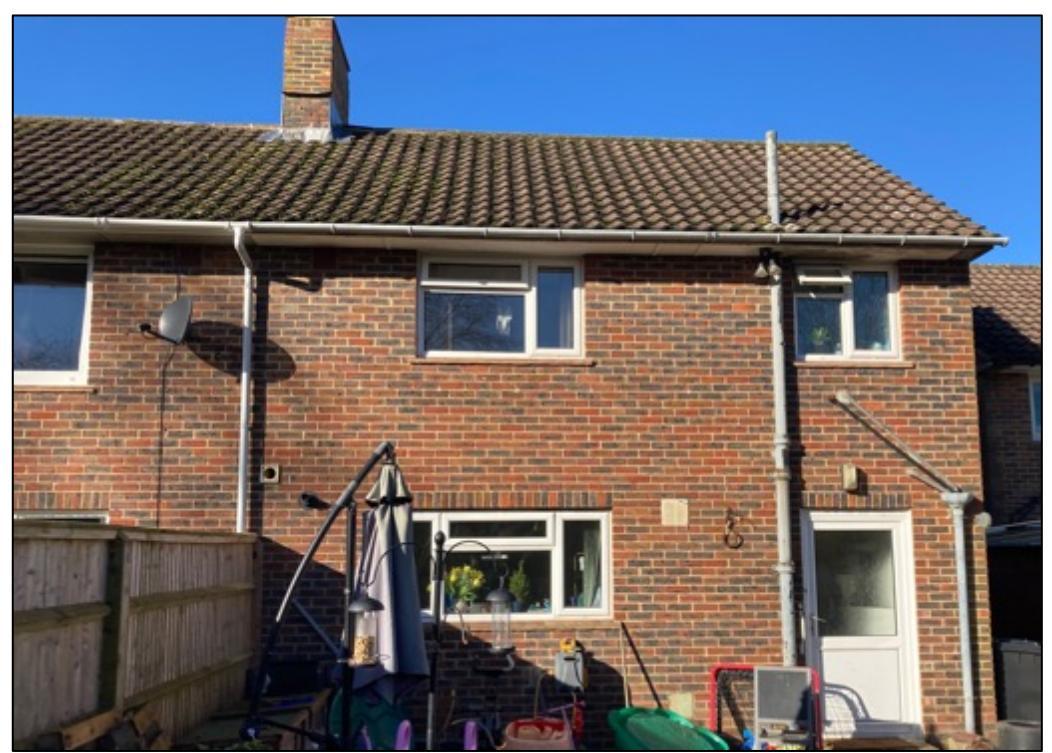
Building section	Description of features	Assessment of suitability (Collins 2016)
Main house - exterior	Brick two-storey residential property with hipped concrete tile roof. No loose or missing tiles. No cracks or gaps in brick work or wooden fascia. No gaps in ridge tiles. No lifted lead flashing at chimney base.	Negligible bat roost suitability

Photograph 1. The rear elevation of the property. Note the intact tiles, brickwork and sealed soffit boxes.

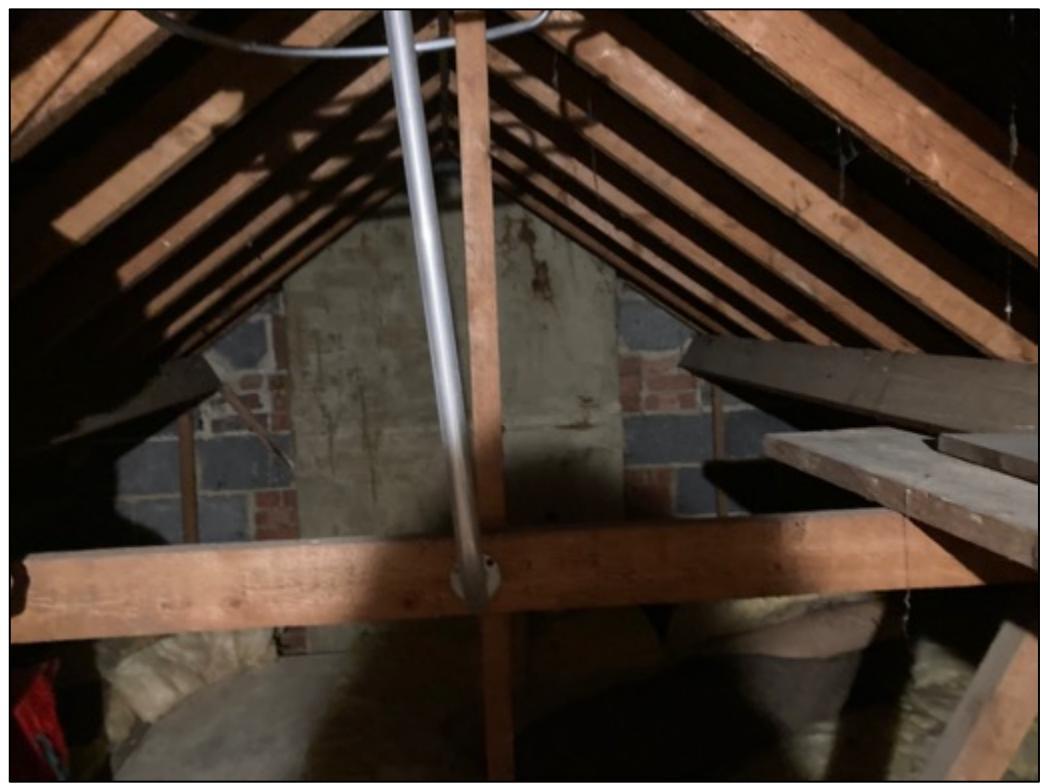
Building section	Description of features	Assessment of suitability (Collins 2016)
Main house – interior	The roof void measures approximately 5m (I), 4m (w) and 2m (h). The void is used for storage and there were no recent signs of disturbance. Membrane is present throughout and a layer of rockwool insulates the floor area. There are no gaps present at the eaves or tears in the membrane. The crossbeams of the wooden supporting frame does not support any cracks or crevices. No evidence of bats was identified within the loft space.	Negligible bat roost suitability

Photograph 2. Internal void space. No evidence of bats was identified.
