Existing Tree Report

In accordance with BS5837:2012:
Trees in relation to Design, Demolition,
and Construction - Recommendations

**PLOTS ADJACENT TO SPRINGFIELD
REJERRA, NEWQUAY, CORNWALL TR8 5QA**

EXISTING TREE SURVEY REPORT

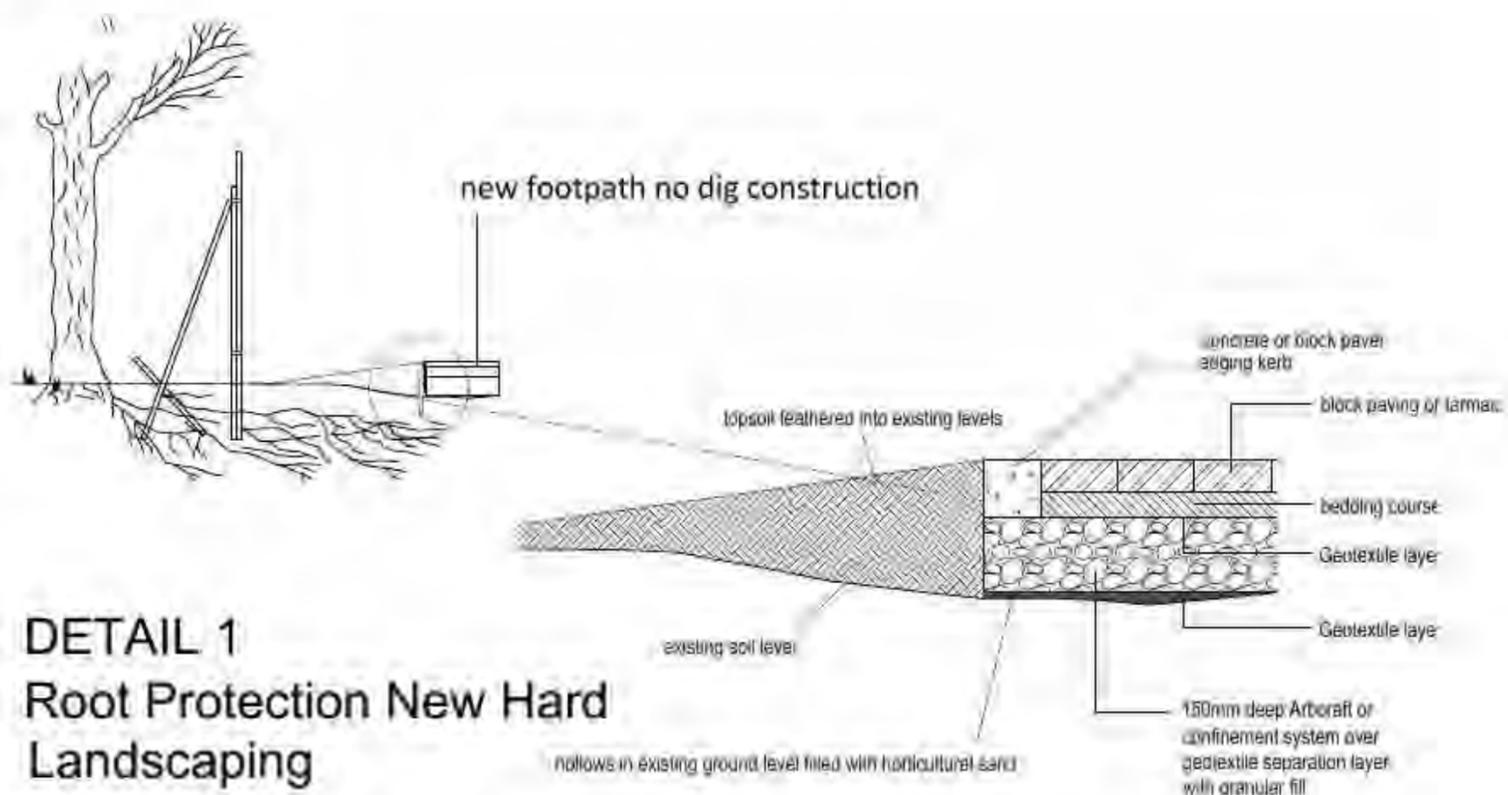
Fig. 1. Example of protective fencing and signage:

Trees to be retained will require protection throughout the duration of the proposed development with protective fencing and signage (see Fig. 1 and 2 below). To ensure retention of adequate protection throughout the development process, regular site monitoring should be carried out on a formal and agreed basis to report on the condition and status of protective fencing and other methods. Protection methods should also give due consideration to the movement of site vehicles and the movement of construction materials to avoid collision with tree canopies.

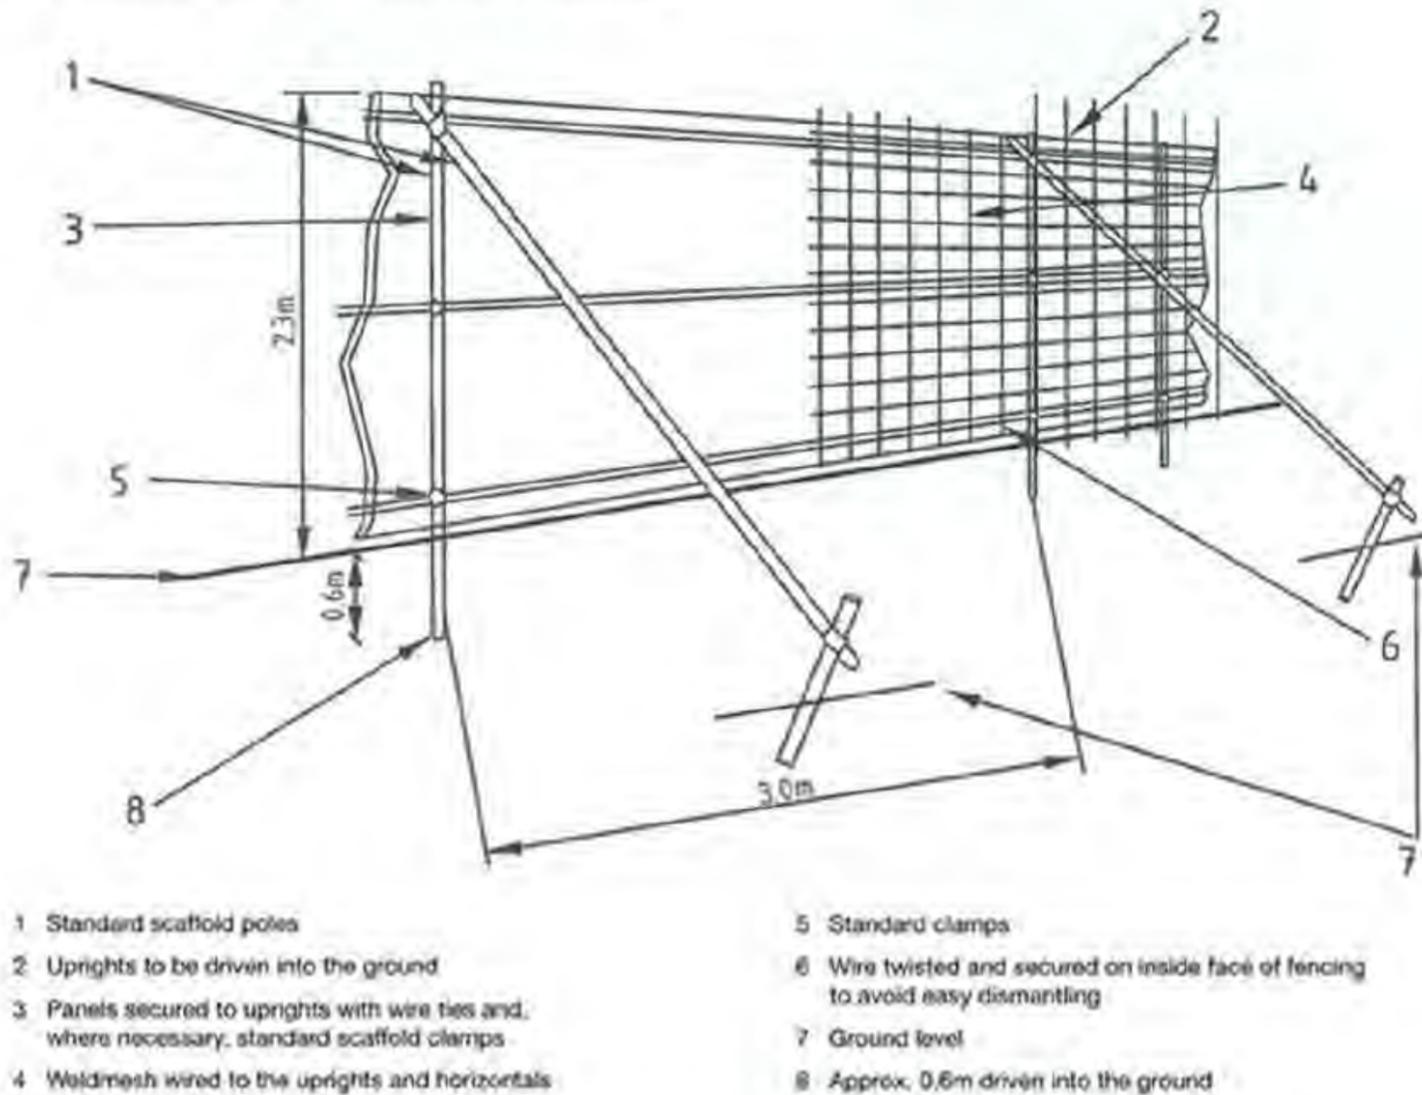
Fig. 2. Protective fencing for tree root protection:

Where necessary, a root protection area was calculated for each tree in accordance with BS 5837:2012. Drawing No. 2068-001 Existing Tree Survey and Root Protection Areas provides details of the extent of calculated RPA. Protective barriers are to be placed around these areas or beyond the line of the canopy, whichever is the greater.

Figure 2. – Protective fencing for RPA
