An archaeological desk-based assessment for the Enderby Relief Road, Enderby, Leicestershire (SP 5409 0030)

# **Trustees of ERB Drummond Deceased**

ULAS Report Number 2016-100 ©2016

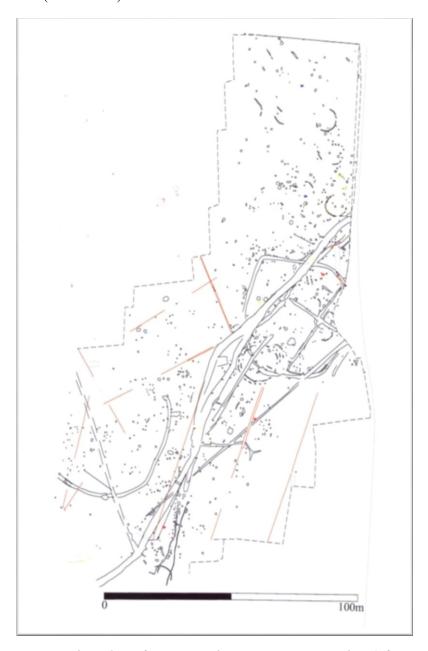
Figure 4: Pre-excavation plan of current Leicester Lane excavation (after Jarvis 2016) Trial trenching along the line of the Roman Road known as the Fosse Way (see below),

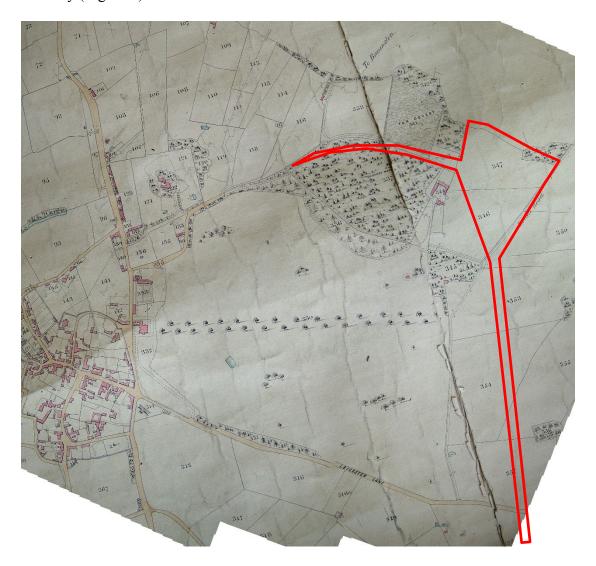
Figure 5: Detail of 1851 tithe map of Enderby with proposed new road approximately highlighted. Scale Unknown

The earliest map of the area to show a decent amount of detail is the 1851 tithe map of Enderby (Figure 5).

This is highly detailed and shows the area before much of the area around Warren Farm had been quarried. The line of the road crosses a number of fields. Mainly fields 346, 347, 353, 354 and 357. The tithe award for the village shows that at this time these fields were known as 'Home Close' (346), 'Gorse Spinney Close' (347), 'First Fish Pool Close' (353), 'Fishpool Close' (354) and 'Second Roe Close' (357). Gorse

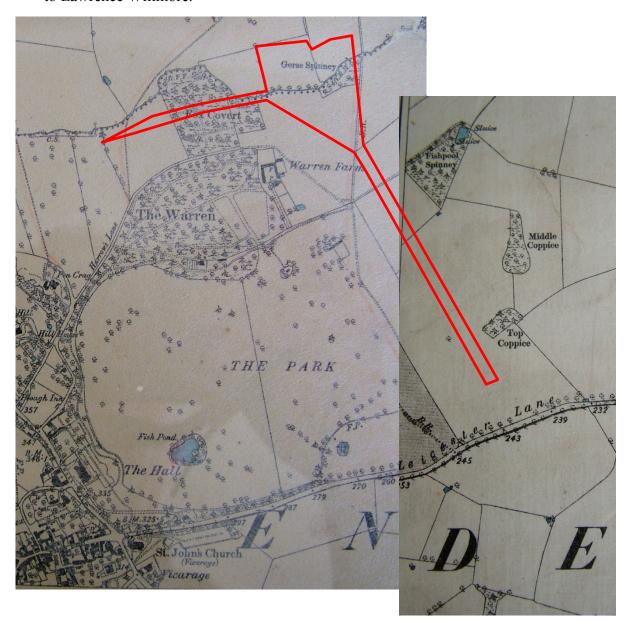
Figure 6: Detail of first edition Ordnance Survey map, sheets XXXVI.NE & XXXVI.NW, with assessment area highlighted. Scale 6 inch to 1 mile

The next available map is the first edition Ordnance Survey map dated 1884. The assessment area lies over two sheets and has been merged for convenience (Figure 6).

Much of the southern and eastern part of the proposed road lies within a single field at this time as many of the boundaries have been removed in this area. The southern part of the road now broadly follows the line of a single boundary running north-west to south-east across the fields.

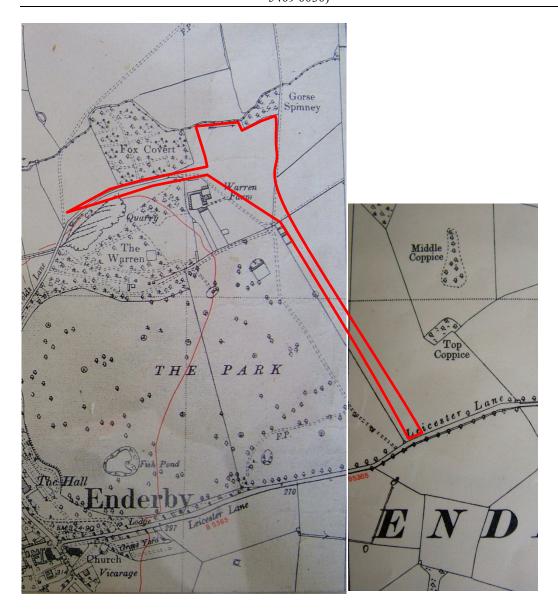
Figure 8: Detail of 1951 edition Ordnance Survey map, sheets XXXVI. NE & XXXVI. NW, with assessment area highlighted. Scale 6 inch to 1 mile

The first map to show any appreciable difference is the OS map of 1951. The site still lies over two map sheets, which again have been merged for convenience (Figure 8).

The wooded area known as The Warren is beginning to be quarried and this is the first map to show the cottages to the south-east of Warren Farm. Otherwise the view is much the same.

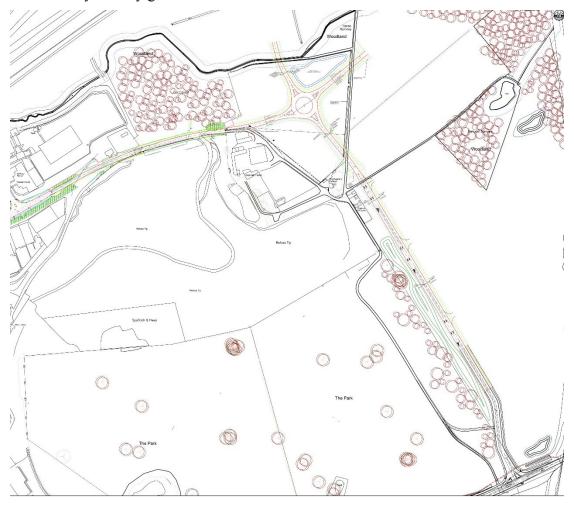
Figure 12: Plan of proposed new relief road. Provided by developer. Scale Unknown
