Alterations to 6 Coastguard Cottages, Langton Herring.

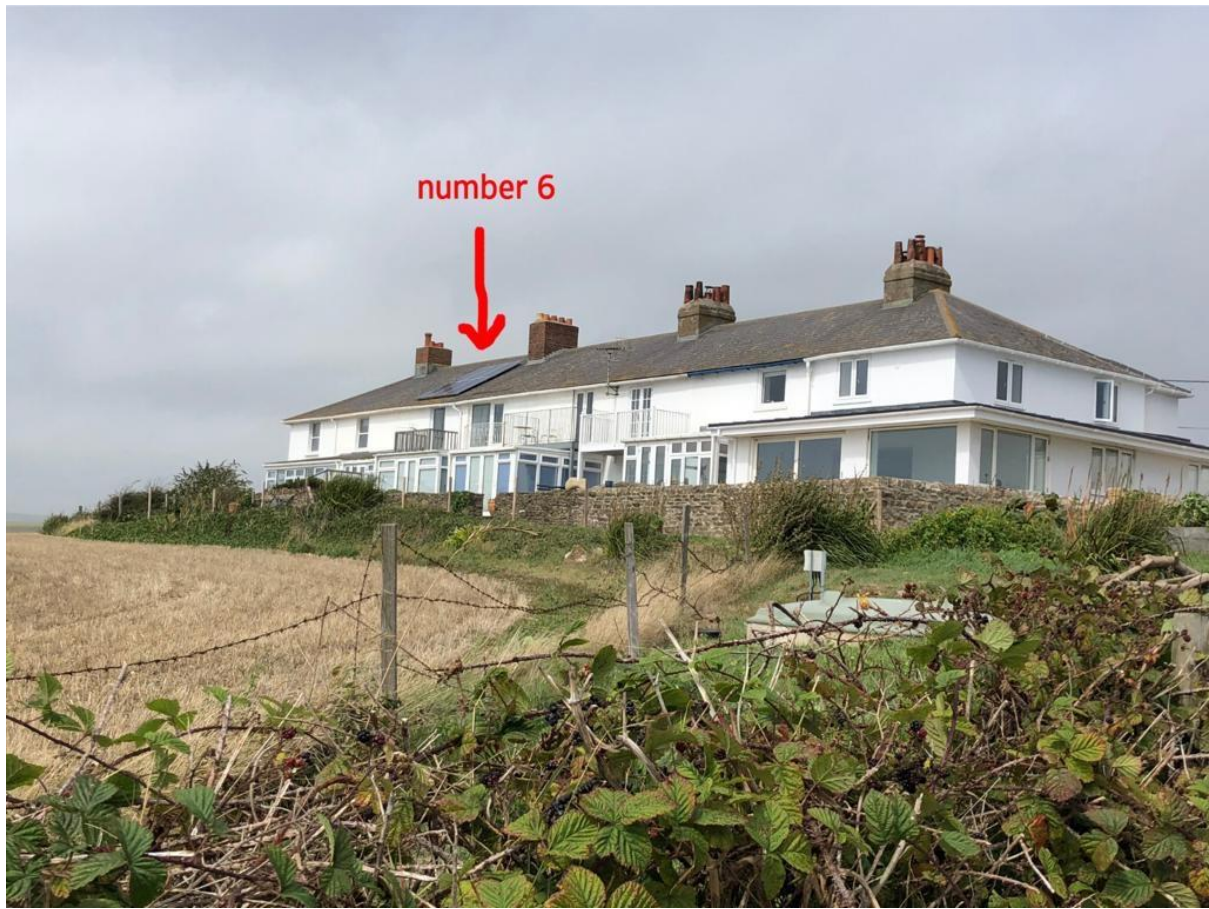
Coastguard Cottages photographed from the south east.

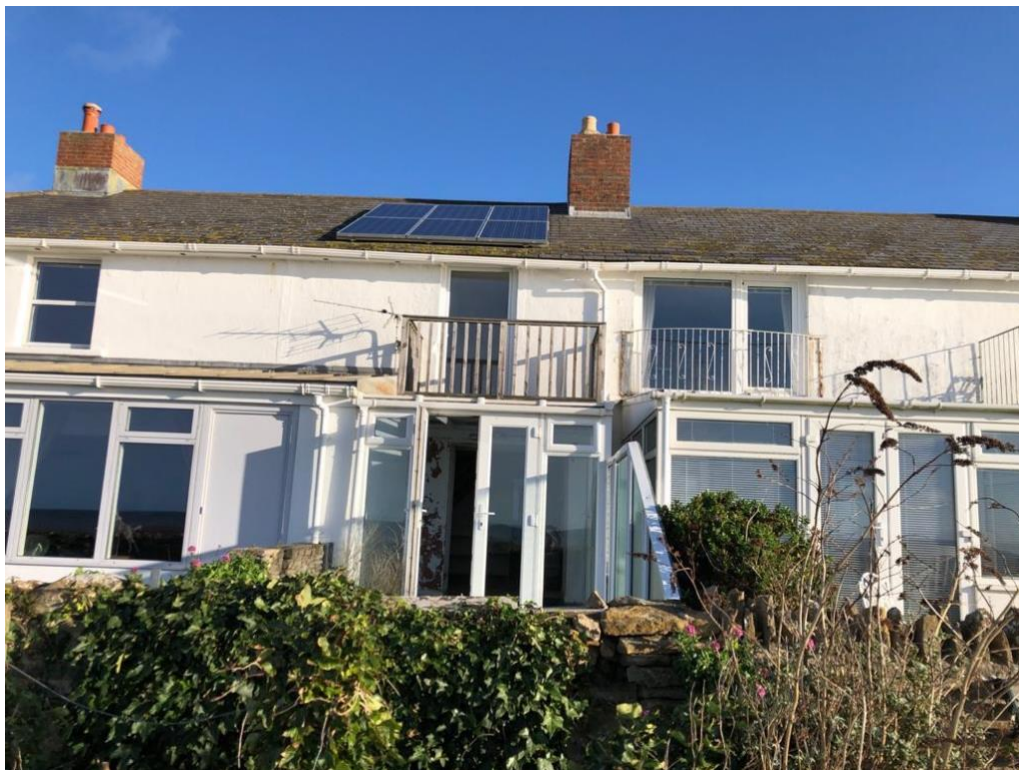
South elevation of 6 Coastguard Cottages

The alterations proposed to 6 Coastguard Cottages simply consist of the replacement of the existing balcony and conservatory, increasing the width of the existing openings to the living room and south facing bedroom with an addition of a window to the south elevation. A Velux window and the replacement of section of roof constructed of substandard plastic sheeting is proposed to the “boot” room to the rear of the main dwelling. In addition the north facing roof to the dwelling is to be altered to a continuous slope removing the V shaped step that is now no longer completely watertight.

The current conservatory and balcony require removing as they currently are allowing significant influx of water into the dwelling. Upon inspection it is clear that repair would not be effective.

Materials proposed for the balcony balustrade is marine grade stainless steel to the handrail and posts with toughened glass forming the safety barrier. The conservatory will be colour coated aluminium with matching materials to the French door and window to the first floor bedroom. All glazing to the south elevation is proposed to be triple glazing. Existing render is to be repaired and repainted to match the existing in colour and texture.
