Project  
**WOODSTOCK STREET CHURCH**

Title  
**WEST FACING ROSE LANCET**

Main Church, West Facing Lancet - Window ref. W67

Drg No. **[21]11** Rev **A**

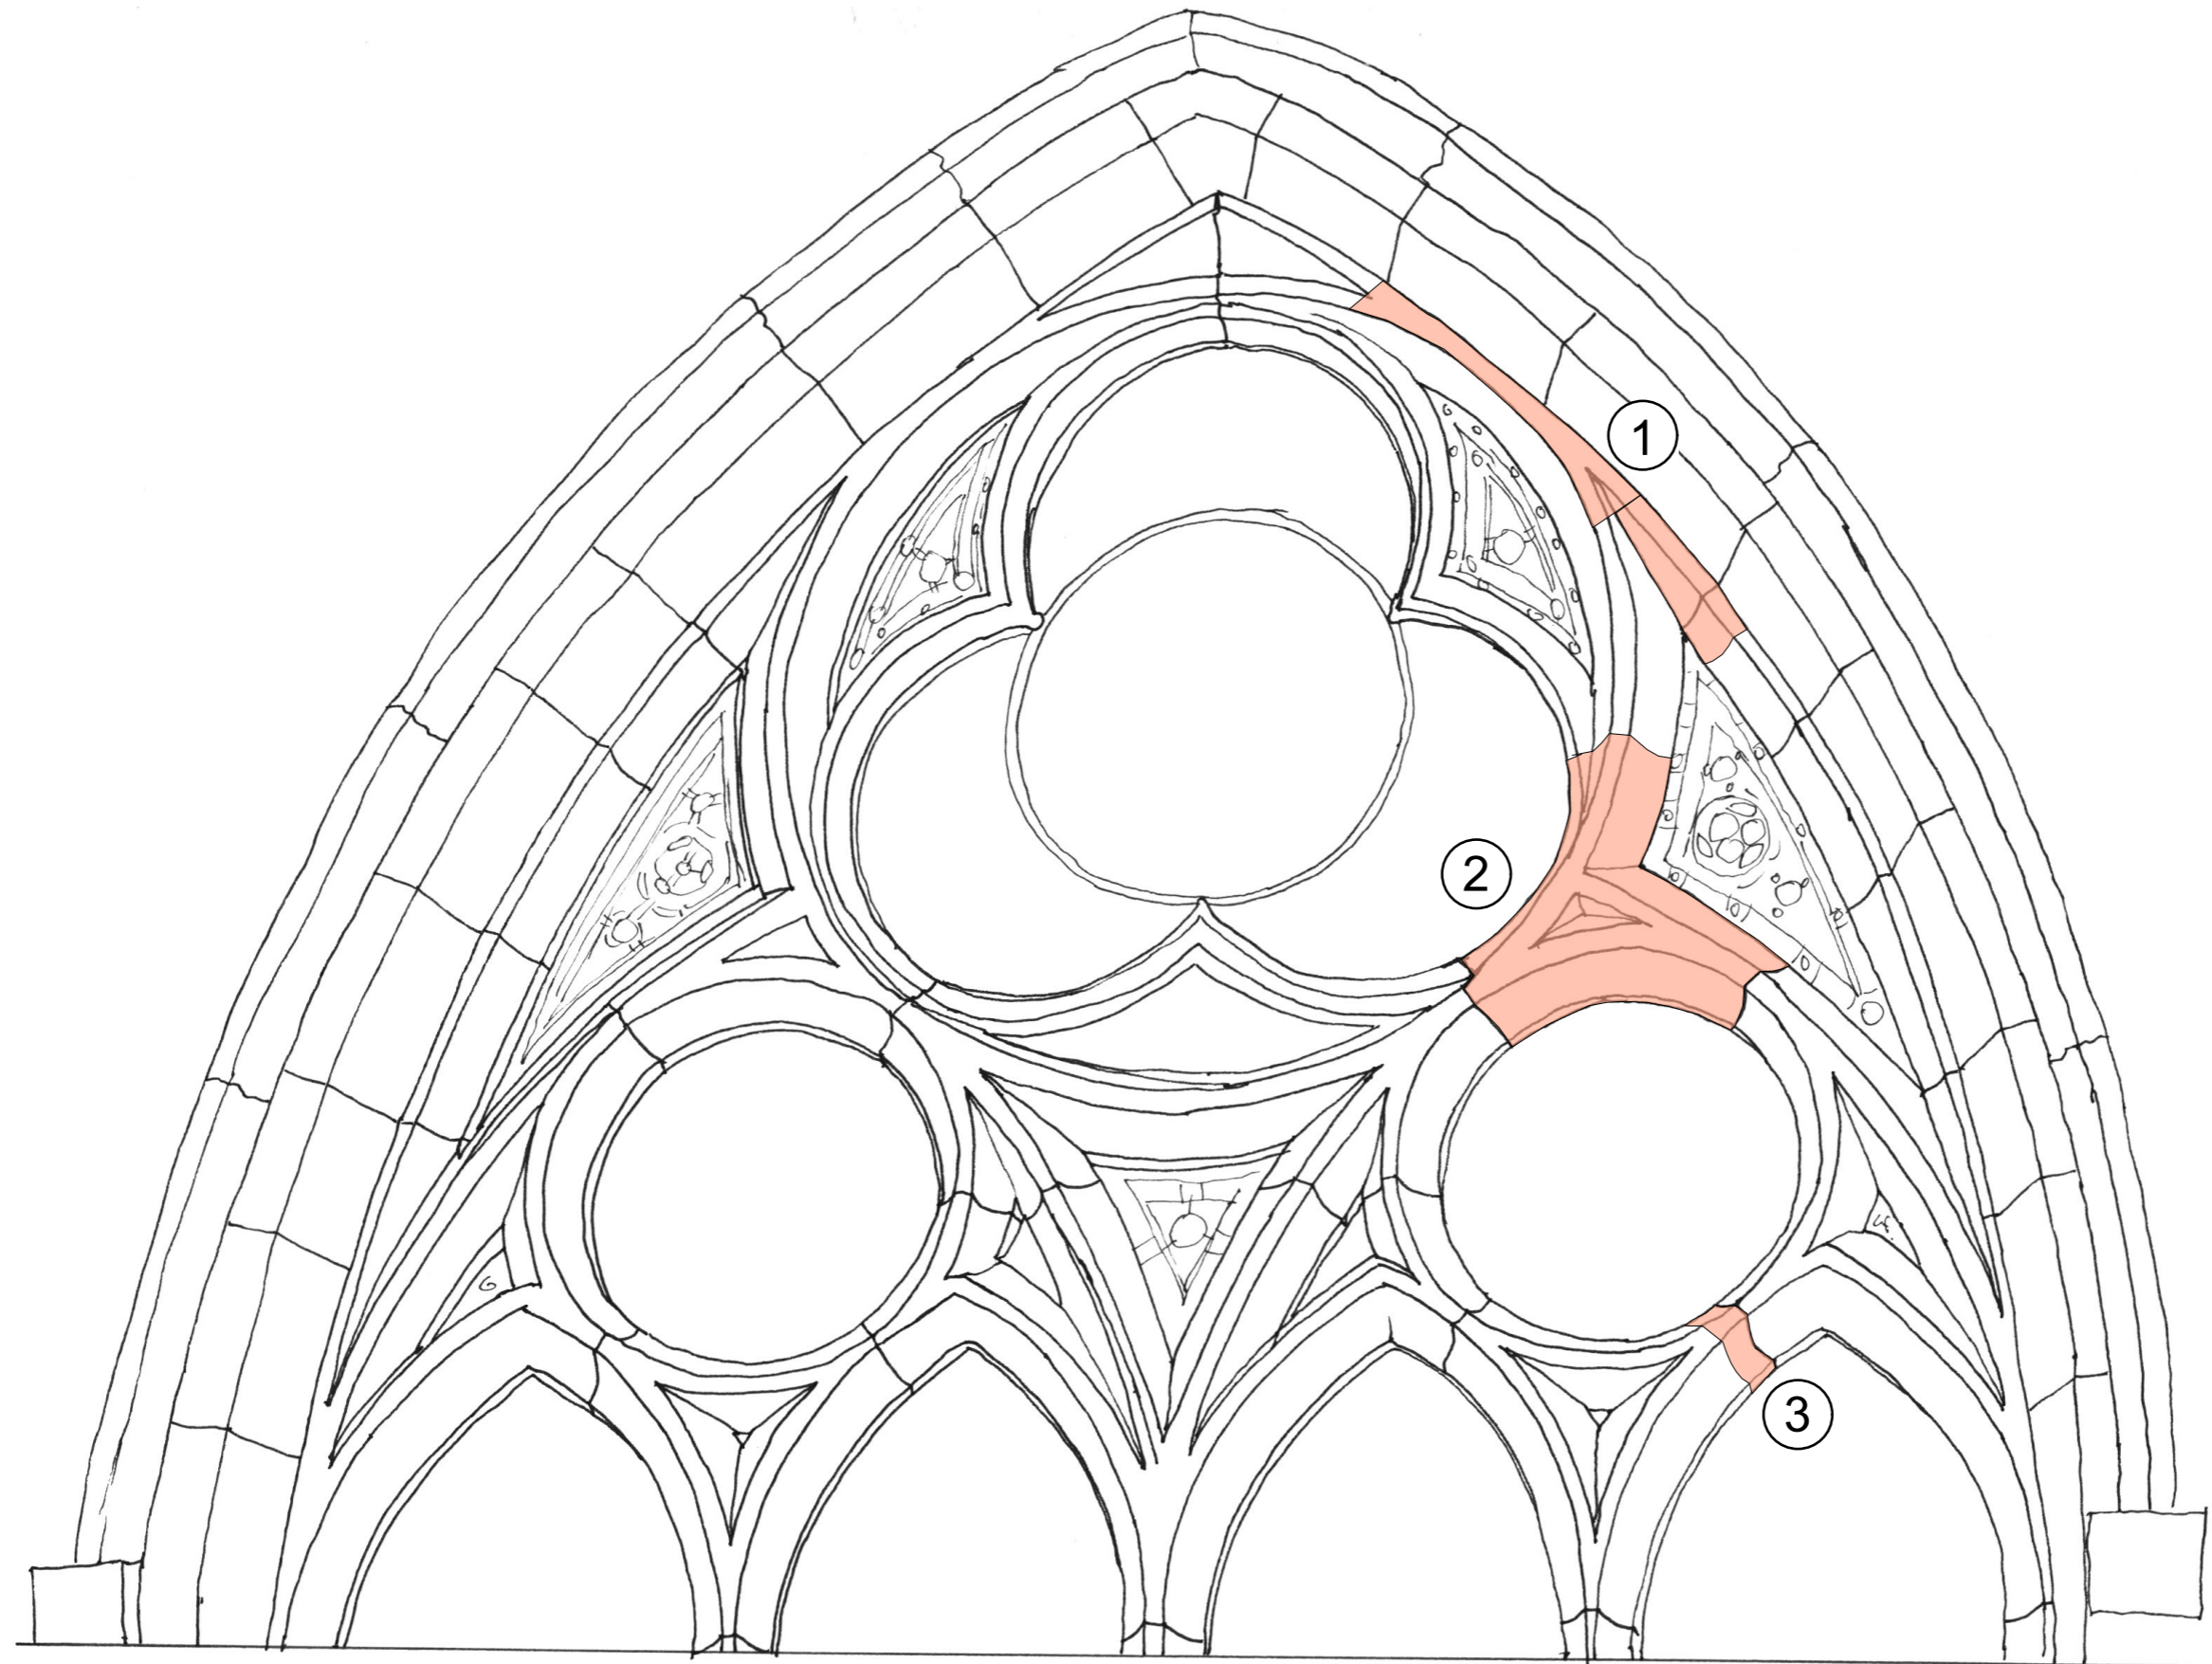
Stone indents: Sandstone to best match existing as determined by petrographic analysis. Unless otherwise indicated repairs at tracery to be full stone indents (Type 1 potential partial indent).

Stone repairs to be carried out whilst stained glass has been removed from site by Rainbow Glass.

All stone indents to be fixed with 6mm SS dowels to SE spec.

Mason, SE and CA to agree on approach to repair type 3 to achieve a robust solution on site. Team to agree methodology for replacement and schedule of works to avoid destabilisation of structure during indents.
