**GROUND INVESTIGATION**

**13A QUEEN STREET**

**SOILTEC LABORATORIES LIMITED**

**Report No: 07750/23**

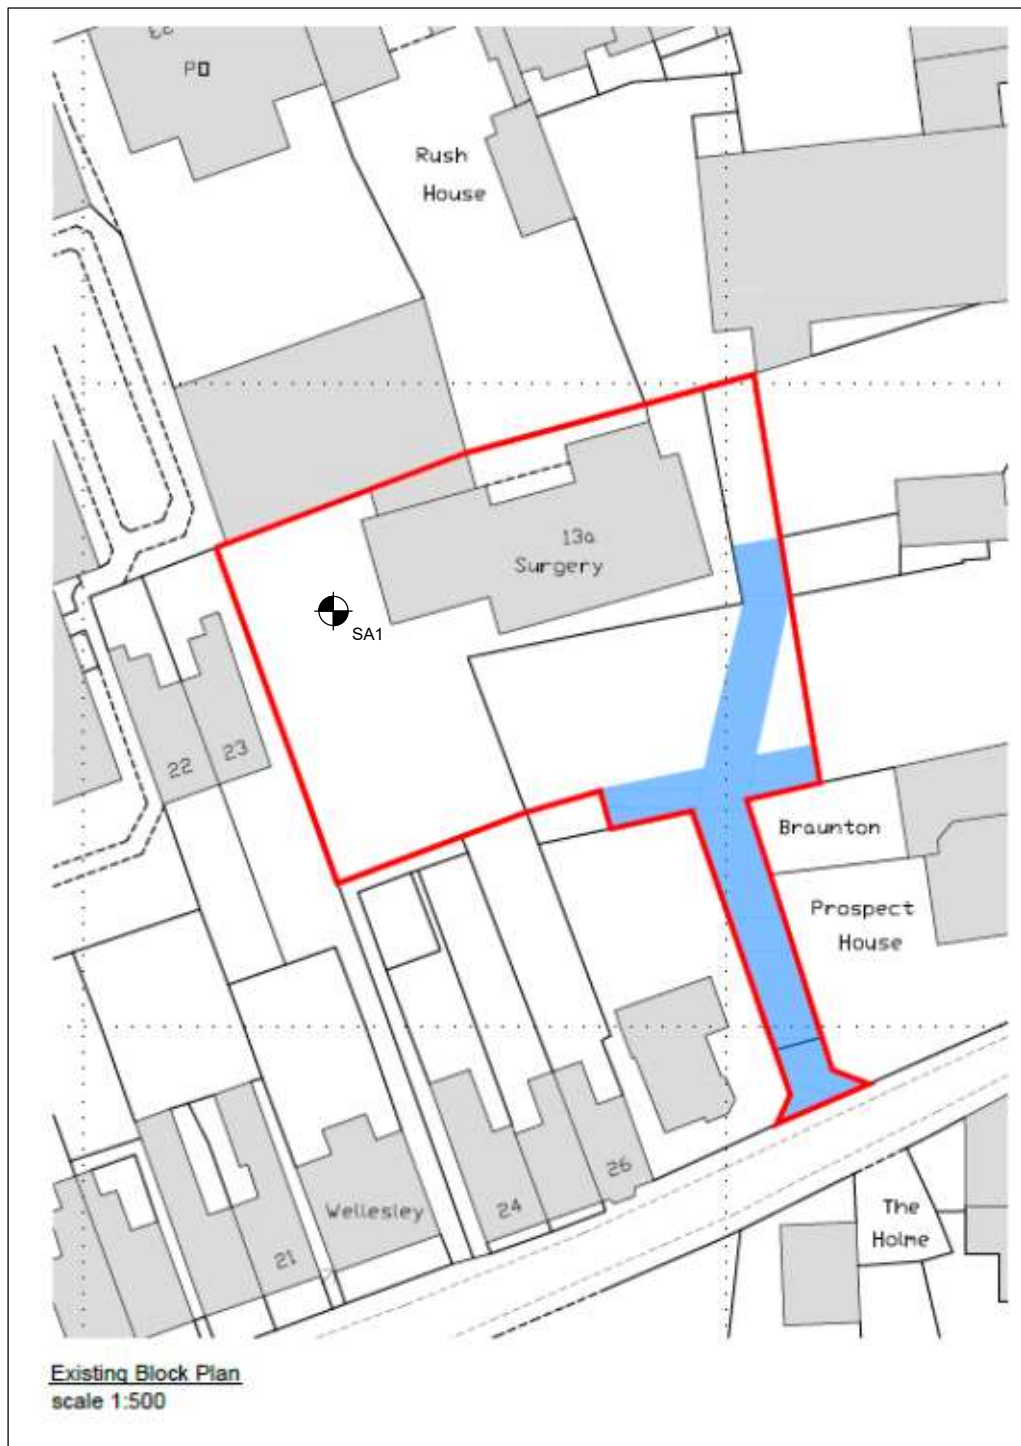
## **SITE PLAN**

The borehole location is shown on the block plan included with this report.
