CLIENT:  
**CHUBB EUROPEAN GROUP SE**

PROJECT:  
**28-30 WARWICK AVENUE LONDON W9 2PT**

TITLE:  
**EXISTING PLAN, ELEVATION AND SECTION AA'**

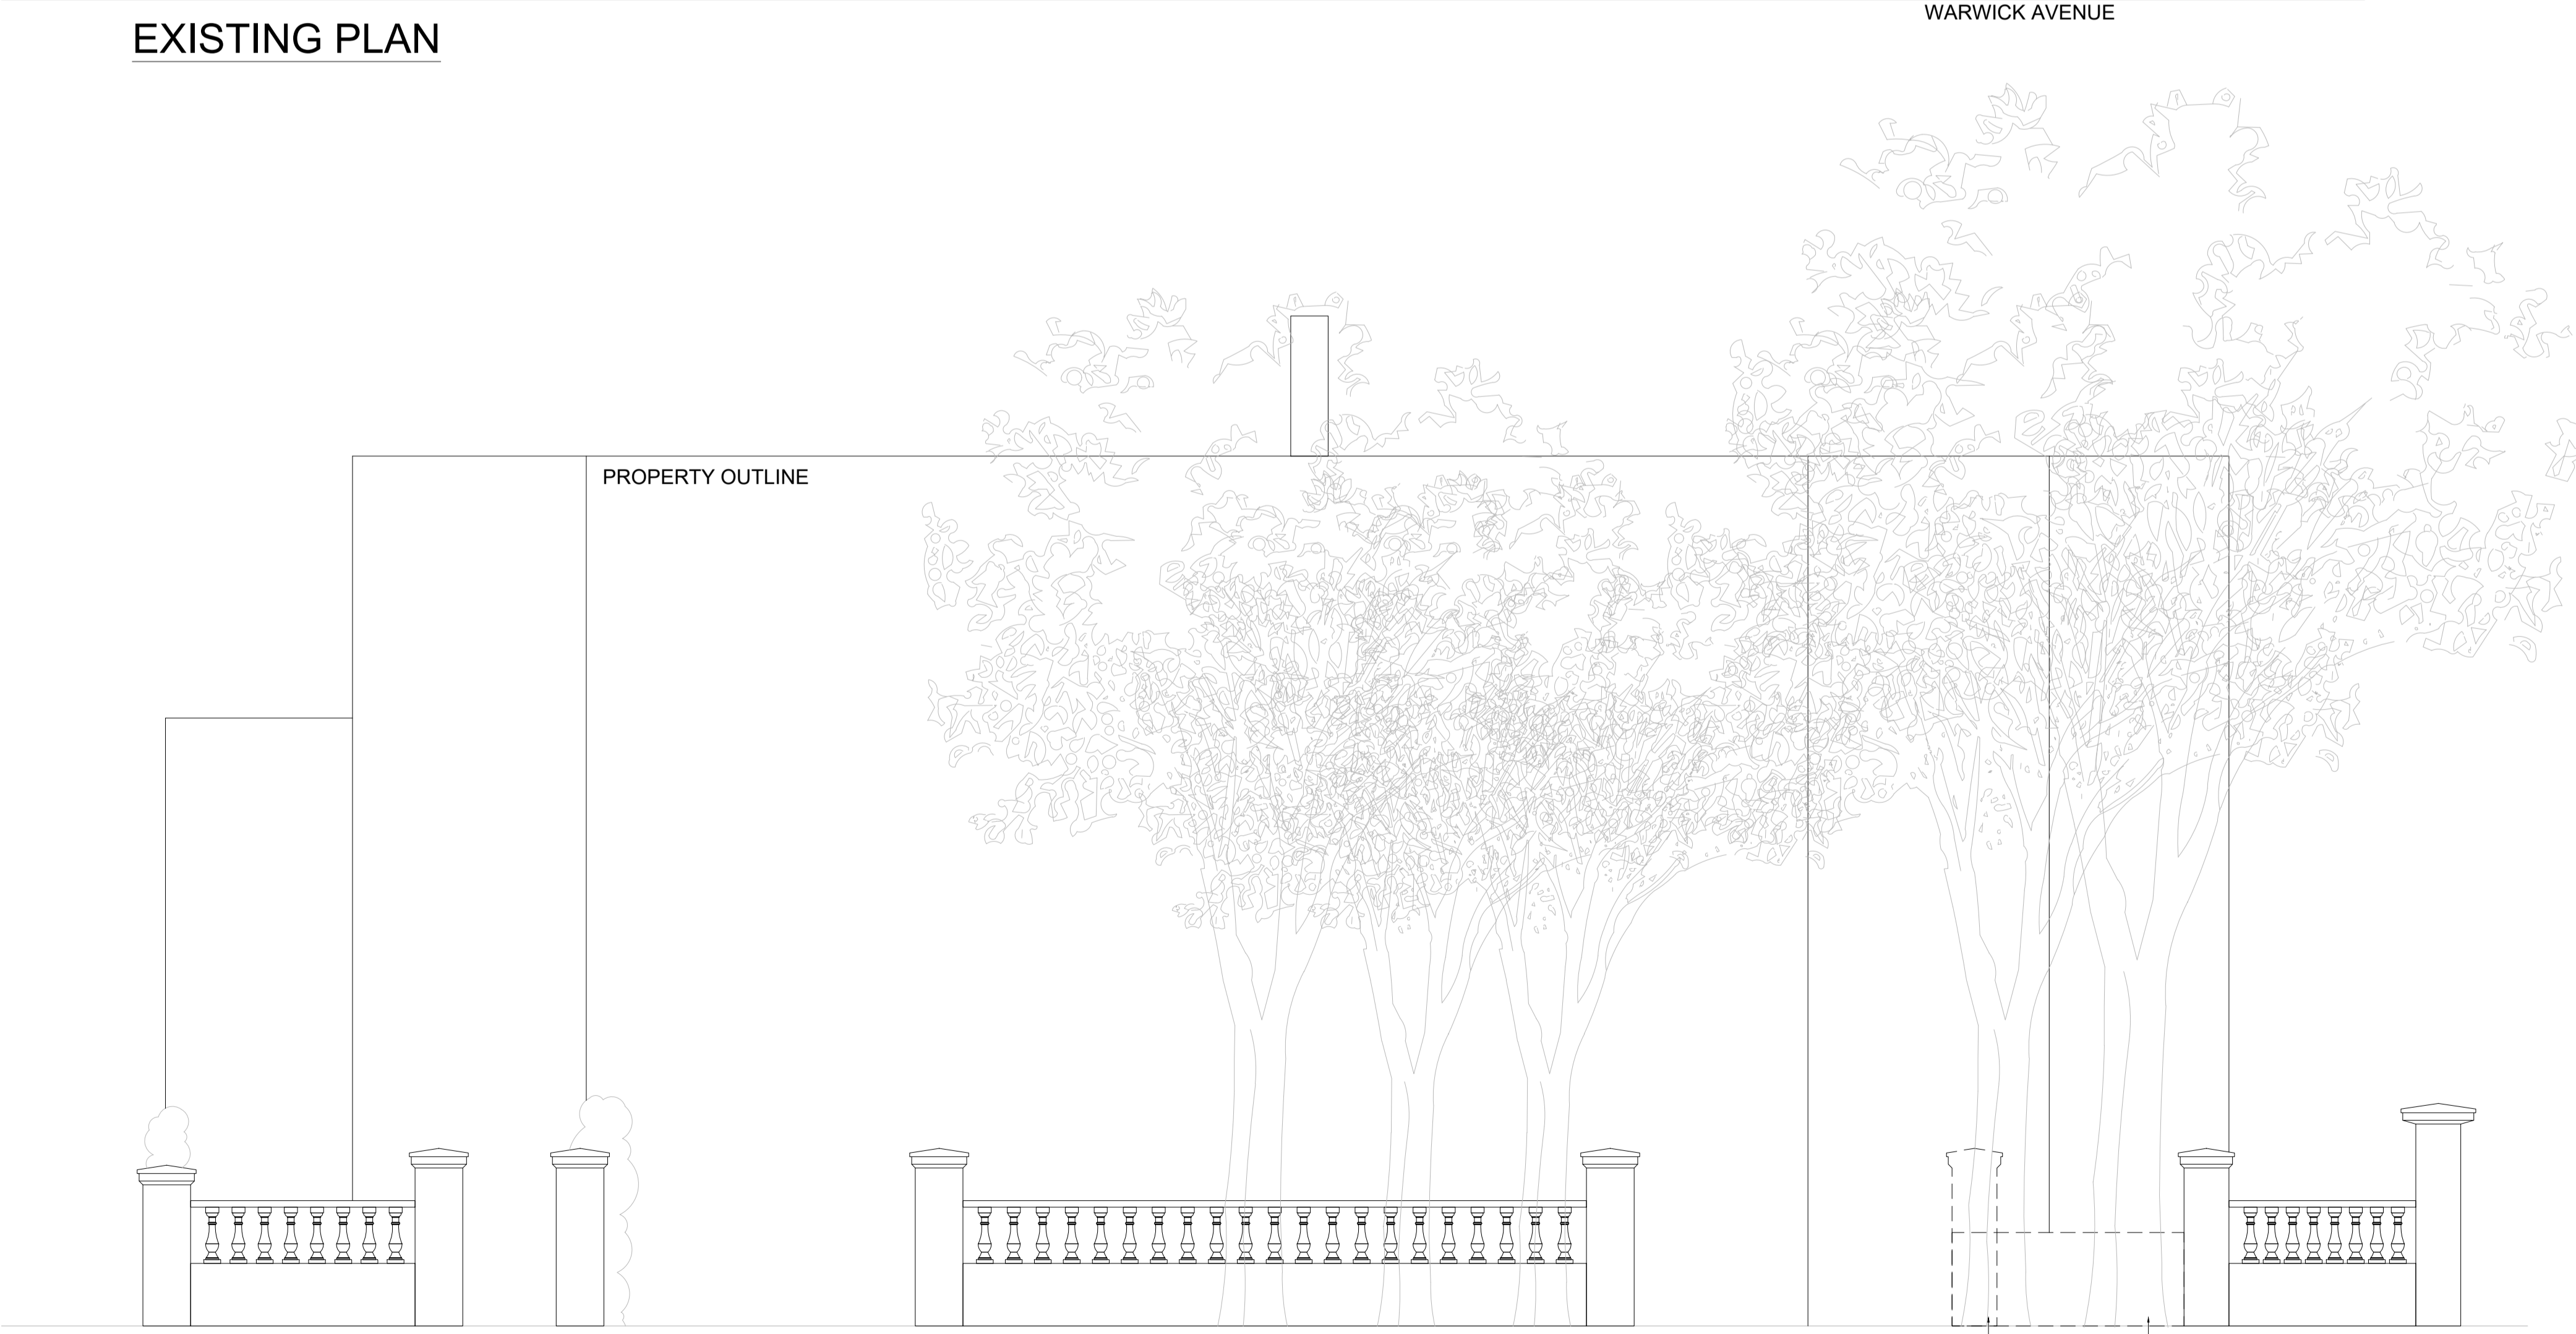
**EXISTING ELEVATION**

COLLAPSED GATE PIER AND WALL SECTION

TEMPORARY TIMBER WALL SECTION
