SOMERSET HOUSE ~ NORTH FACADE
 SKETCH SECTION THROUGH PARAPET

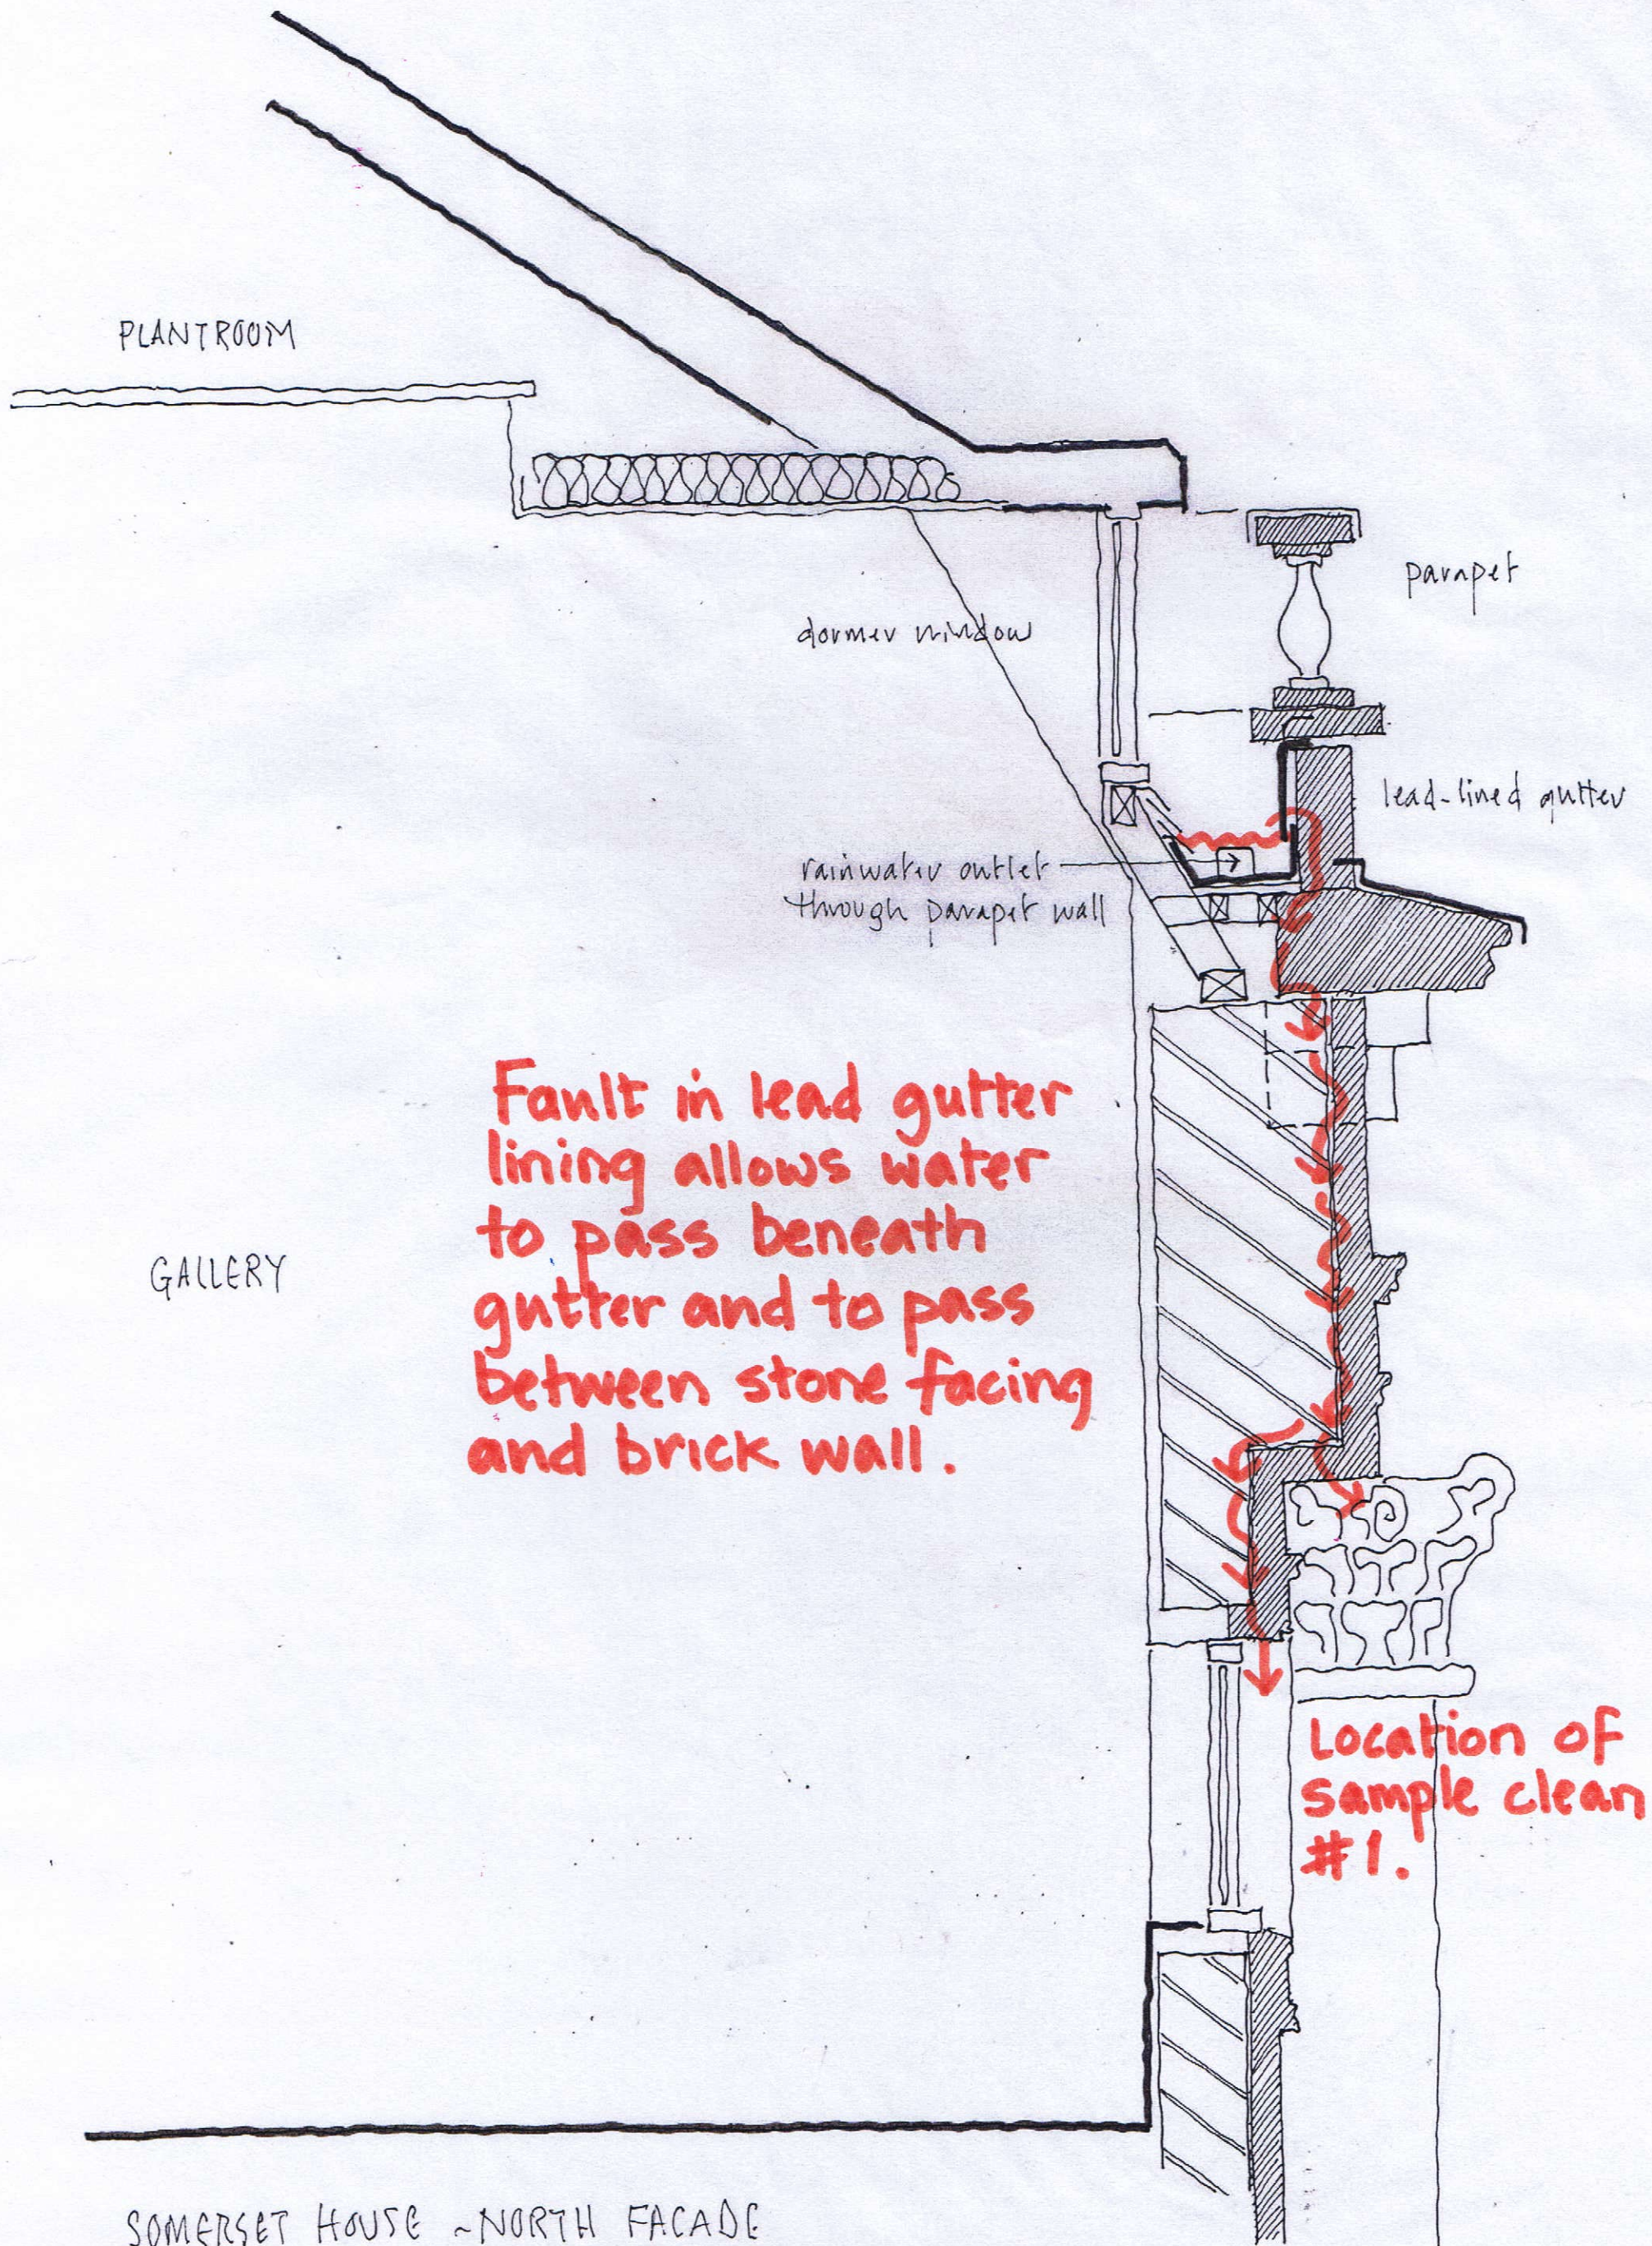
Fault in lead gutter lining allows water to pass beneath gutter and to pass between stone facing and brick wall.

Location of sample clean #1.
