Arboricultural Report

Impact assessment and method statement

Wisma Mulia
Bridge Road
Frampton on Severn

Ref: WTC_569.01

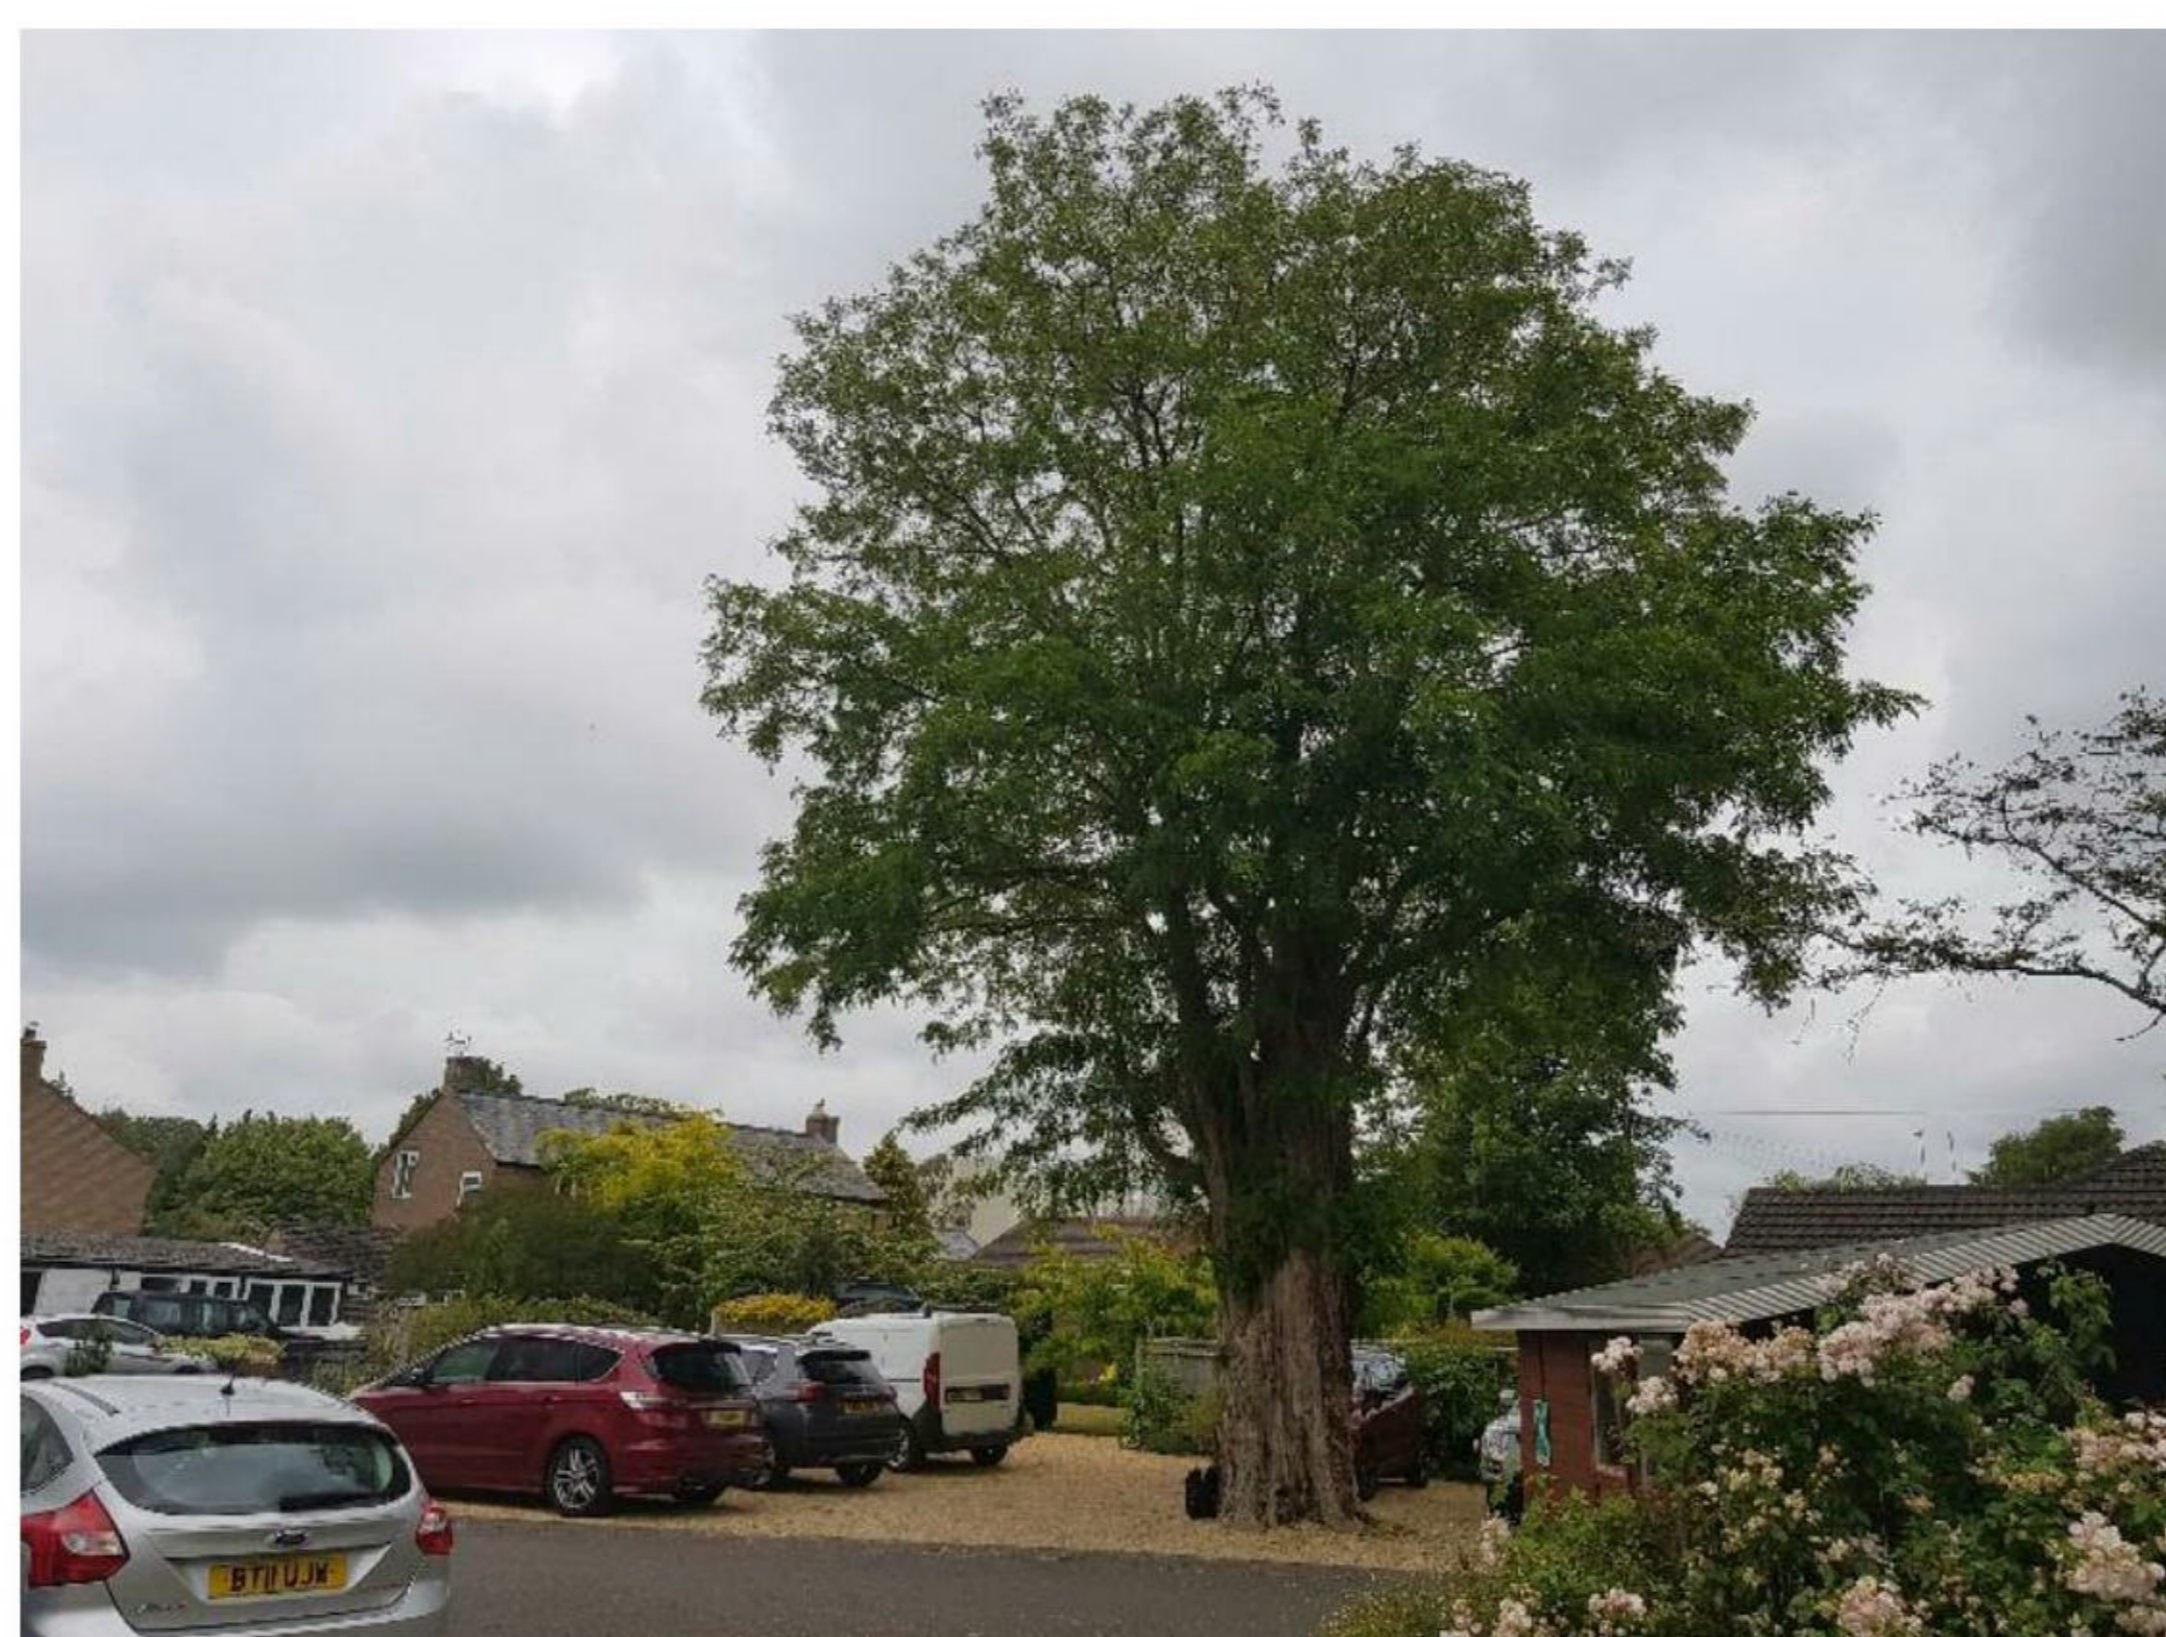
3.1.2 T1 is a mature, ‘B’ category Robinia, historically managed as a pollard. It is subject to TPO ref 285. The proposals sit partly in the RPA of this tree and so piled foundations are proposed. This is further detailed in section 4 of this report.

Plate 1: T1 – ‘B’ category Robinia

4.9.1 The proposed garage sits within the RPA of T1 and so the structure will bear upon piled foundations. The design and installation of these is beyond the scope of this report and should be undertaken by the project structural engineer. However, piling operations can still be damaging to trees unless protective measures are taken.

- 4.9.2 The following methodology shall be followed to ensure minimal disruption to the rooting area of T1:
- 4.9.3 Piling holes to be marked out on site by the project structural engineer

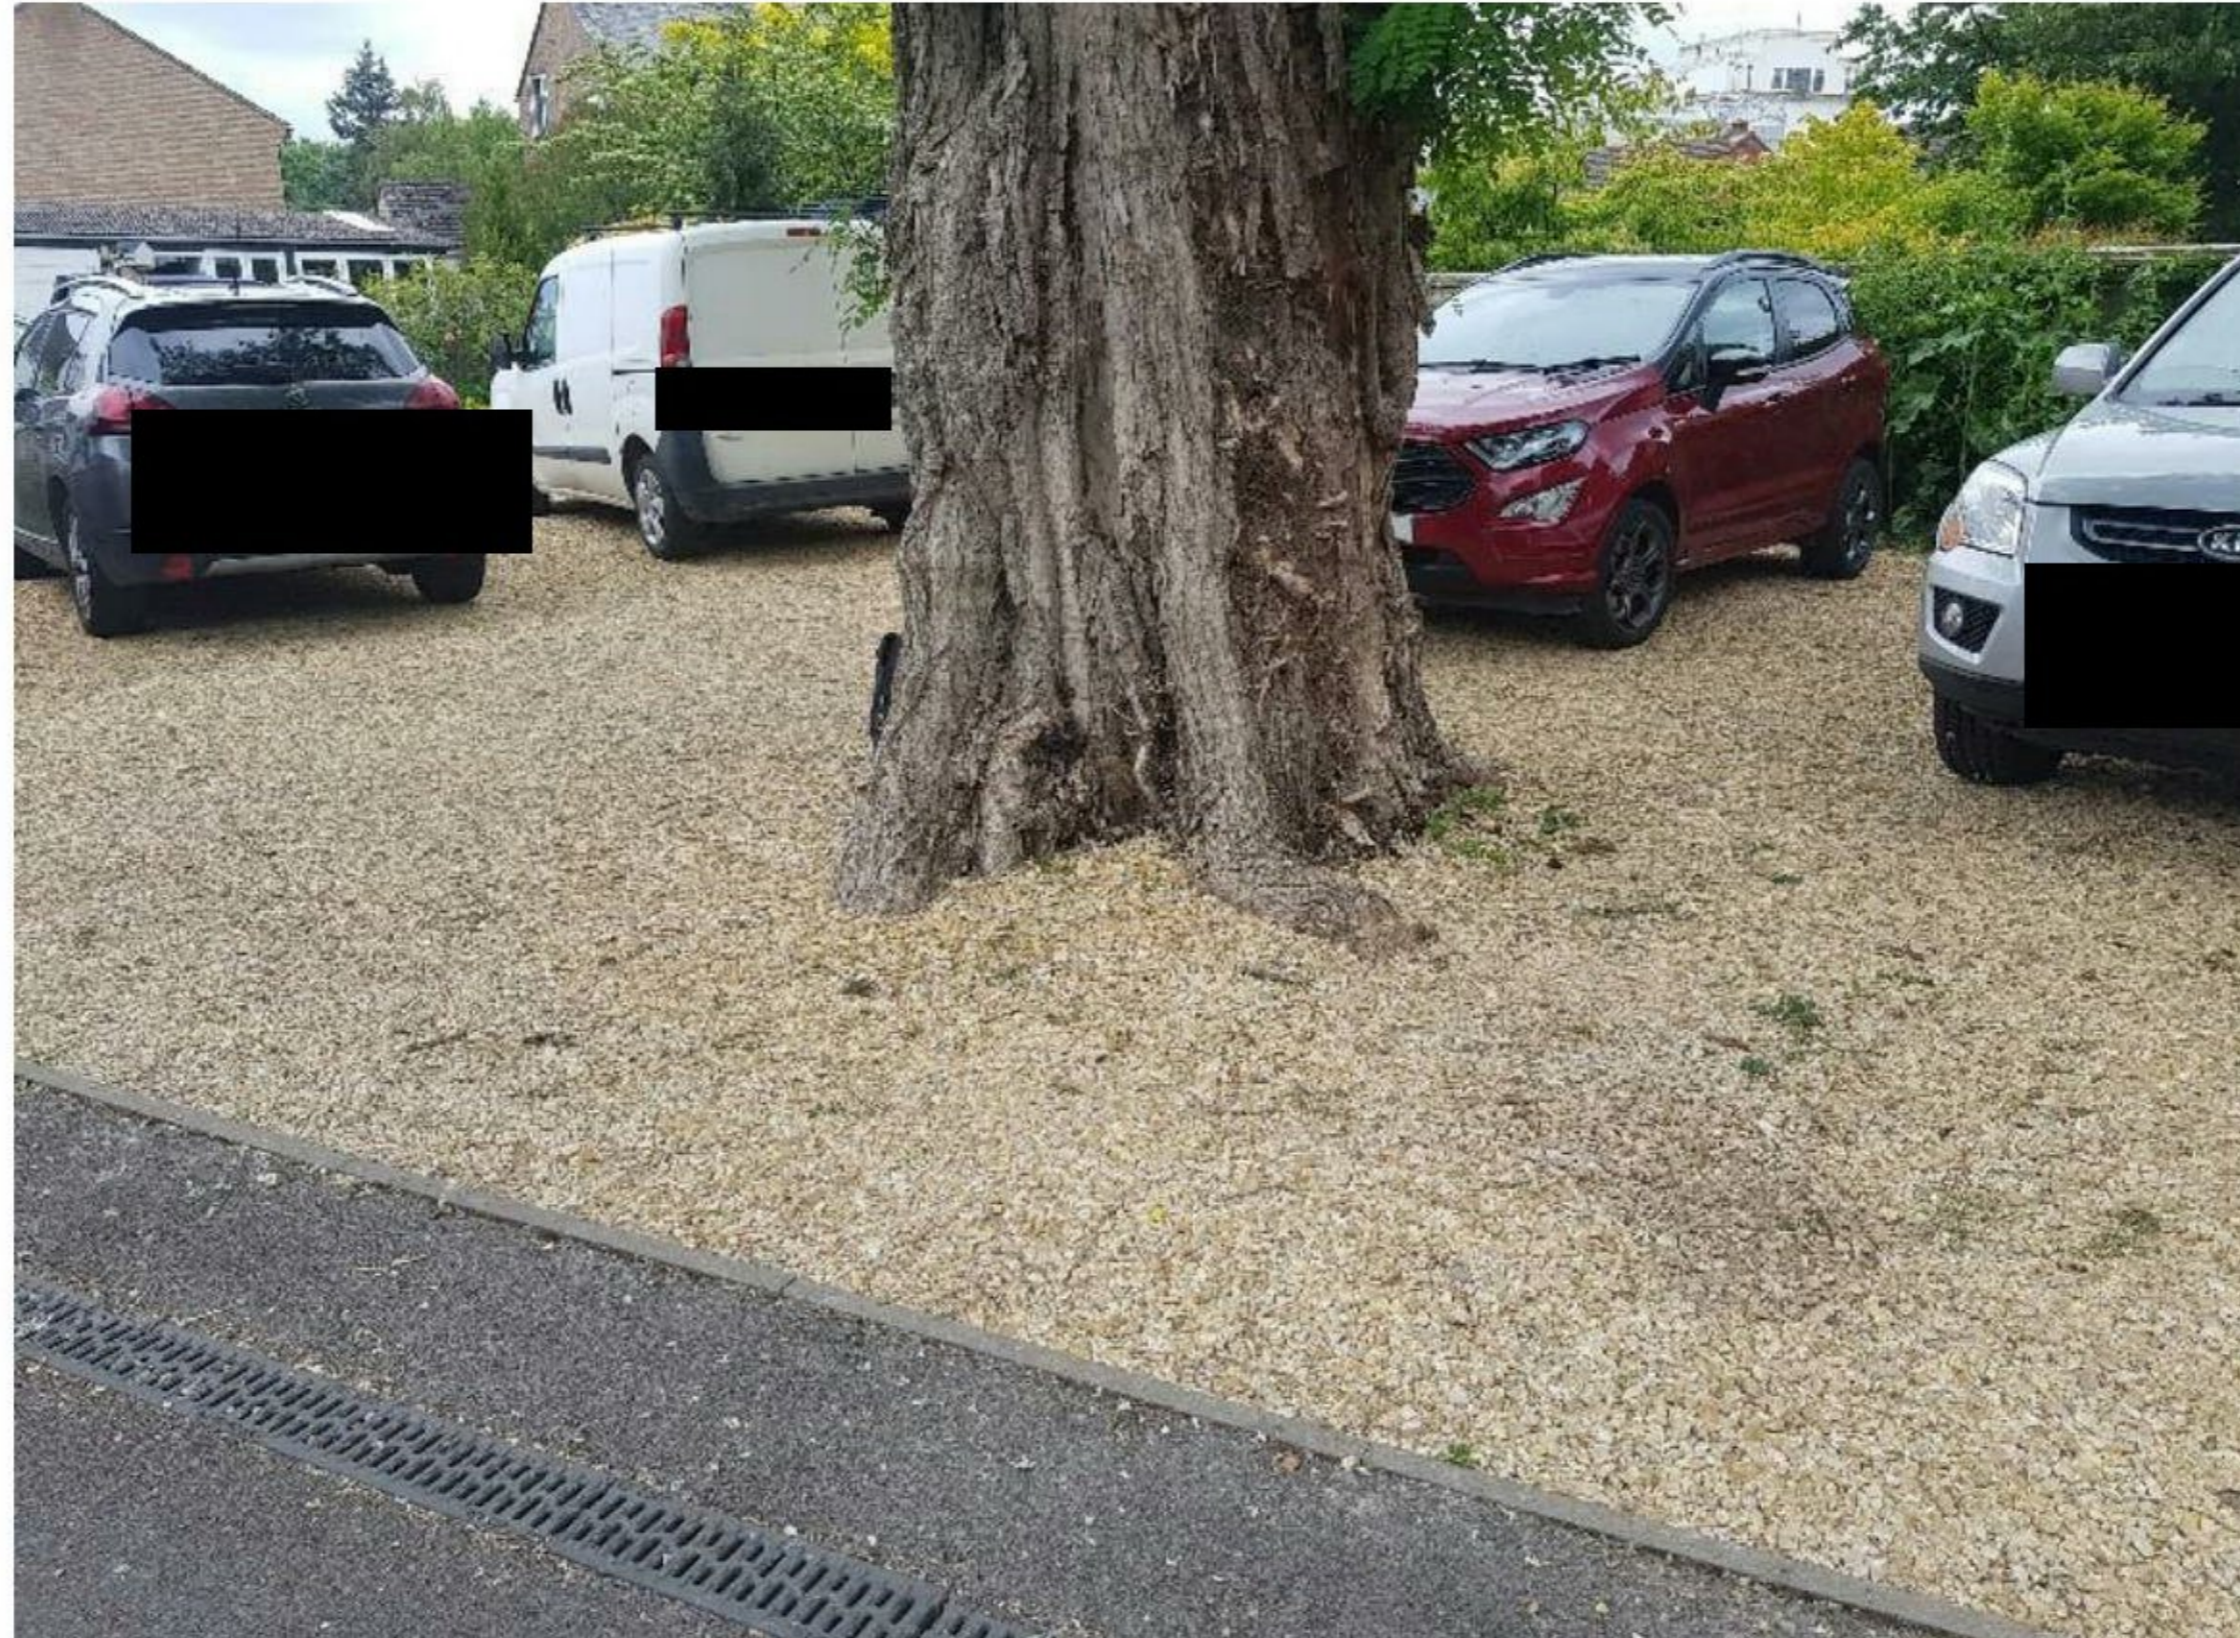
3.1.3 T1 is growing within a car parking area with crushed stone surfacing. Immediately to the south is an asphalt surfaced driveway. Lawned areas exist 6m to the south and 8m to the west.

Plate 2: T1 – Base of tree surround by crushed stone surface and parked cars.

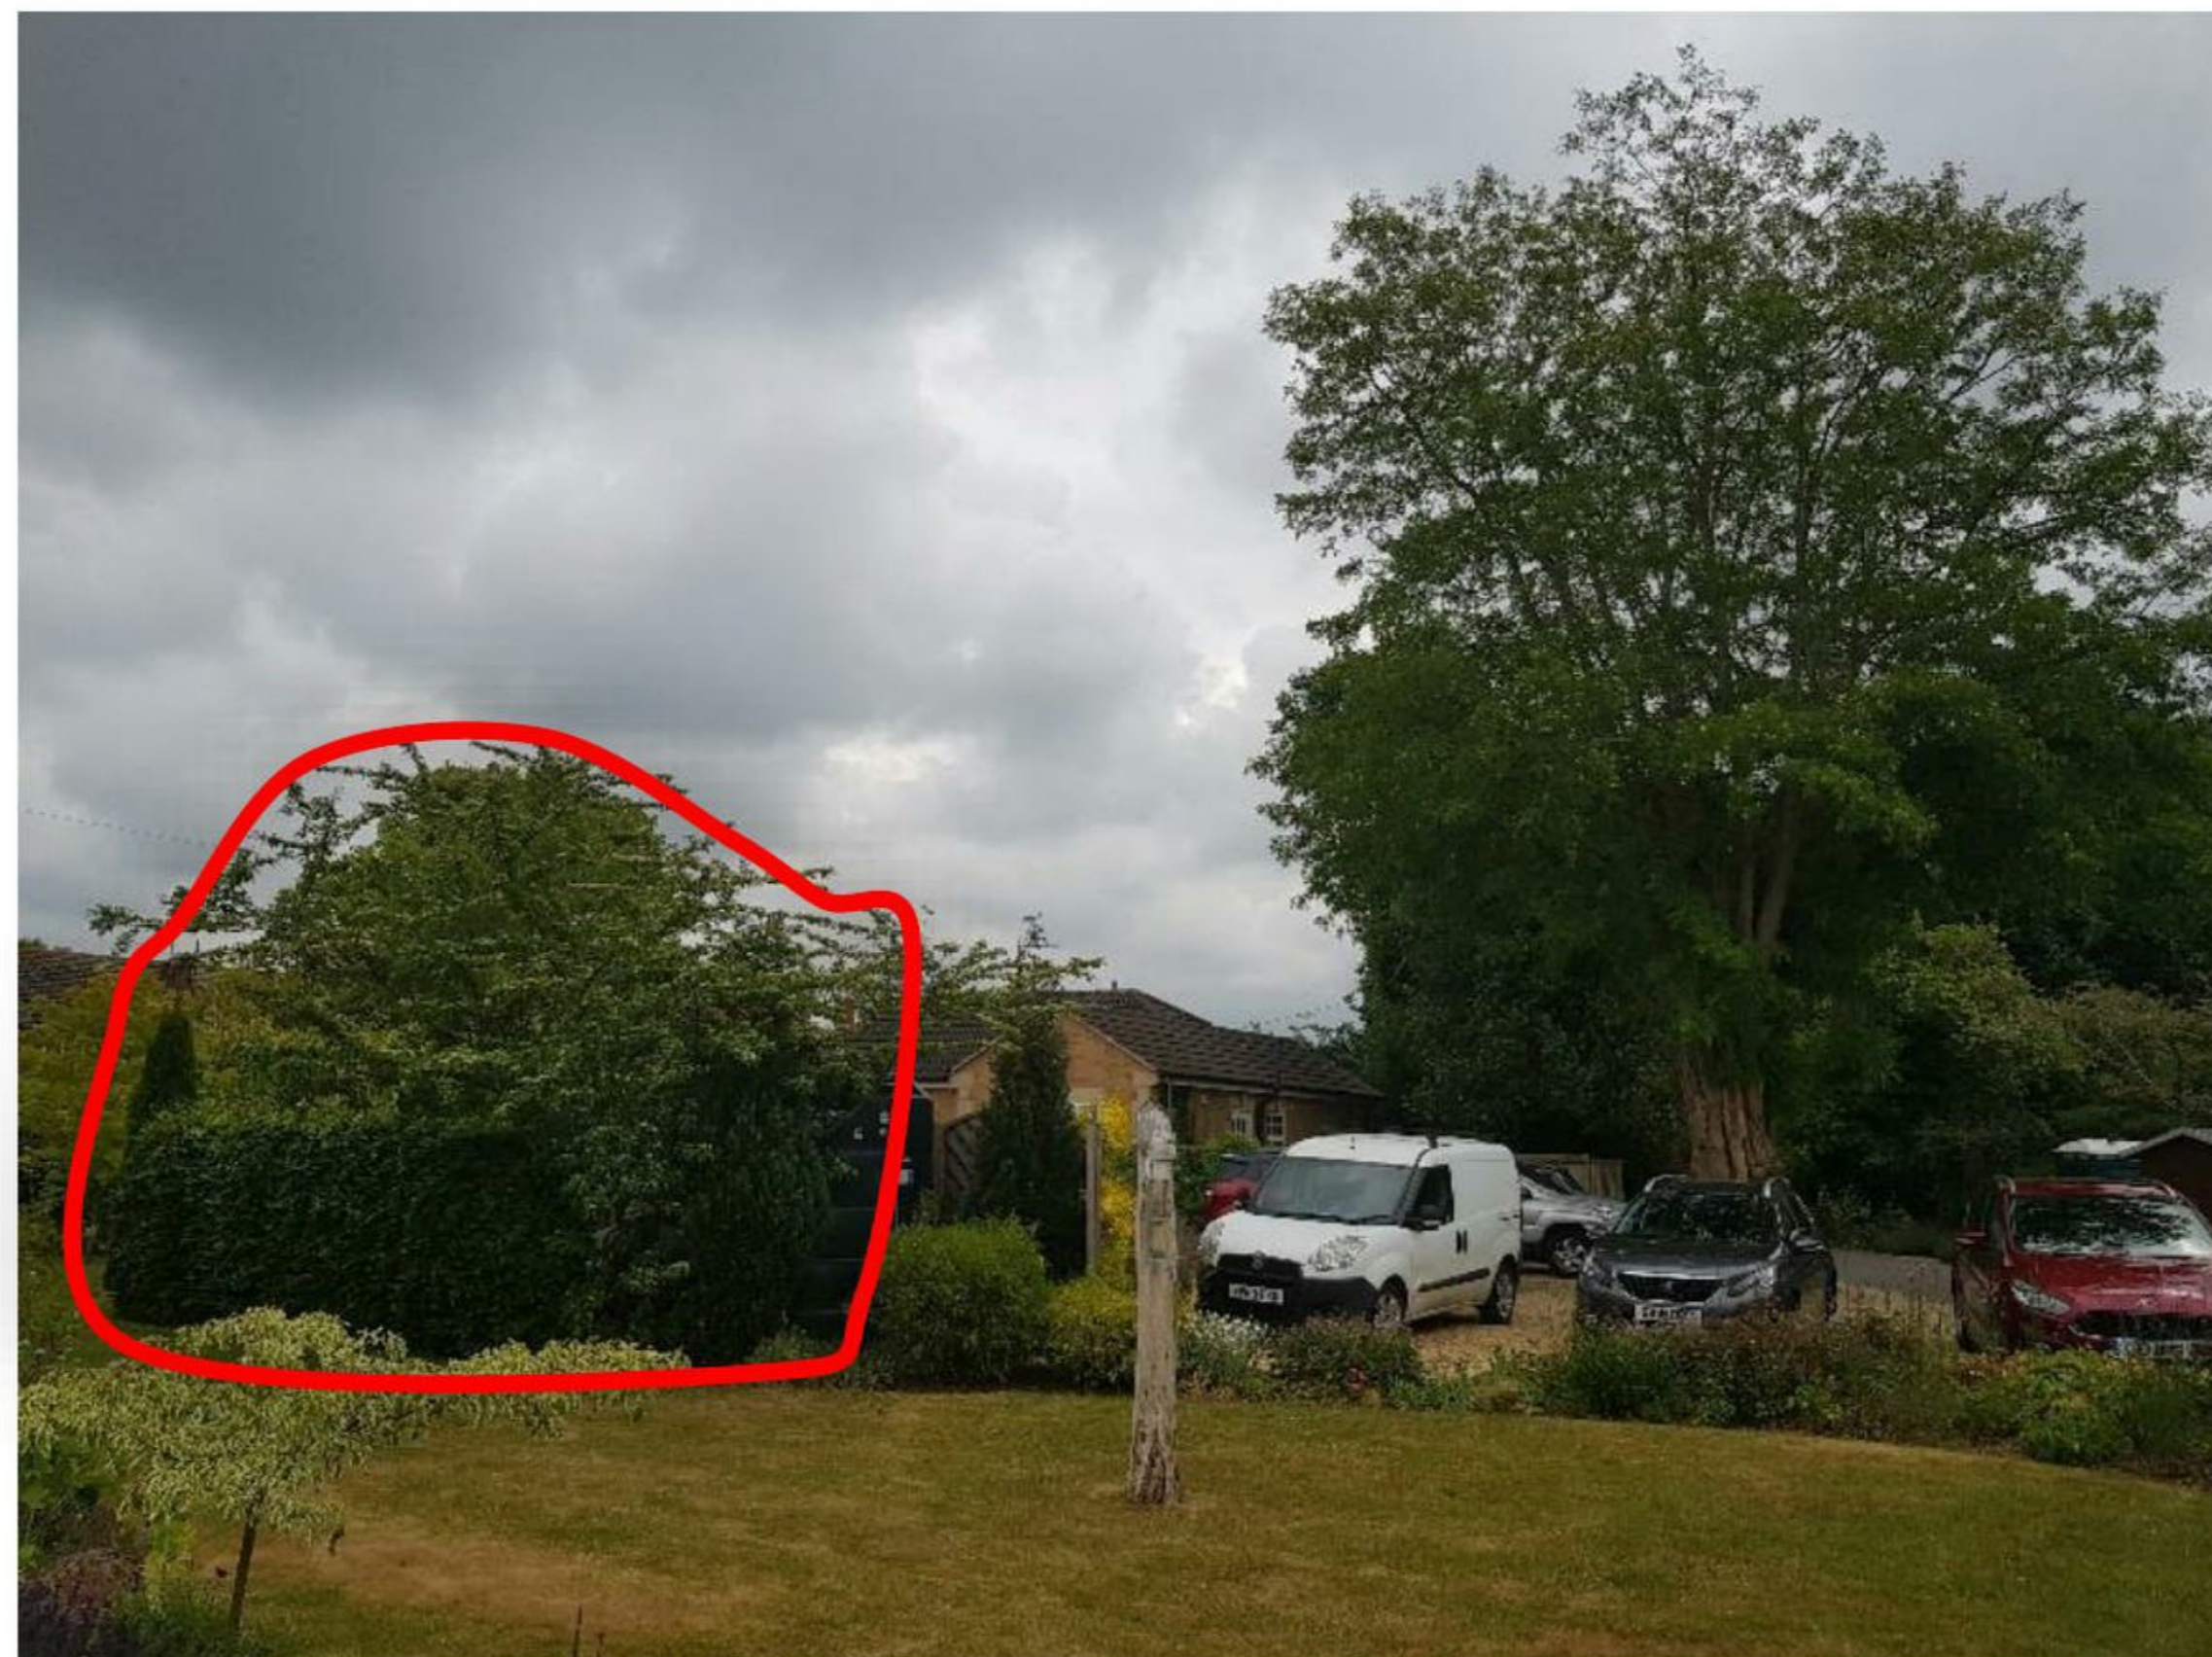
3.1.4 G1 and H1 are a 'C' category group consisting of 2 x cypress and 1 x cotoneaster, and a short beech hedge. These are currently screening an oil tank which is to be removed prior to development. These trees will also be removed to facilitate the build. There is scope on site for mitigation planting.

Plate 3: G1 and H1 (outlined in red) for removal. T1 is visible on the right of the photo.

3.5.1 1 group and 1 hedge are proposed for removal as a result of this development.

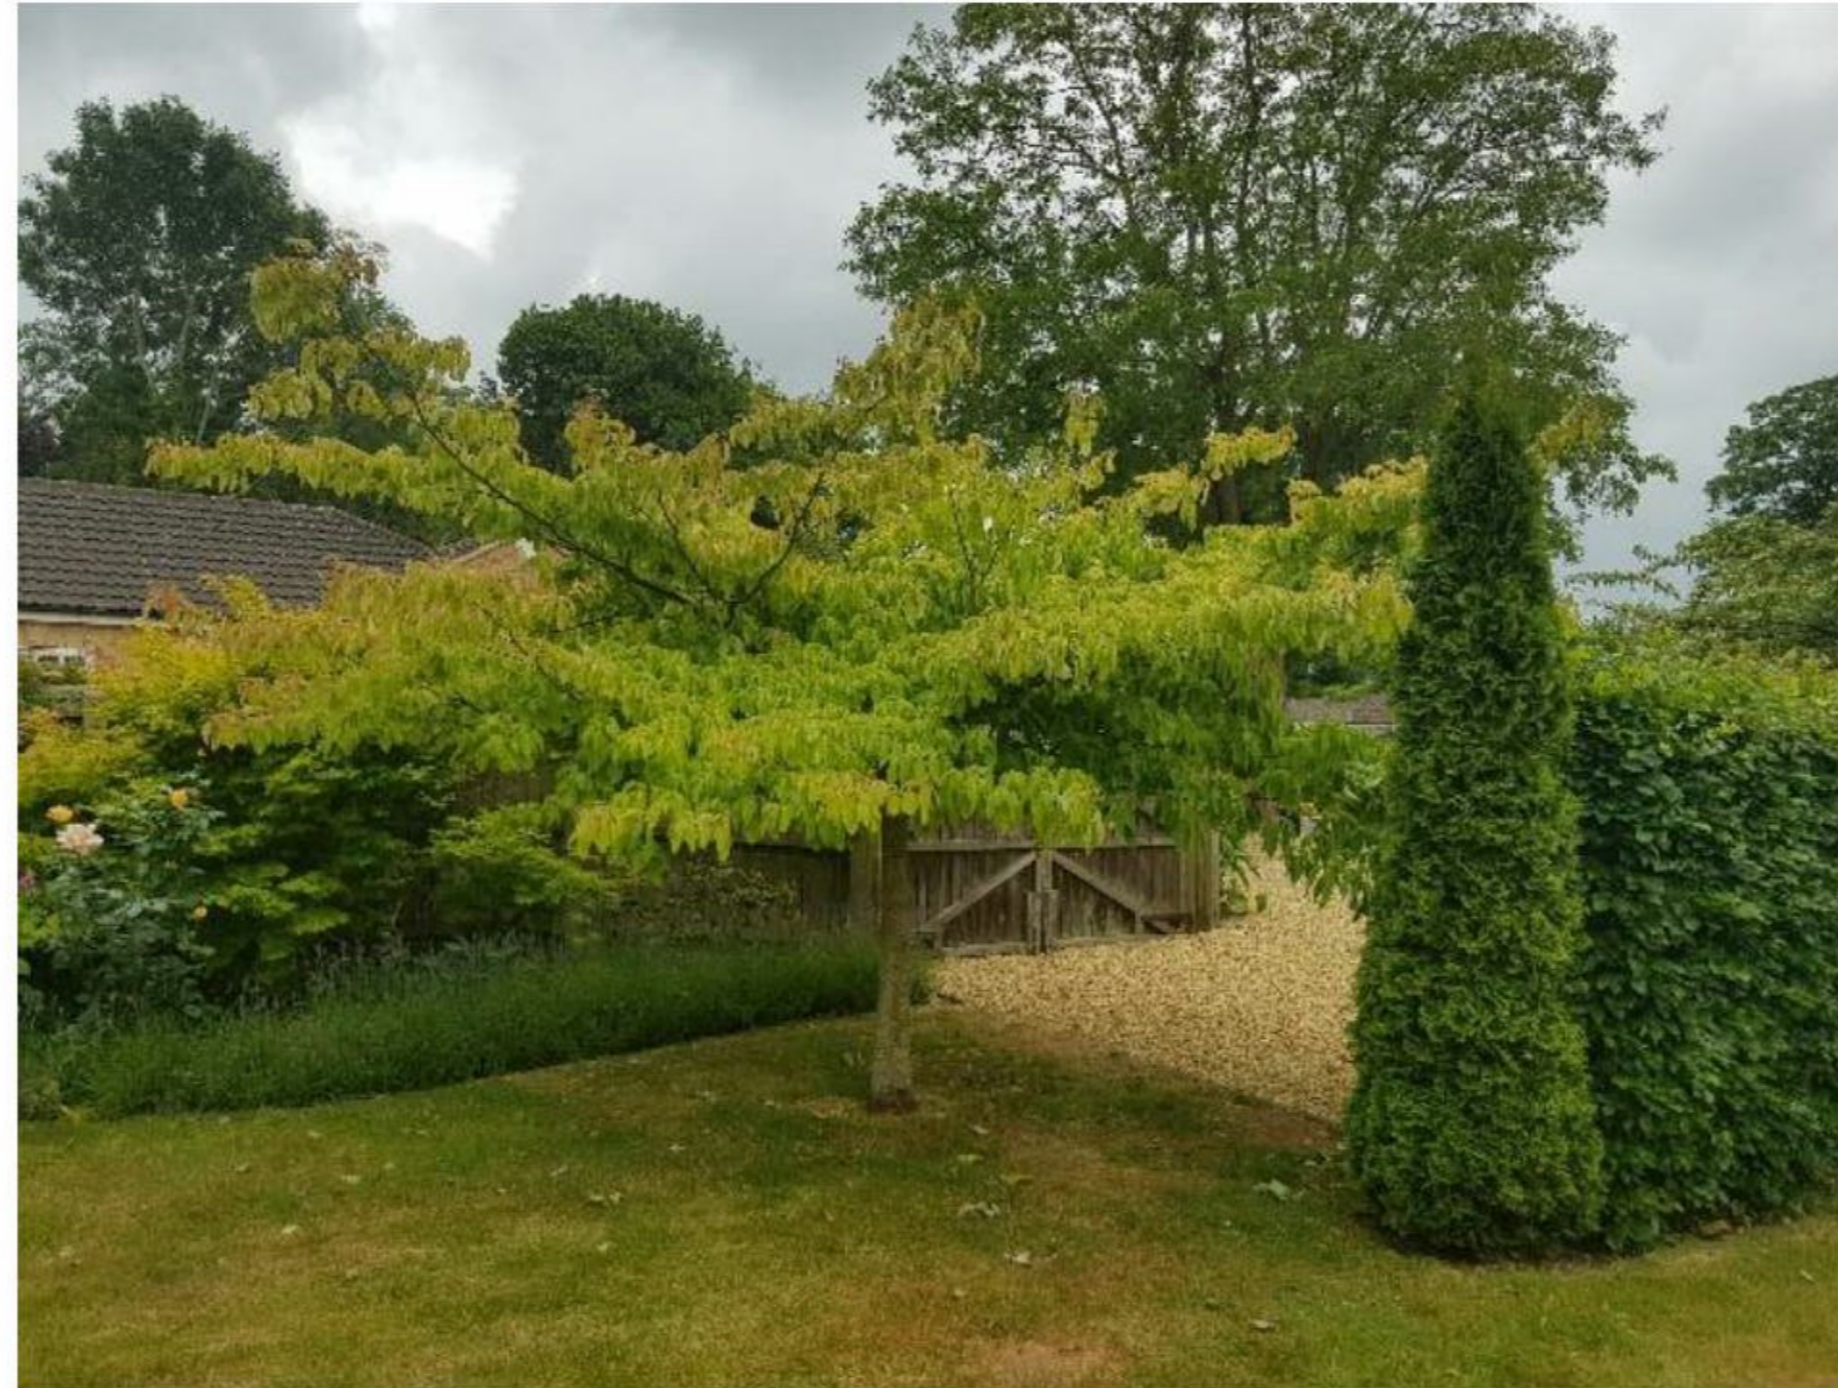
3.1.5 T2, T3, G2, G3 and S1 are 'C' category, small ornamental trees which will be protected throughout the build.

Plate 4: T2 – Cornus kousa

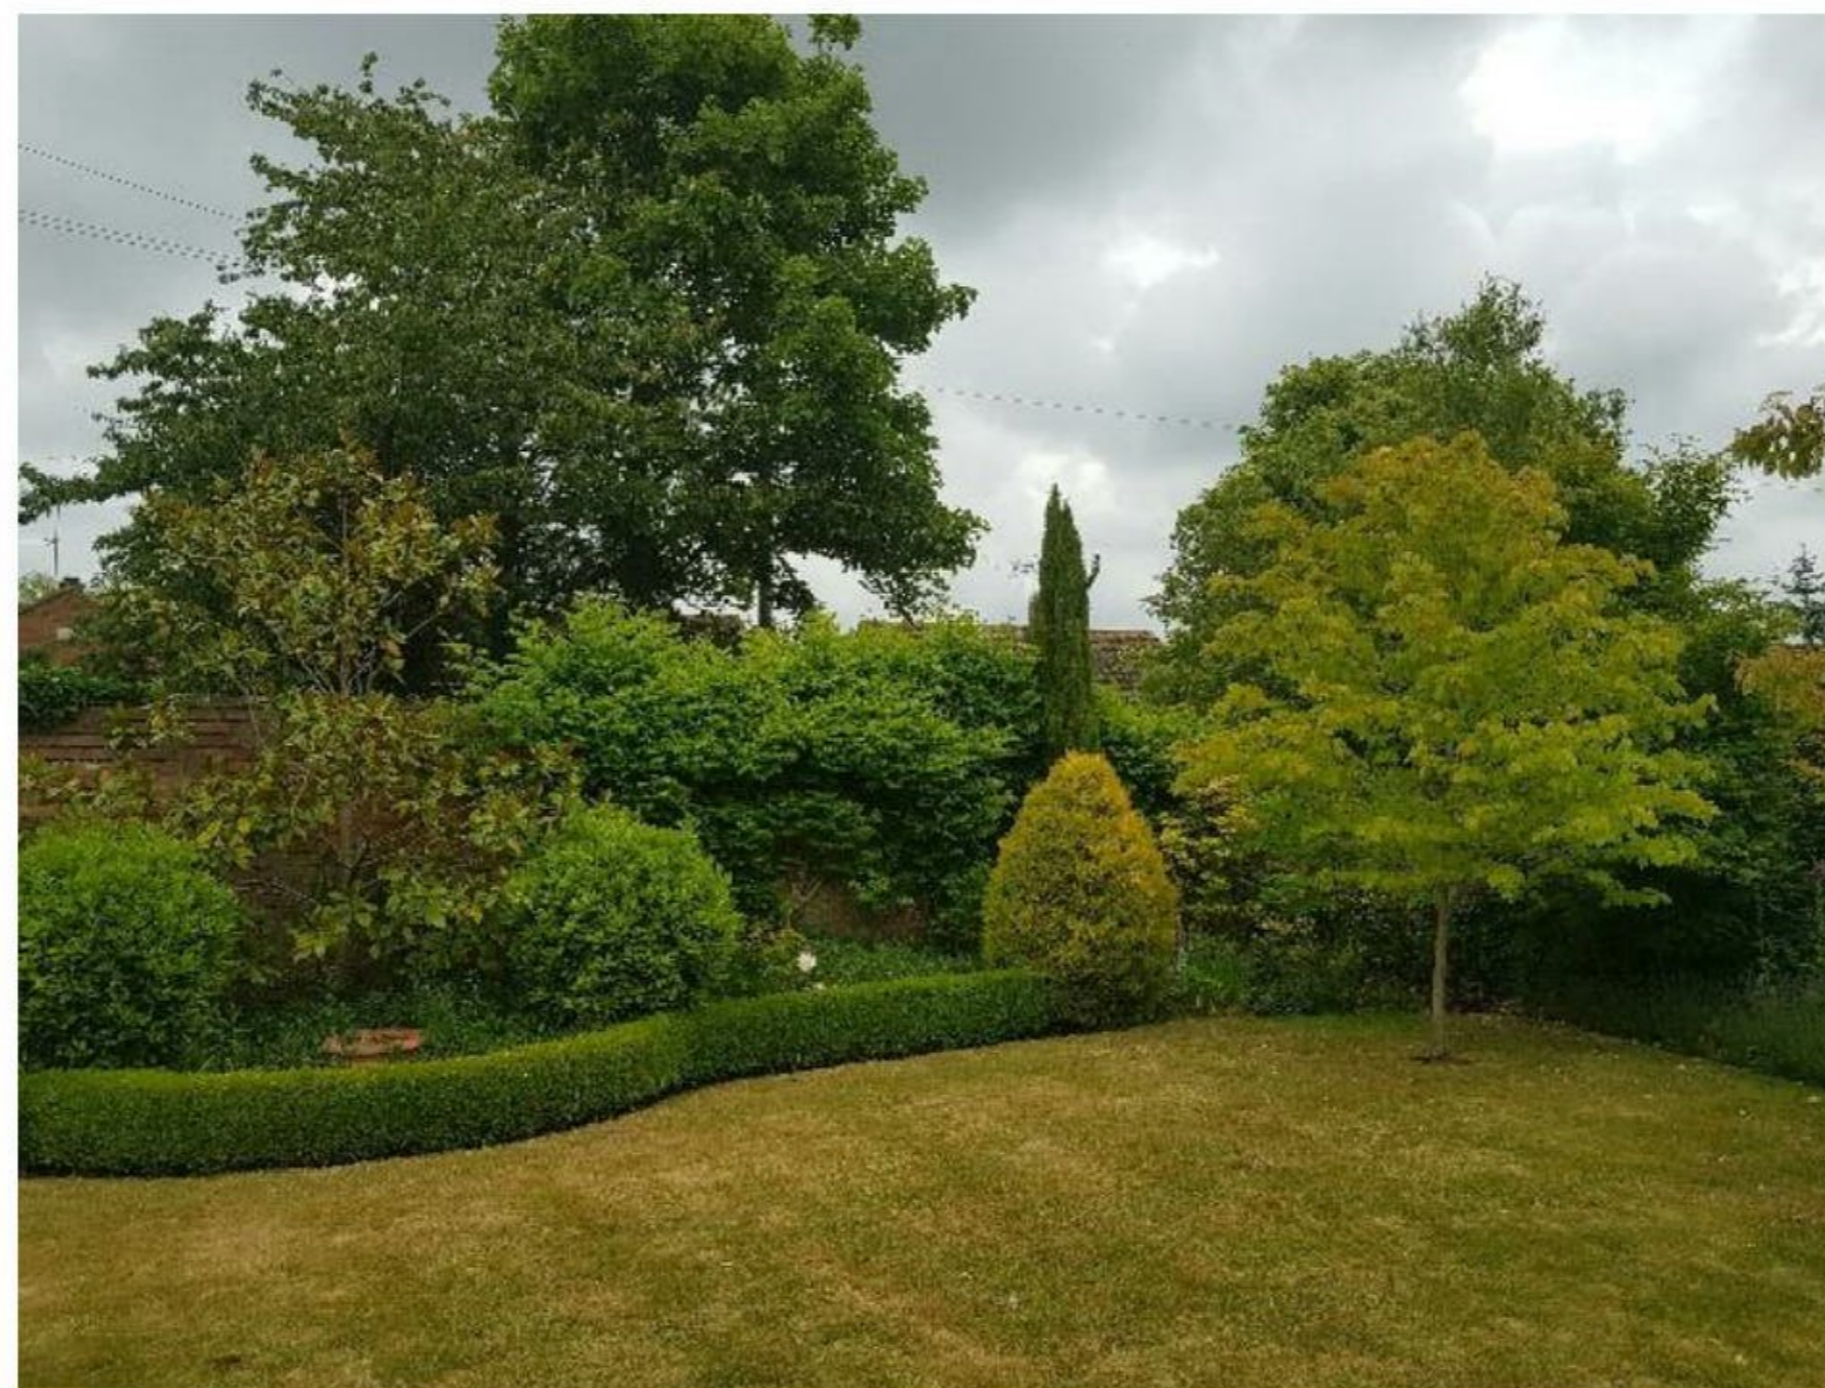
Plate 5: G2 – mixed tree/shrub group

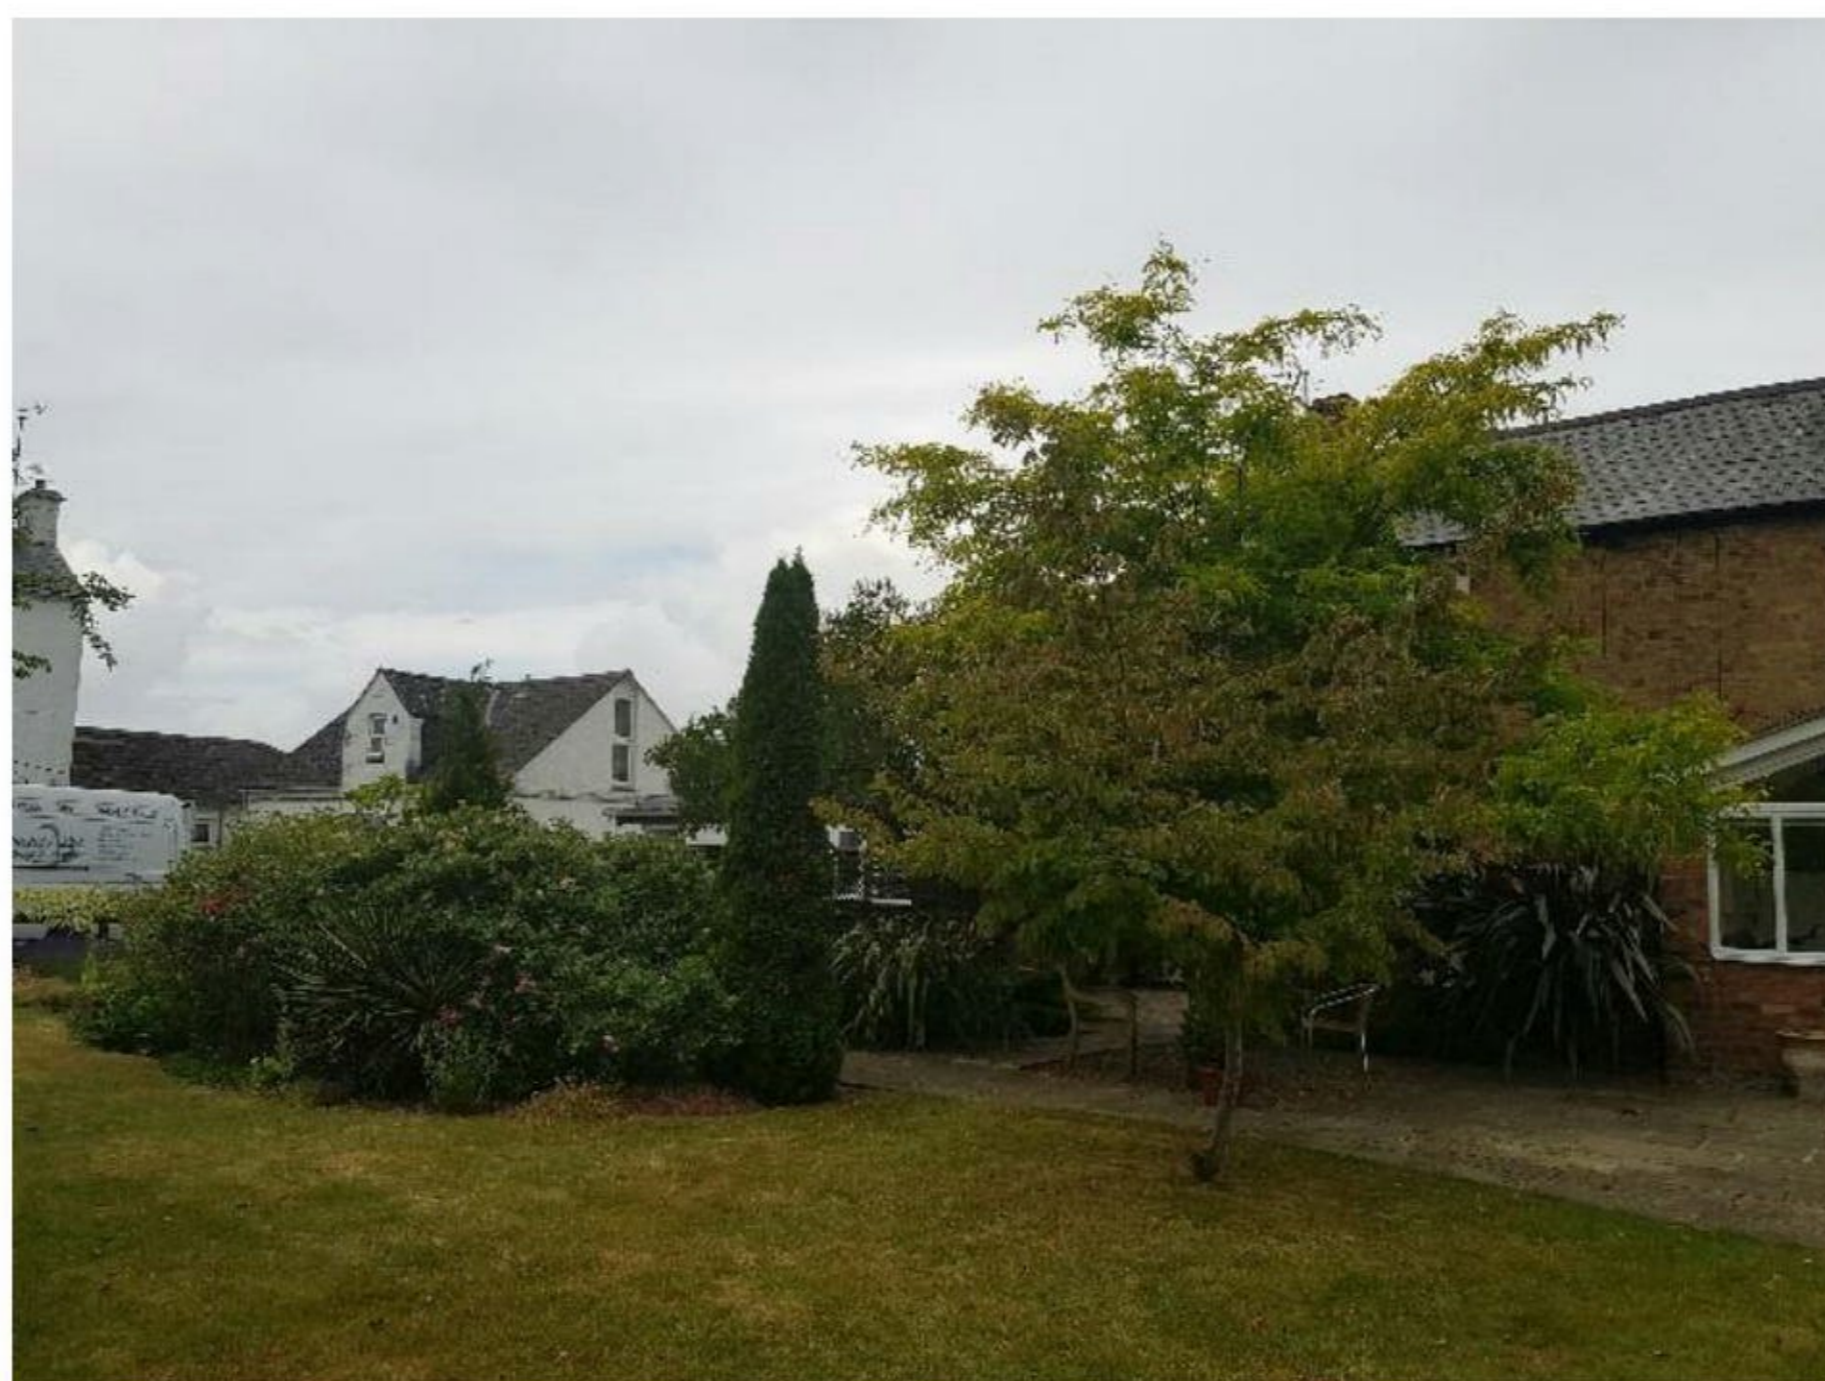
Plate 6: T3, G3 and S1
