Appendix C –  
Visual Representation

## Proposed pergola structure with polycarbonate roof sheeting

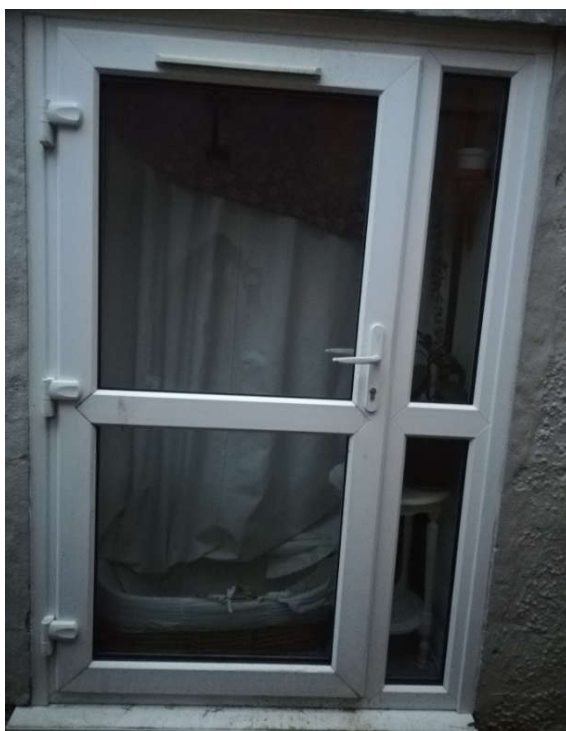
Existing window (west facing northern extension) to be replaced with double glazed patio doors, to improve light quality within room and access to lobby

- JELD-WEN 1500mm Canberra oak French doorset
- Traditional oak side hung French doors
- Supplied with hardex polished chrome handles
- 54mm solid oak engineered door leaves
- 24mm toughened double glazed units with black warm edge spacer bar
- Premium solid oak engineered doors
- Engineered oak veneered frame
- Manufactured in the UK
- 10 year manufacturers guarantee against manufacturing defects
- Multi-point locking system from ERA's Vectis Plus range for added security
- Available factory pre-finished with a golden oak or dark oak stain
- Brickwork opening dimensions (H x W) 2100mm x 1500mm
- CE marked
- Uvalue: 1.6W/m3K

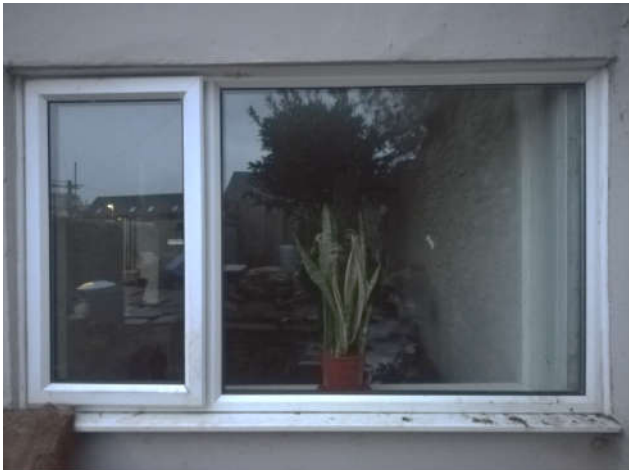
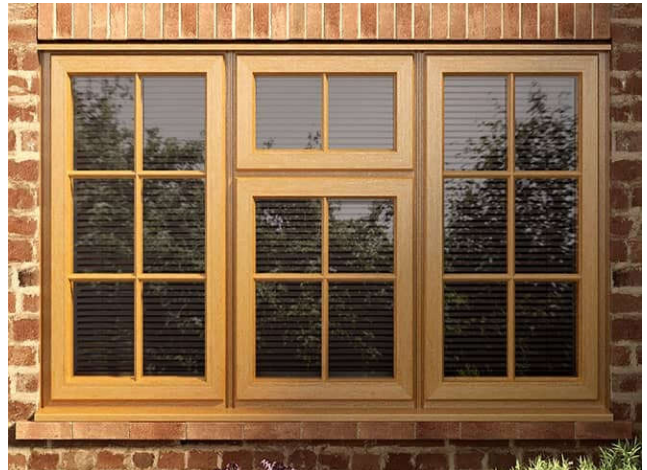
Proposed replacement window (south facing northern extension) Proposed windows to be casement hardwood timber style with golden oak finish.

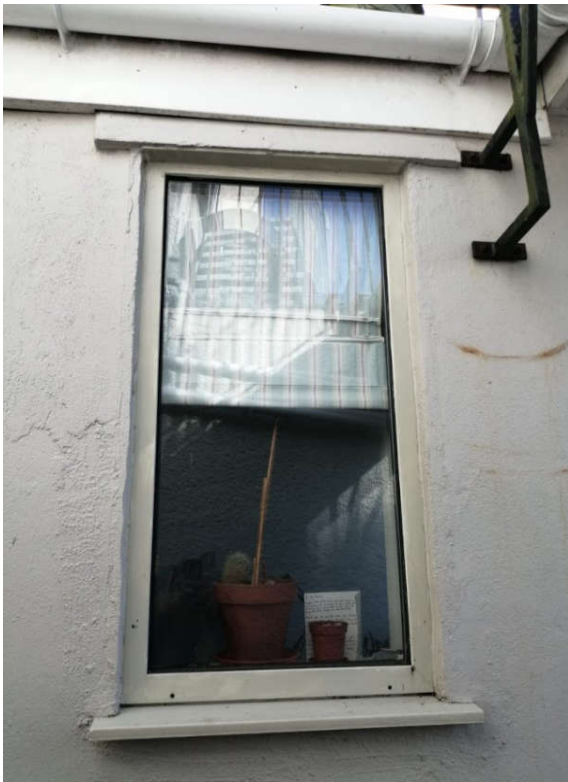
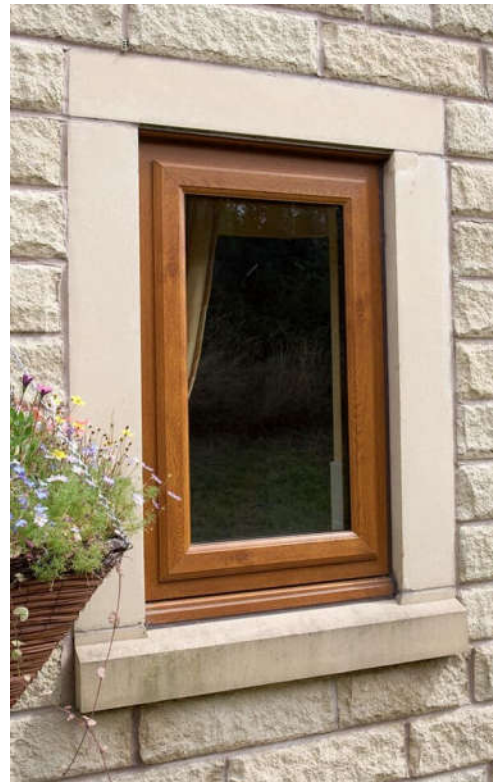
Existing windows (east facing southern extension)      Proposed windows east facing southern extension

Left and right window on west tenement to open out with hinges on each edge closest to their respective walls. Central top window to open outwards with hinges at the top. Central bottom window is fixed.

Proposed windows to be casement hardwood timber style with golden oak finish.

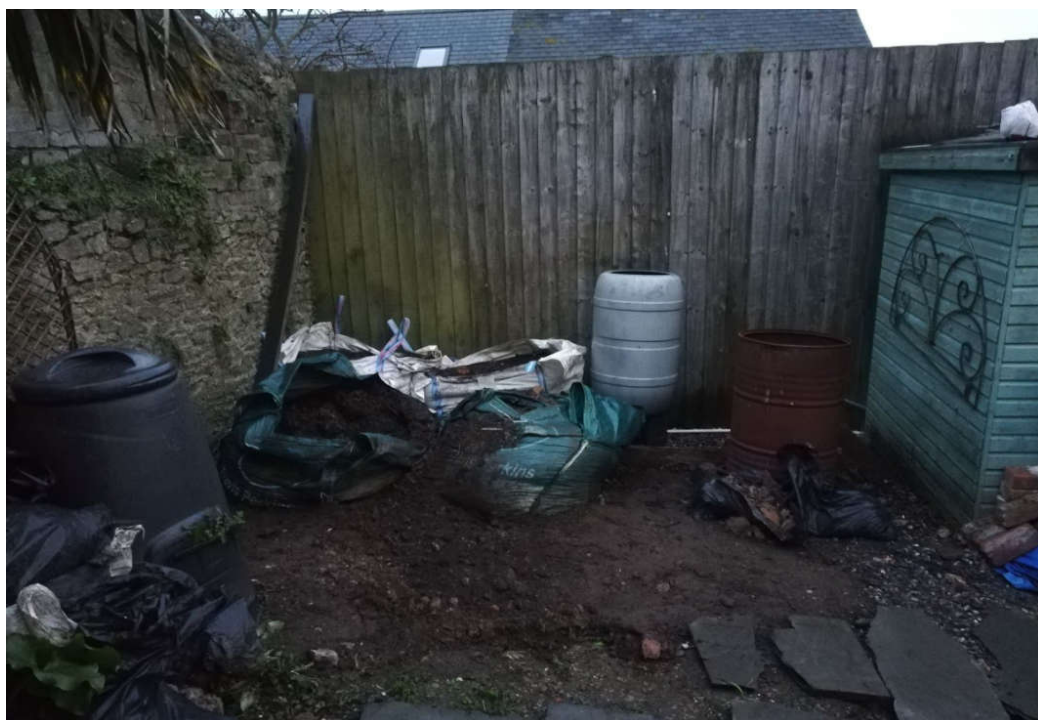
Proposed shed with green roof (to sit next to existing)

Proposed shed location
