JOB TITLE Poltmore House Portico
CLIENT Poltmore House Trust
DWG TITLE Entrance Hall Window Repairs

A3 SCALE	DRAWN	STATUS	JOB NO.	DWG NO.	REV
1:20, 1:1	SW	TENDER	1099.02	PPP20

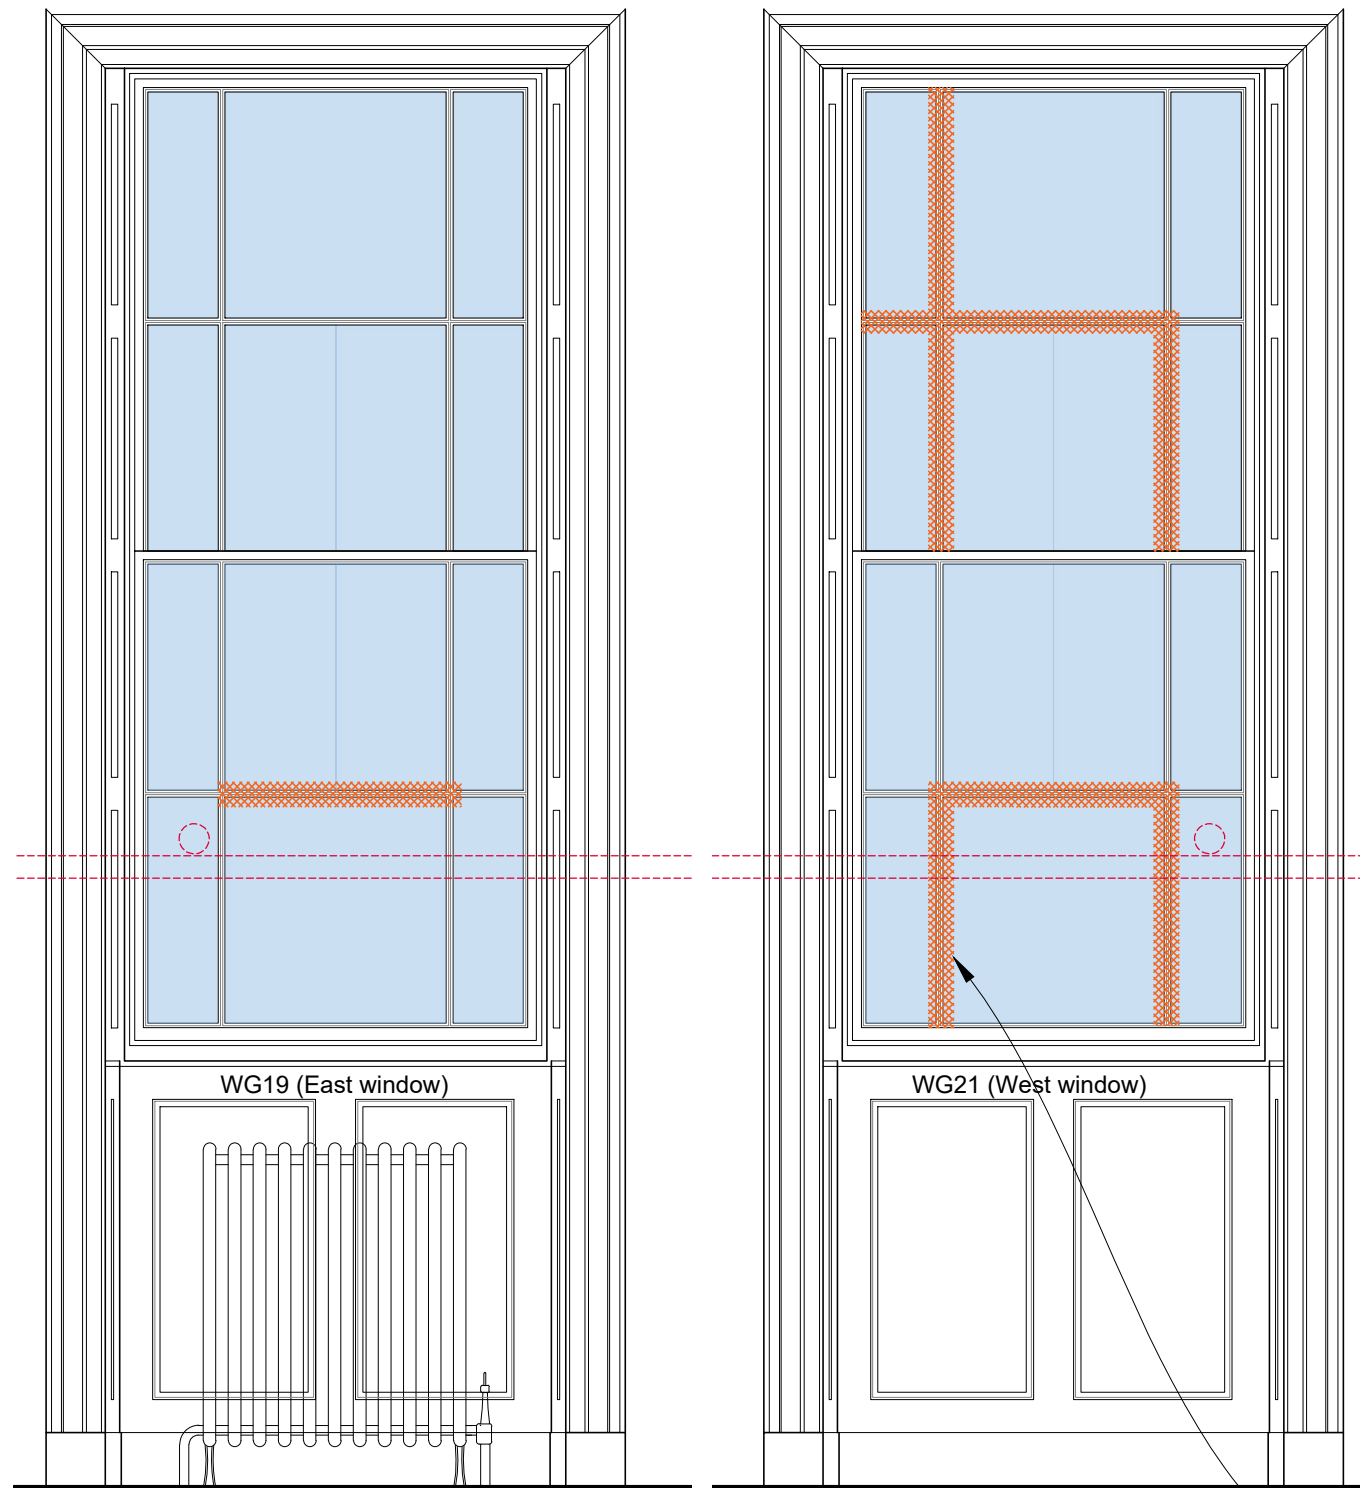
INTERNAL WINDOW ELEVATIONS scale 1:20

Hatch indicates preliminary assessment of missing joinery

Work require to 2 no windows to Entrance Hall:-
Remove scaffolding currently braced through window. Remove outer temporary protective screens and grills and allow further assessment of condition by Conservation Architect.
Allow for repairing sash and case windows by piecing in missing glazing bars to exactly match the profile of the existing. Ease the sashes and adjust to full working order. Provisionally renew sash cords and replace missing ironmongery to match original profile. In addition fit discrete recessed brass locks to midrail. Fit toughened plate glass provisionally to match thickness of existing. Allow for adjustments to existing shutters to allow them to operate fully. Existing shutter knobs and ironmongery to be retained. Provisionally fit additional security shutter bars to rear of shutter. Allow for repairs to shutter linings and Ingo panelling as necessary prior to preparation, priming and painting. Note that the existing paint may be lead based.
