City Halls & Old Fruitmarket Roofworks City Building

Roof 3B - Plan

CHF-HML-03-RF-DR-A-12105

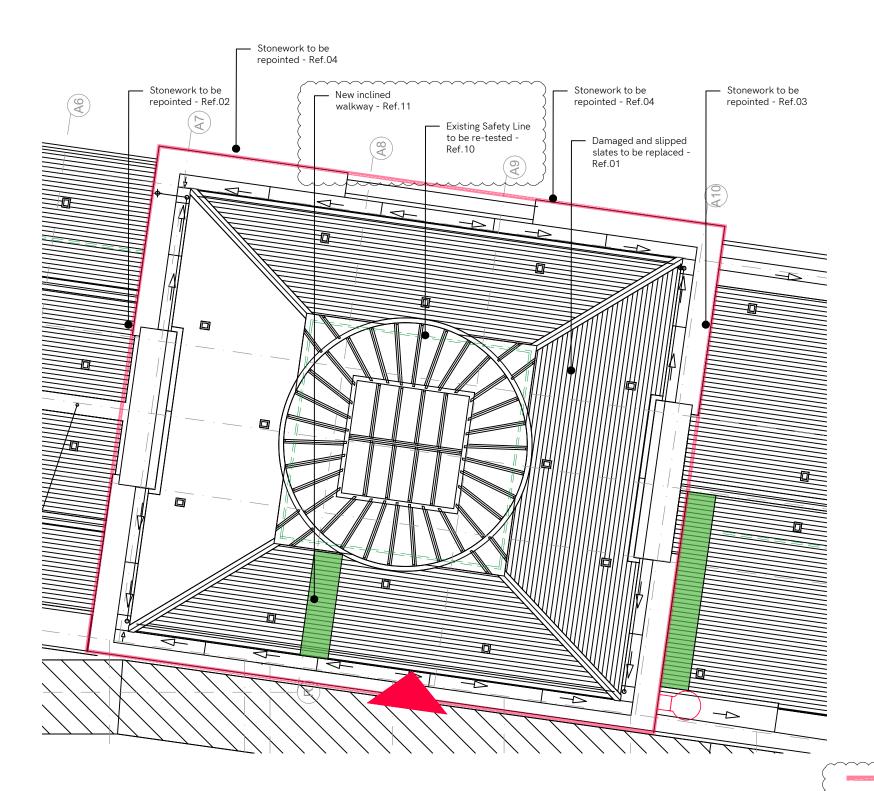
Ref.01 - All slate roofs to be inspected and all slipped and damaged slates to be carefully removed (without damaging adjacent sound slates).

Ref.07 - Existing system to be assessed by a lightning protection specialist

Ref.08 - Sacrificial lead flashing to be installed at base of slate roof where it meets a lead gutter

Ref.09 - Lead slate pieces to be fitted around all roof penetrations
