# Heritage Impact Assessment

Flat 3, 40 Montagu  
Square, London

March 2021 | Project Ref 6604

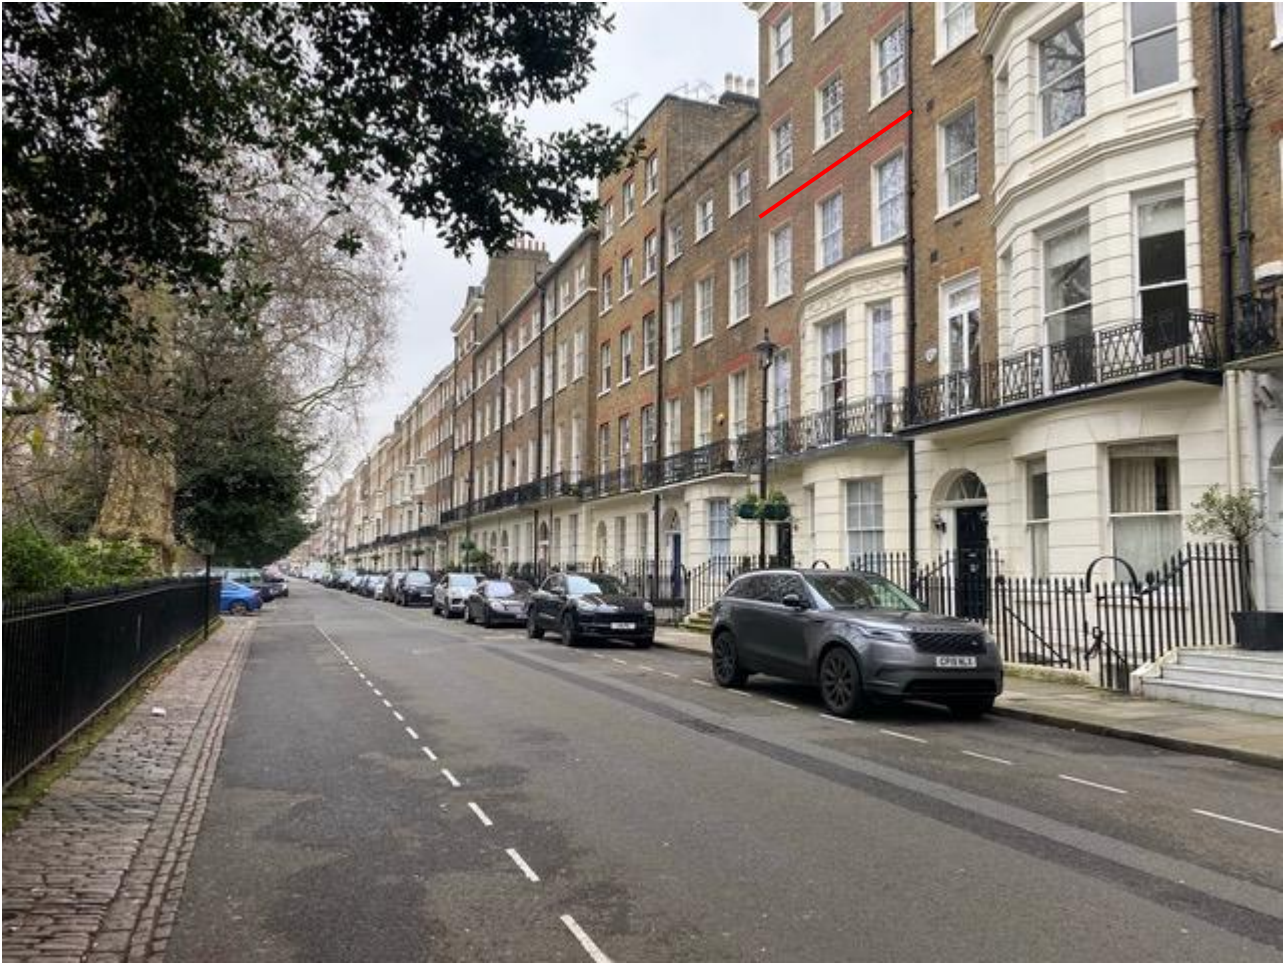
Figure 1 - General view of 40 Montagu Square (marked by the red line) in the context of the neighbouring terrace. Note that there is no absolute conformity in terms of building heights, storey heights, balcony heights, or the widths of the various blocks in this terrace.

**1.1** This Heritage Impact Assessment has been prepared by Dr Jonathan Edis, Director of HCUK Group, on behalf of Mr and Mrs O. Merican. It relates to Flat 3, 40 Montagu Square, London, which is a grade II listed building (Figure 1) within Portman Estate Conservation Area.

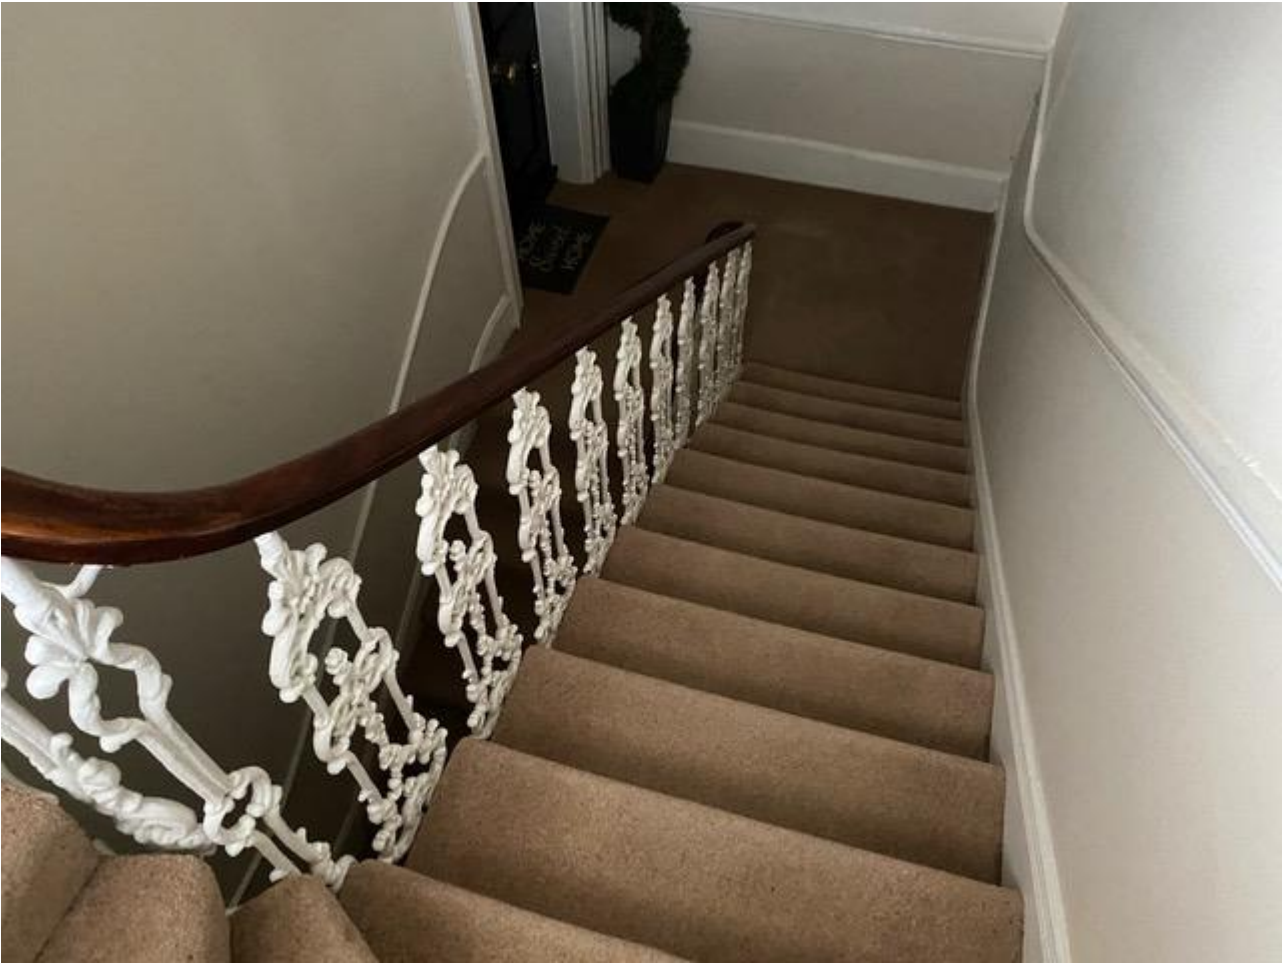
Figure 2 - The main staircase of c.1850 to c.1870.

**3.6** Internal inspection of the building indicates that the lower part of the main staircase is typical of the period c.1850-c.1870 (Figure 2), and that the upper part of the same staircase dates approximately to the Edwardian period (Figures 9 to 11). The extension of the "mid C.19" segmental bow on the frontage is consistent in date with the staircase. It is difficult to see how the entire staircase (and the cornices etc in the stair well) could have been replaced throughout the whole building without totally remodelling the internal floors and the room layouts, so it is likely that the building was comprehensively altered during the mid-Victorian period, with further change to the upper floors about half a century later.

- 3.11** There is a degree of artistic interest in the innate architecture of the building, for example in the iron balustrade of the staircase (Figure 2).

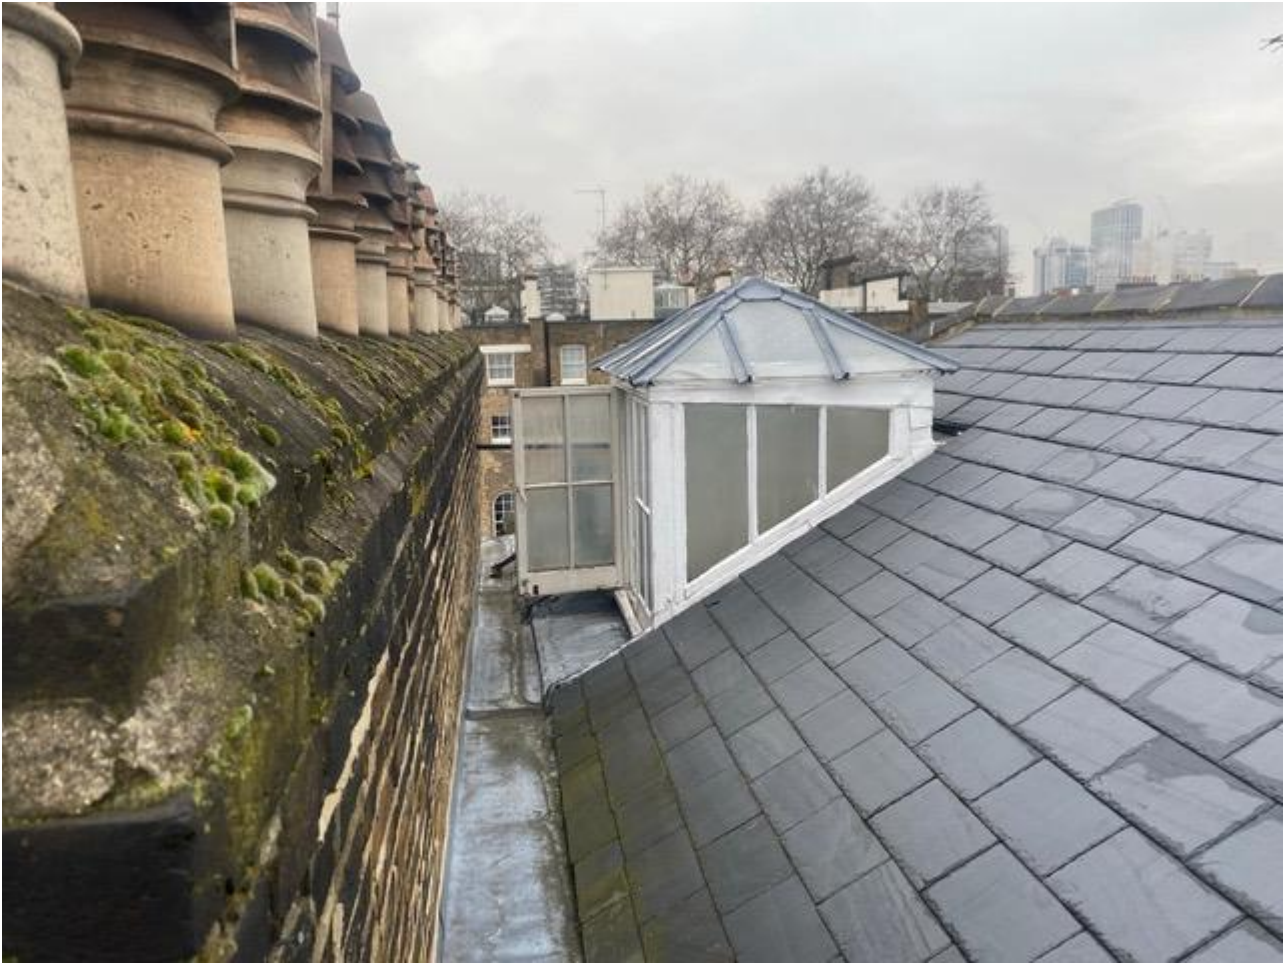
Figure 3 - The existing roof lantern, of early 20<sup>th</sup> century construction.

- 4.5** The principal change at roof level is the removal of the existing lantern, which appears to date to the early 20<sup>th</sup> century, perhaps around 1920 (Figures 3 to 5). It is made of timber, with wired glass on the pyramidal roof, and reeded glass on the cheeks and the casements. The interior is boarded, and it has cut through an earlier hipped roof which, from the appearance of the joists and boarding is itself likely to be a late 19<sup>th</sup> century or early 20<sup>th</sup> century alteration (Figure 6). There is nothing of special interest in the fabric of the existing rooflight, and its removal will not harm the significance of the listed building.

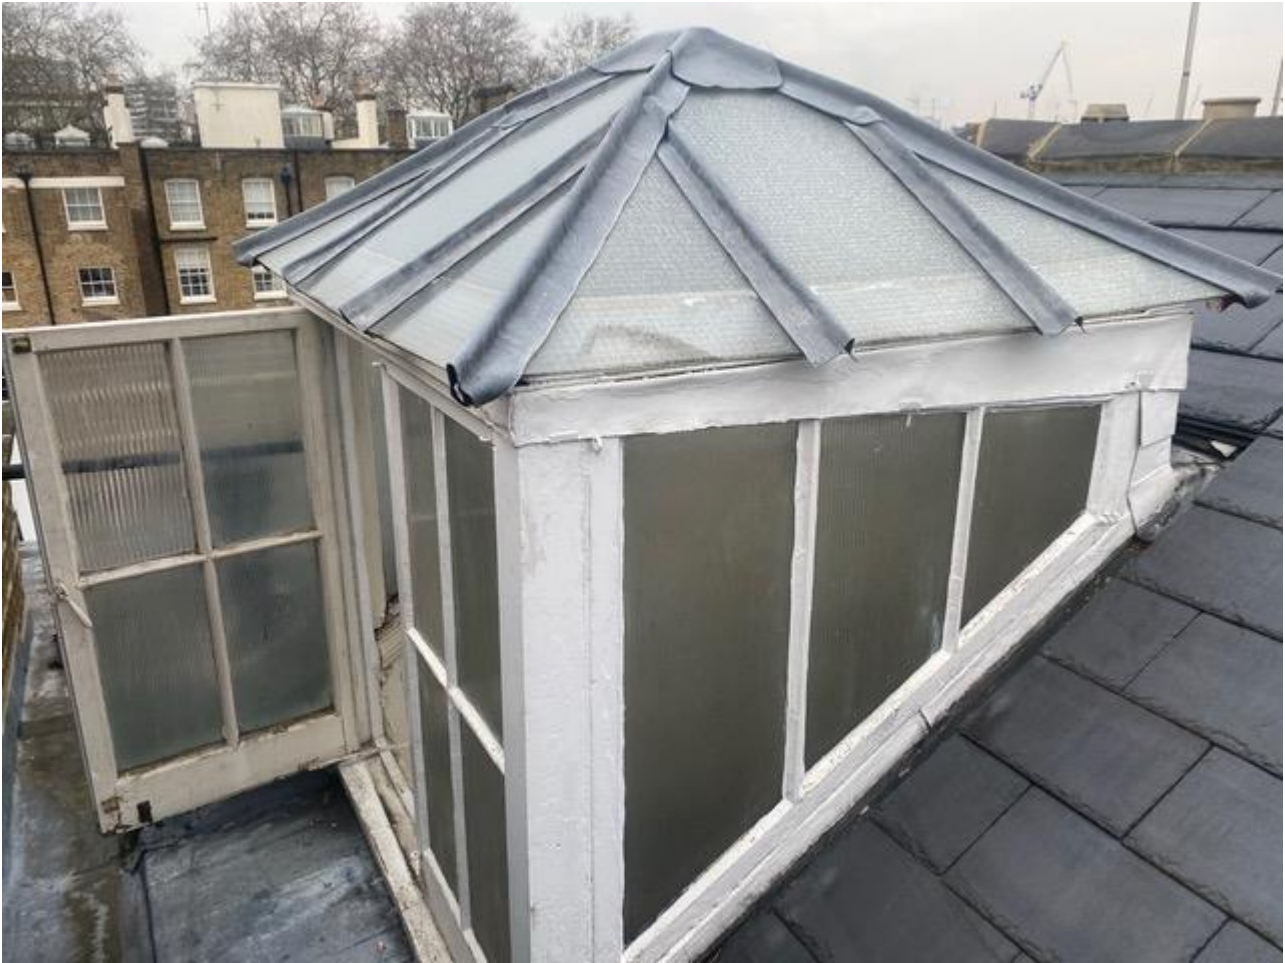
Figure 4 - The existing roof lantern, of early 20<sup>th</sup> century construction.

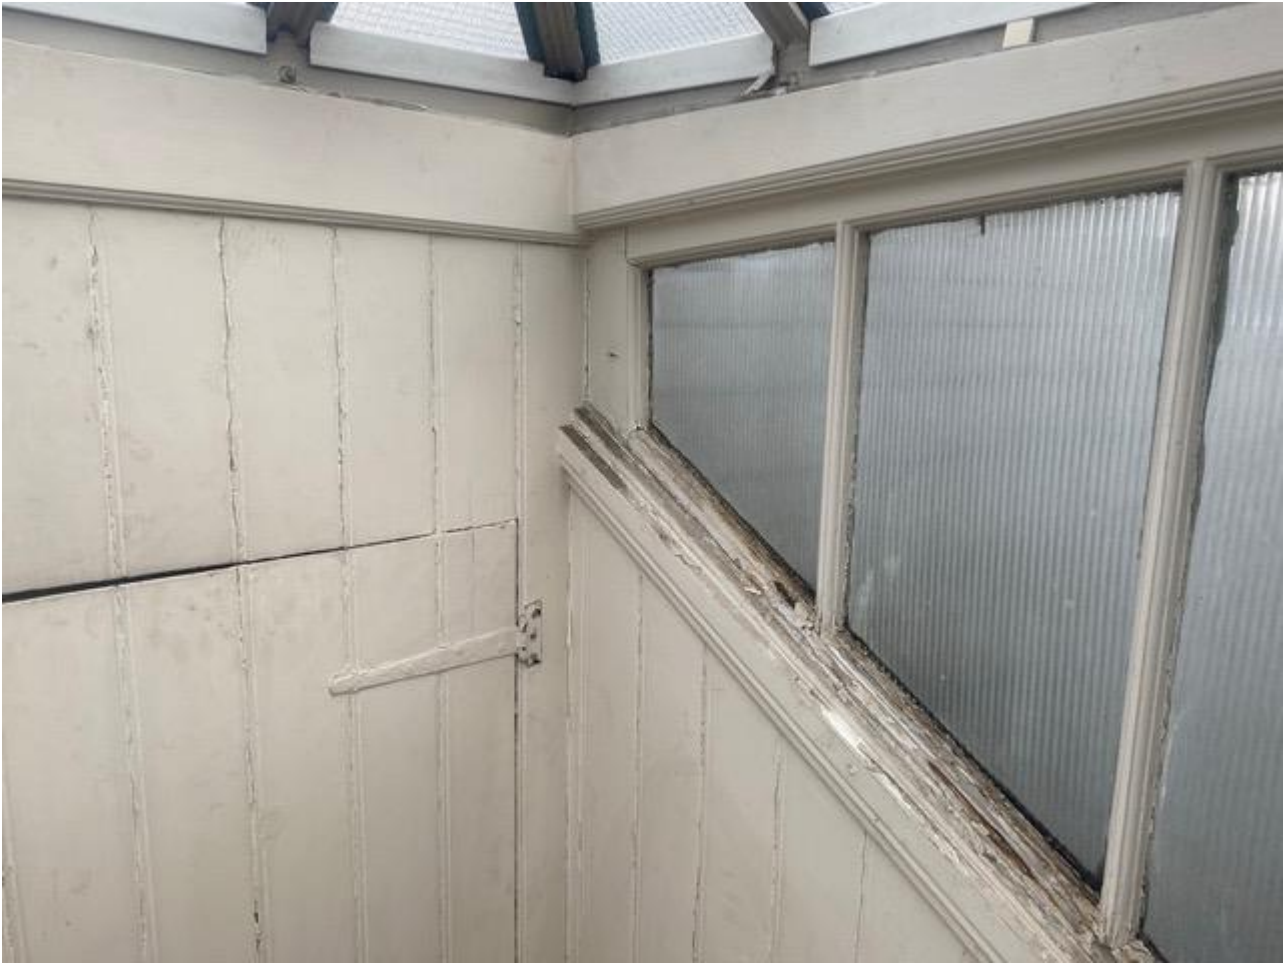
Figure 5 - The interior of the existing roof lantern.

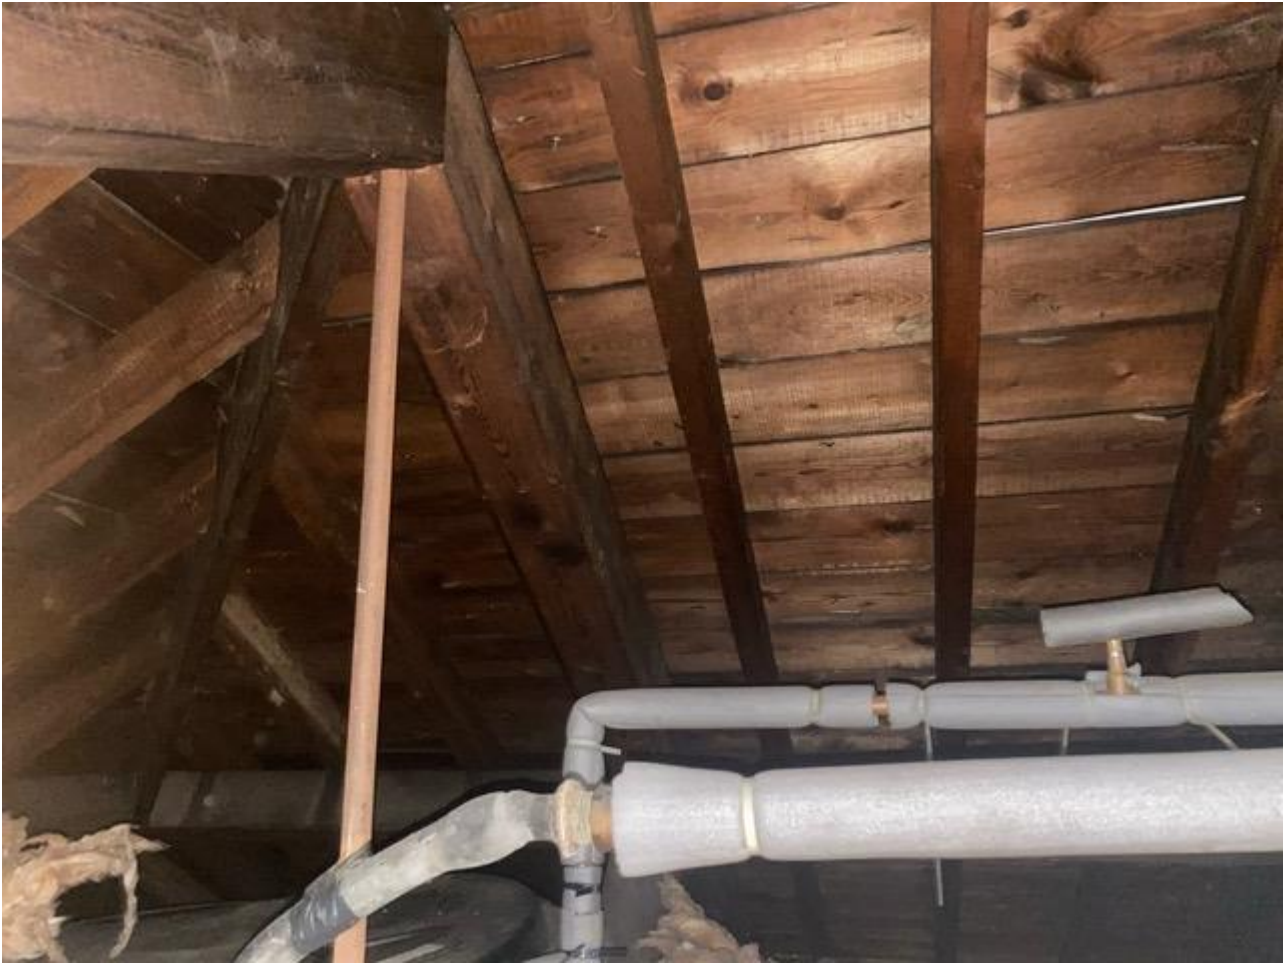
Figure 6 - The interior of the hipped roof, of late 19<sup>th</sup> or early 20<sup>th</sup> century date.

- 4.6** A new and enlarged rooflight is proposed. This will cut out more of the hipped roof, but the fabric of that structure is very unlikely to be original. The new rooflight will not be visible from ground level. In design terms it should be compared favourably with the lantern at 39 Montagu Square that was approved in 2008 (08/07584/LBC) (Figure 8). Other broadly similar lanterns have been approved, including 2 Montagu Square (14/0557 and 16/03489). When observed from roof level, the whole area abounds with incremental alterations and changes, most of which are hidden from public view and have no effect on the special interest of the townscape – including the structure on the roof of the neighbouring listed building, 41 Montagu Square (Figure 7).

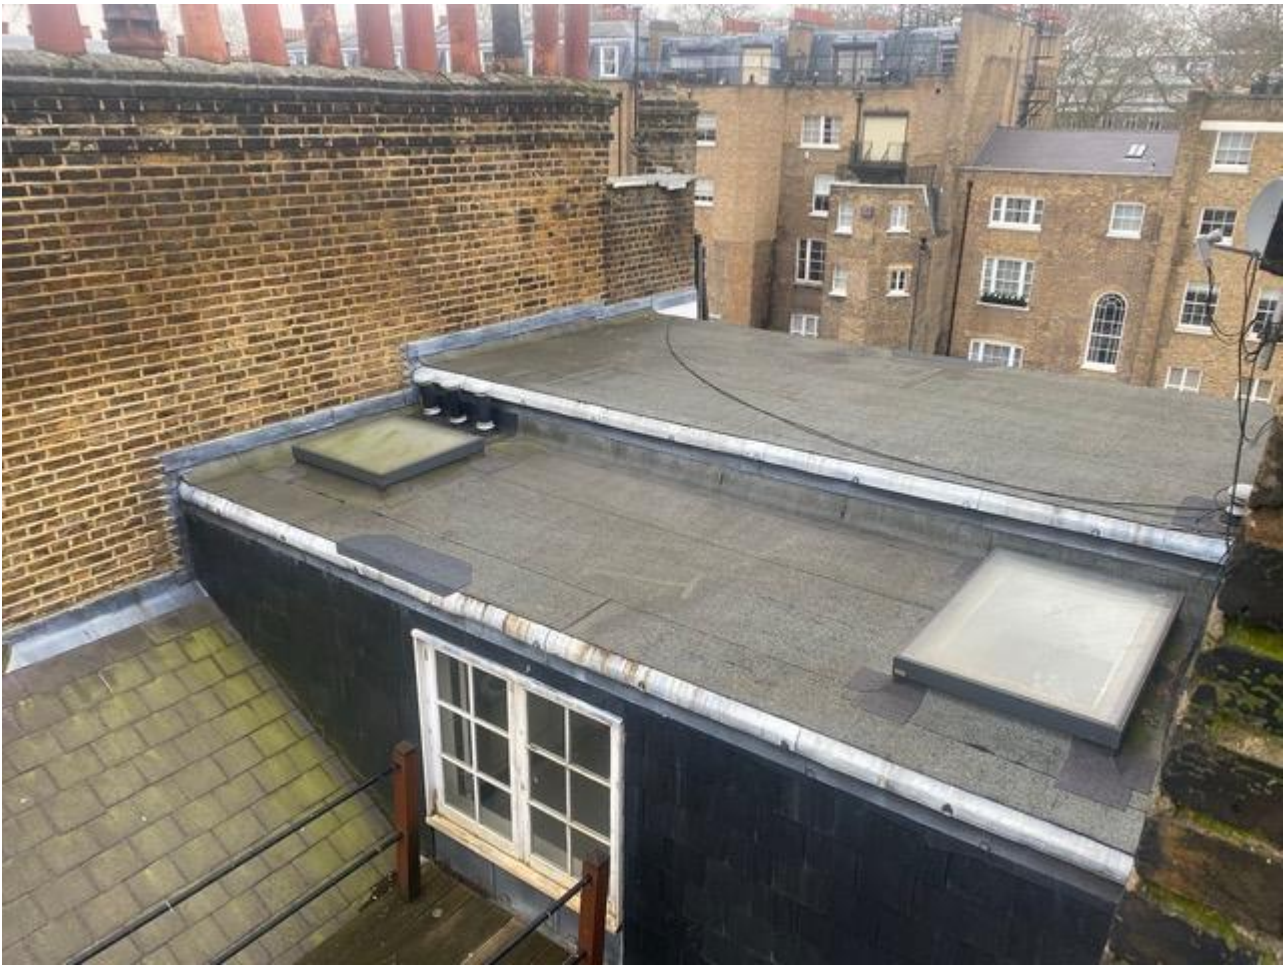
Figure 7 - Modern roof structure looking down on 41 Montagu Square.

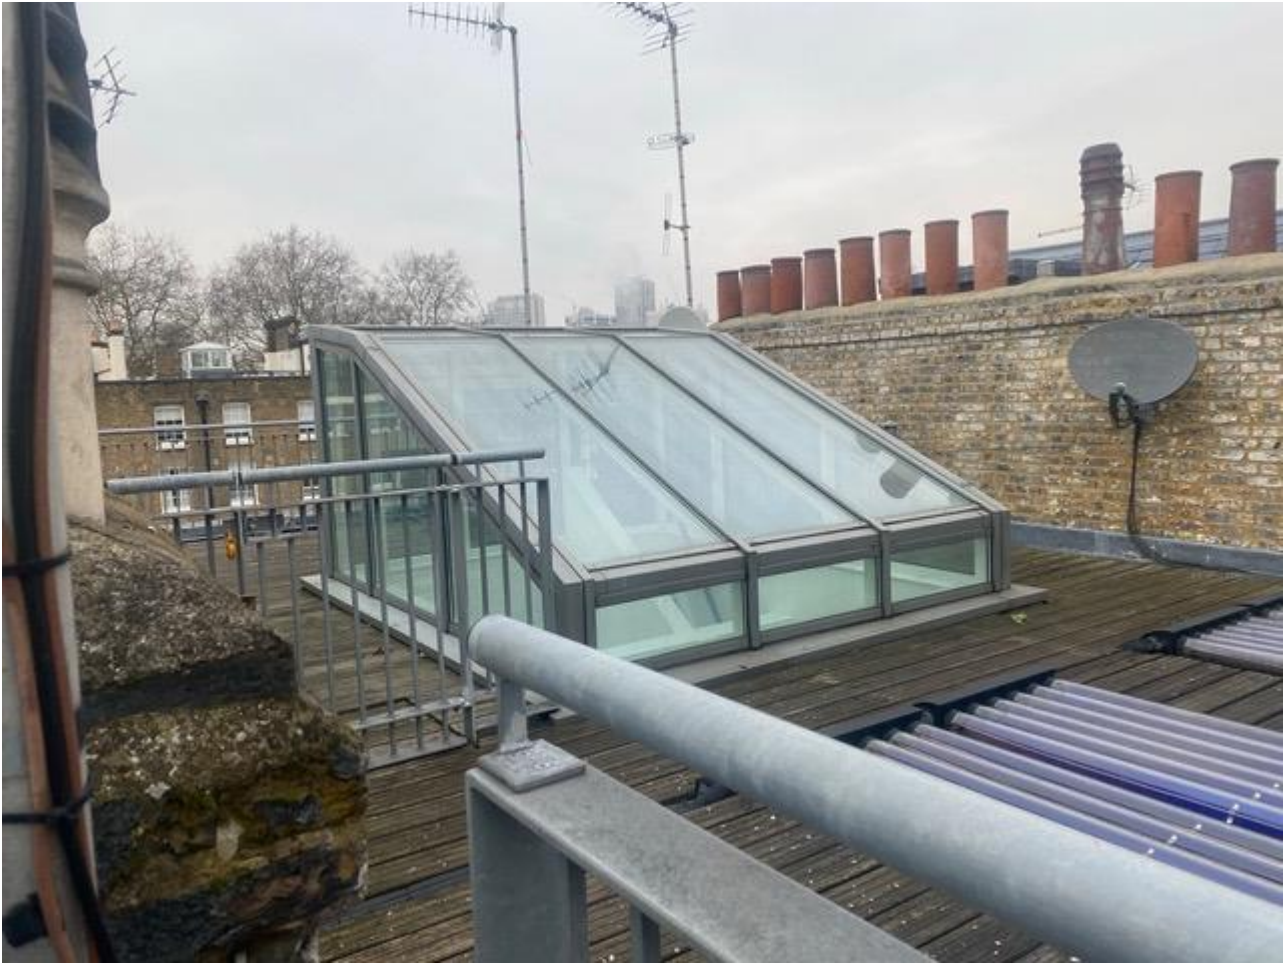
Figure 8 - Modern roof lantern (c.2008), 39 Montagu Square.

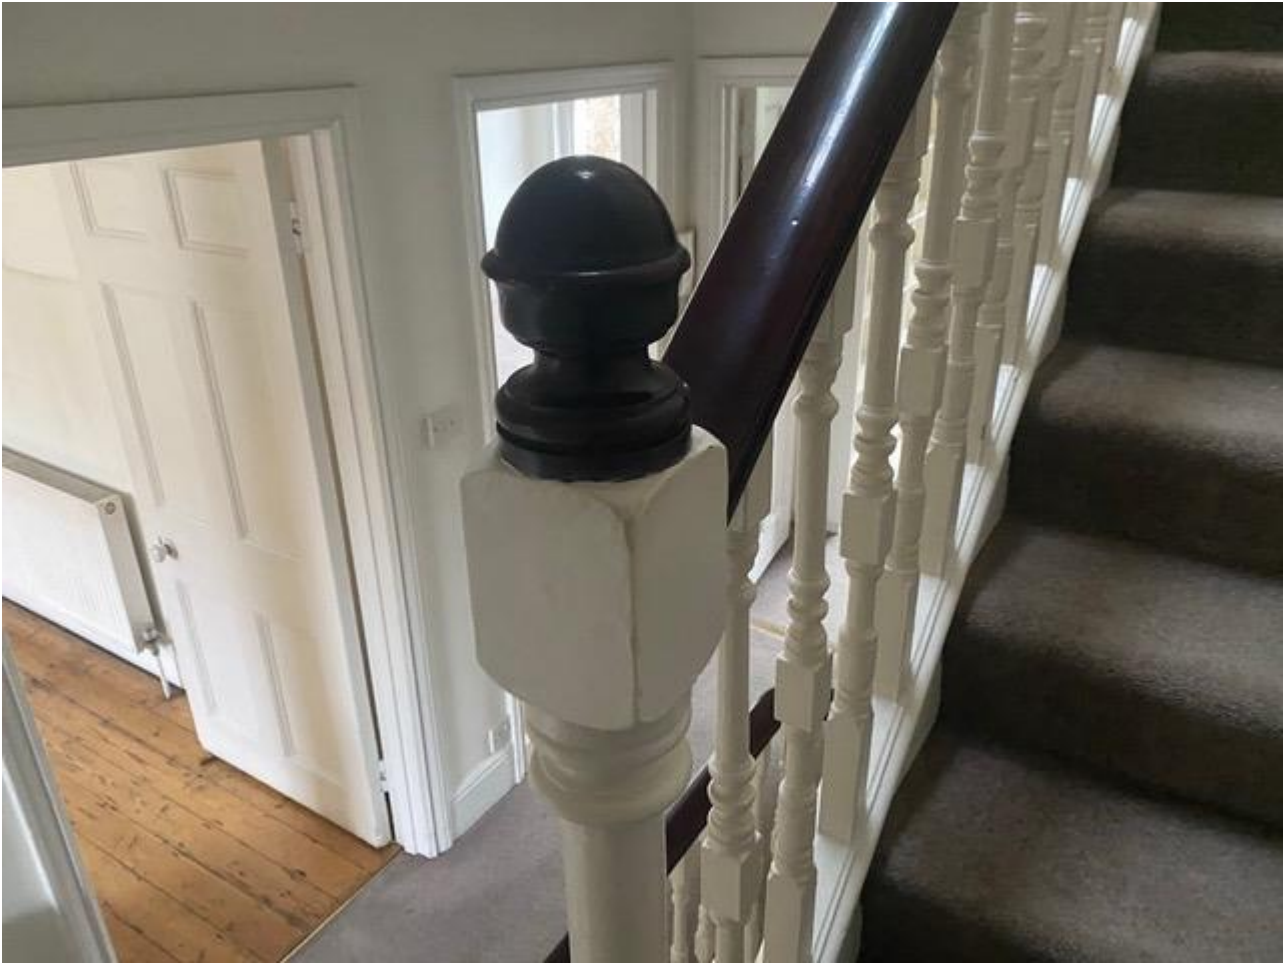
Figure 9 - The upper staircase, of broadly late Victorian or Edwardian date, between the third and fourth floors in 40 Montagu Square.

(Figures 9 to 11) and fireplaces (Figure 13)<sup>5</sup> in number 40 suggests that the layout dates from the late 19<sup>th</sup> or early 20<sup>th</sup> centuries.

- 4.12** In order to accommodate easy and safe access to the roof lantern and better access to the main rooms, it will be necessary to widen the landing at third floor level. It is proposed to adjust the existing timber staircase (Figure 11), which appears to be of late Victorian or broadly Edwardian date. The handrails and balusters can be

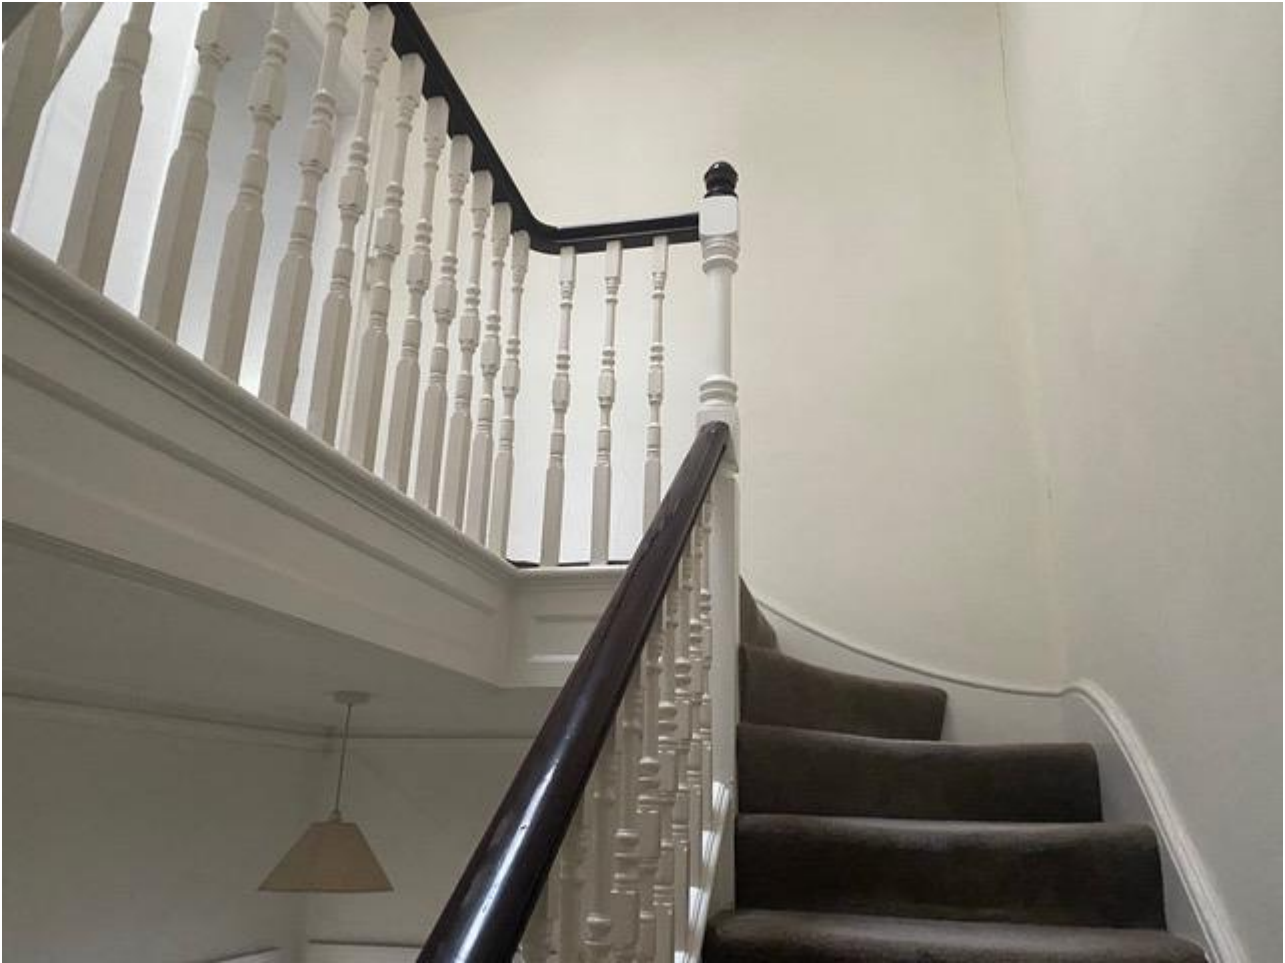
Figure 10 - The upper staircase, of broadly late Victorian or Edwardian date, between the third and fourth floors in 40 Montagu Square.

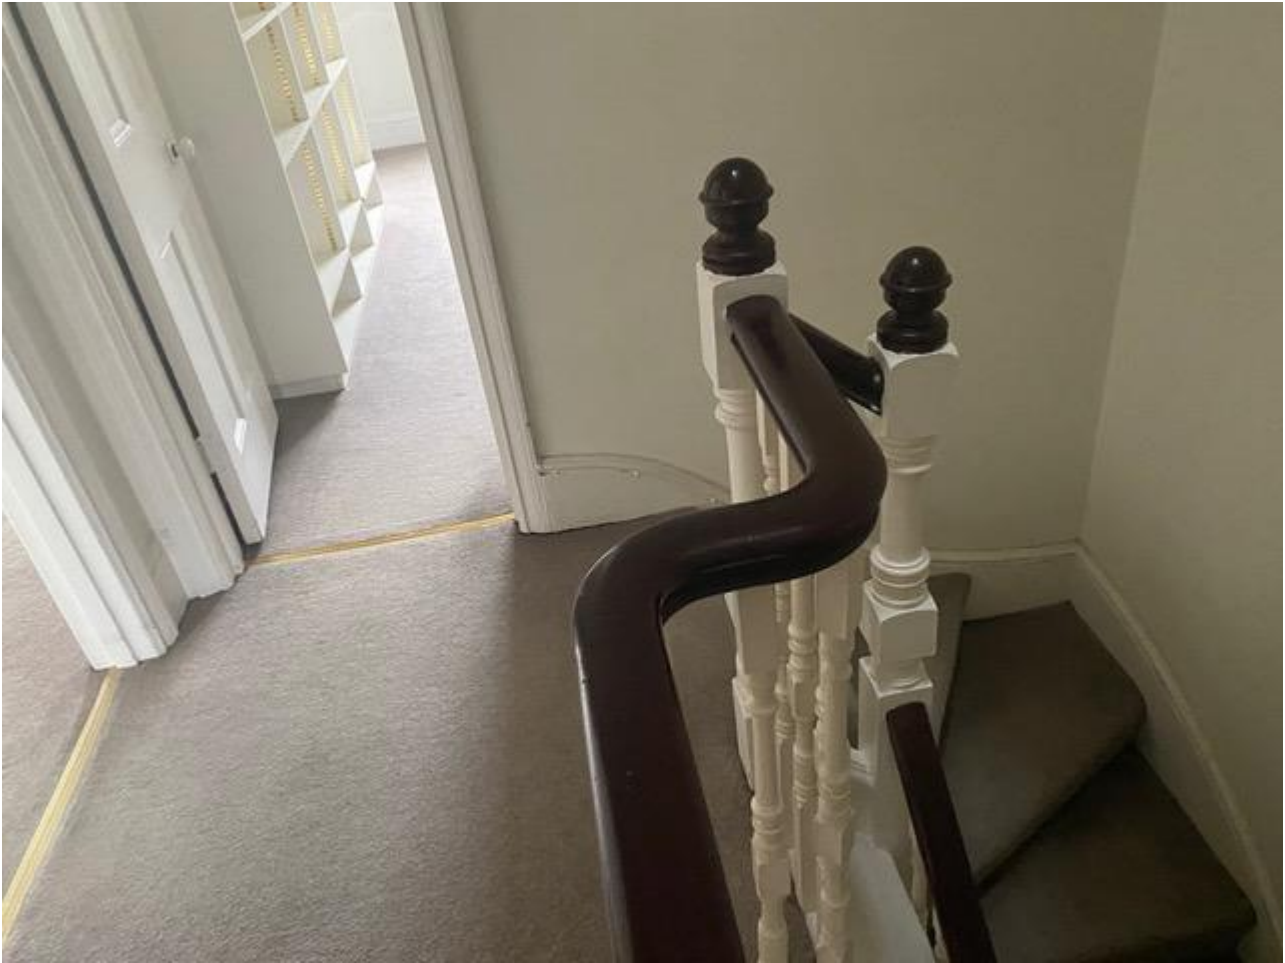
Figure 11 - The landing of the upper staircase, of broadly late Victorian or Edwardian date, third floor, in 40 Montagu Square.

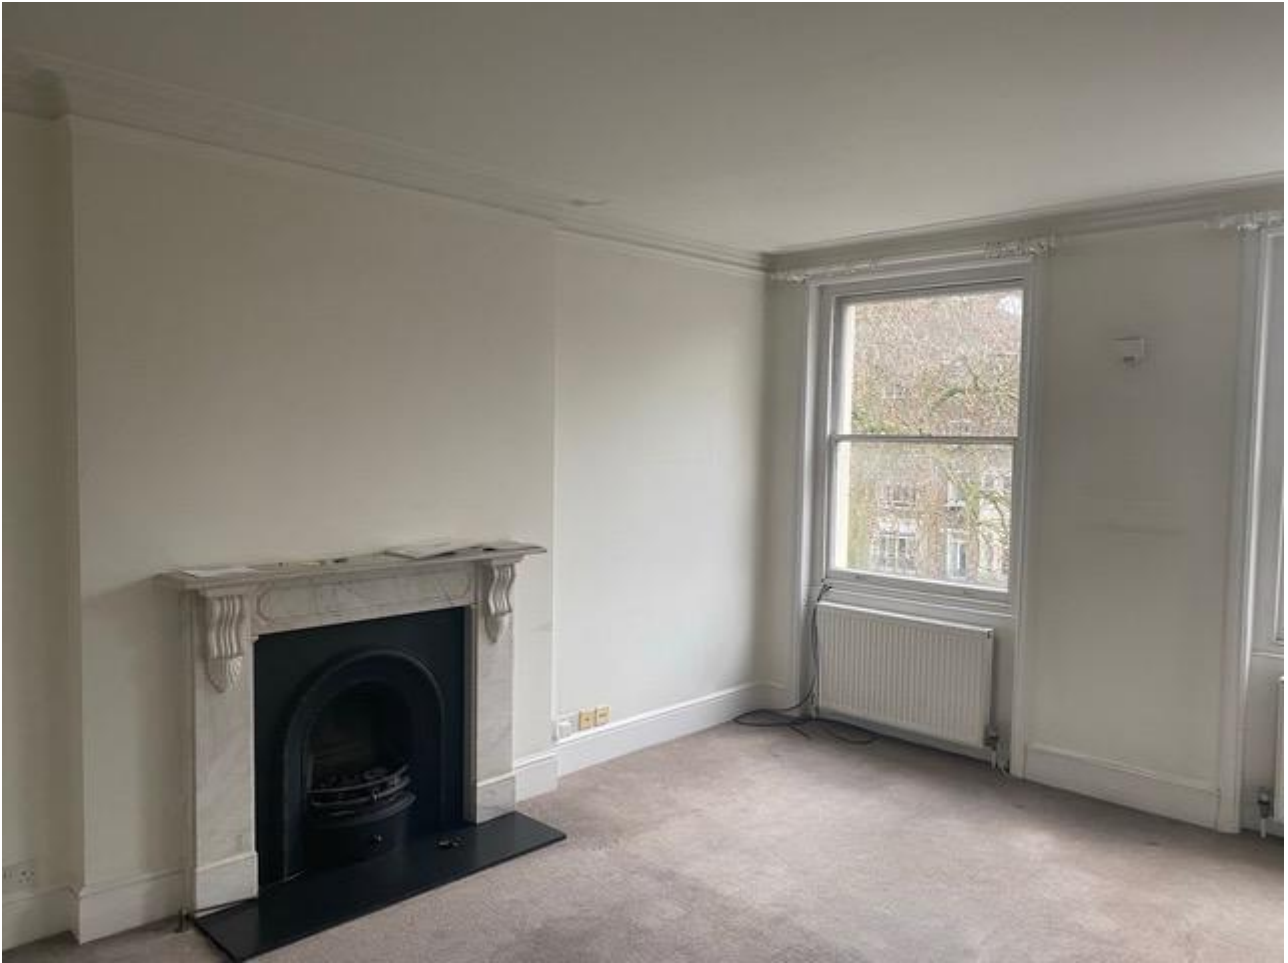
Figure 12 - Fireplace in main room, third floor, 40 Montagu Square

<sup>5</sup> In number 40, the fireplace in the small third floor room at the front is late Victorian or Edwardian, and the fireplace in the larger room is probably Victorian (See Figures 13 and 12 respectively). They may not, of course, be original to the building, but they are, nevertheless, in character. The timber surround to the fireplace at the back is relatively modern (Figure 14).

- 4.13** It is proposed to insulate and re-lay the floor, which will involve carefully taking up the floorboards and replacing them (Figures 18-20). It is intended that the height of the floor surface will remain unchanged.
- 4.14** Radiators will be provided, and gas fires will be overhauled within the existing fire surrounds (Figures 12 to 14).

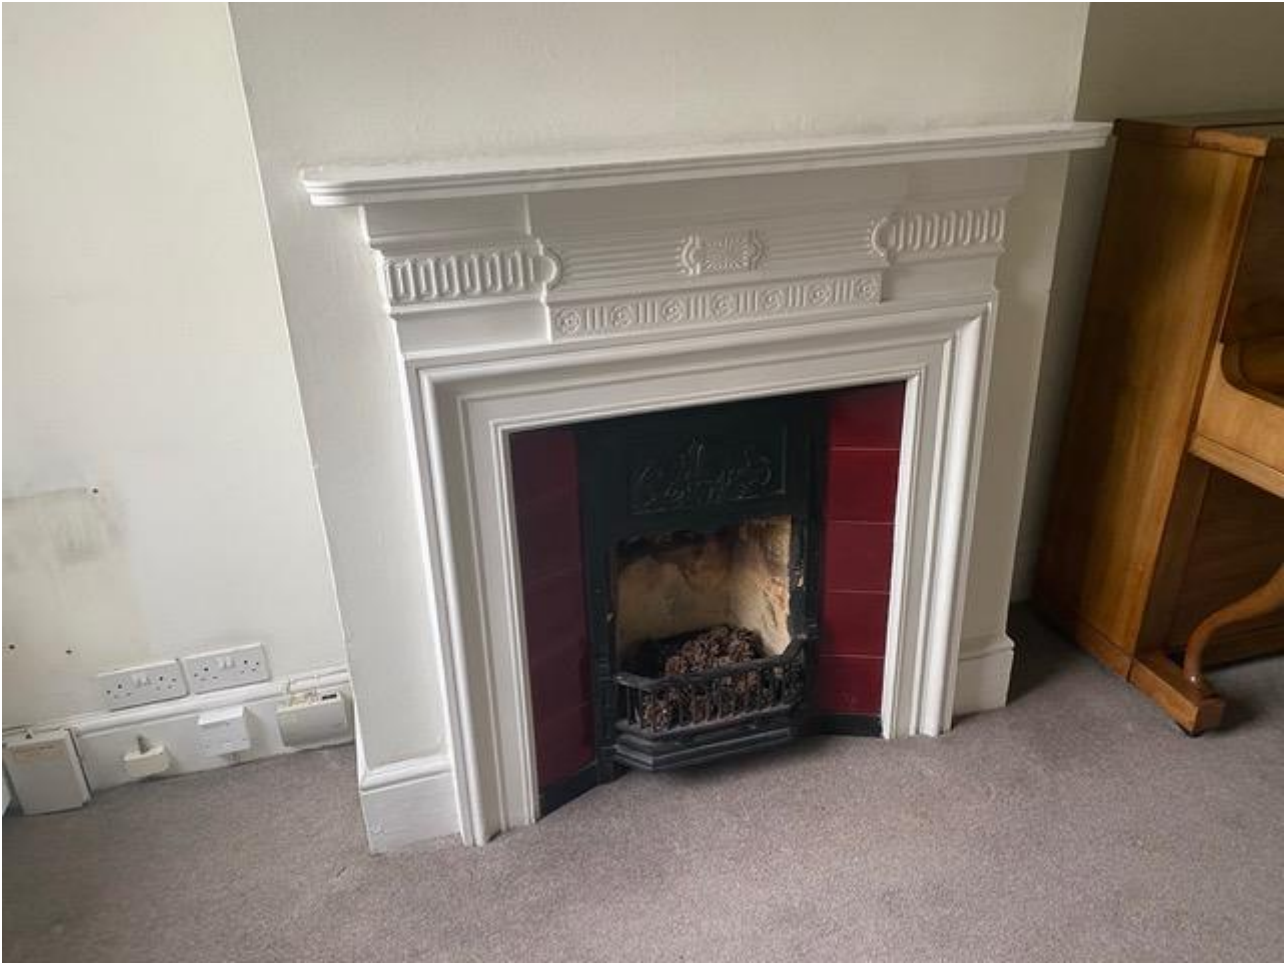
Figure 13 - Fireplace in smaller front room, 40 Montagu Square.

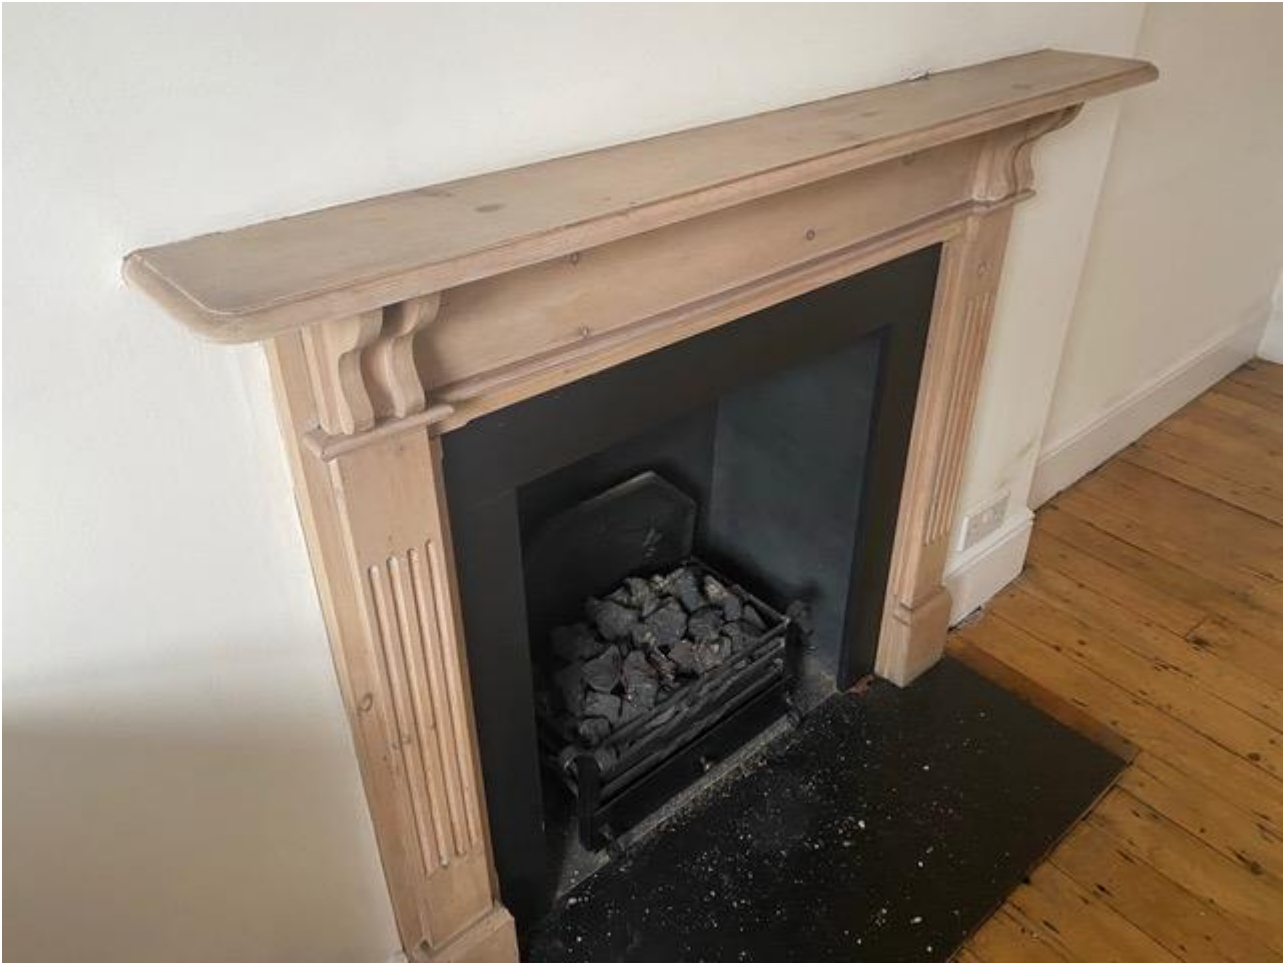
Figure 14 - Modern fire surround, rear part of third floor, 40 Montagu Square

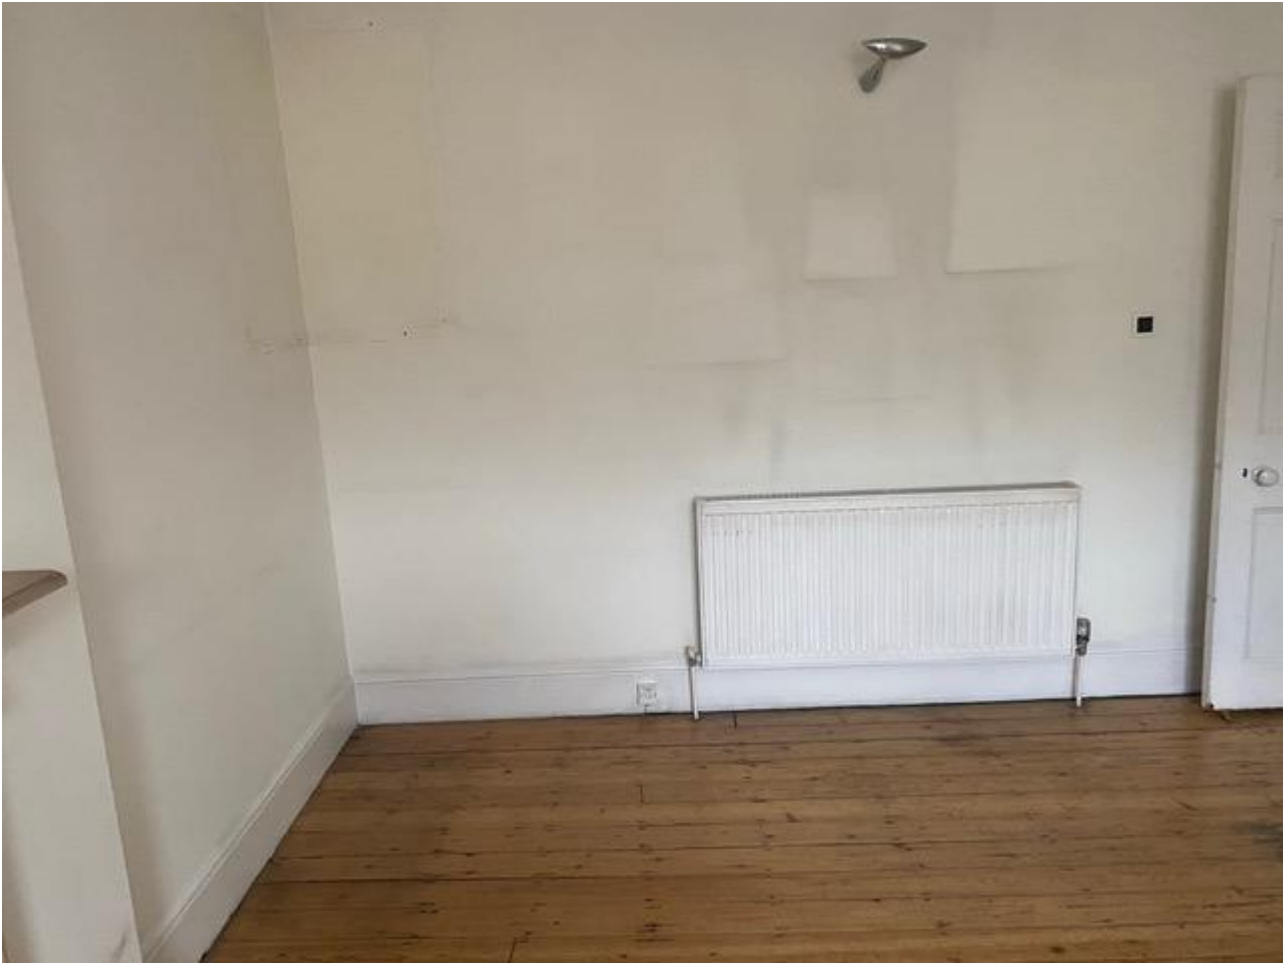
Figure 15 - Dividing wall between the third floor front and back rooms, seen from the back room (kitchen) looking towards the front.

- 4.10** Two new openings will be formed in the internal partitions at third floor level. One will open the partition between the front and back rooms, currently a living room and kitchen respectively. Another will open up the partition between the front living room and the smaller, narrower room at the front. In both cases it has been decided to leave nibs and downstands so that the existing (probably mid-19<sup>th</sup> century) layout can still be “read” at all times. Cornices and existing timber beams in the ceiling will be retained. Furthermore, retractable timber shutters will be provided where the two partitions are to be opened up. This will allow the appreciation of either (1) a contemporary open-plan arrangement when the shutters are opened, or (2) a more traditional three-room arrangement when the shutters are closed.

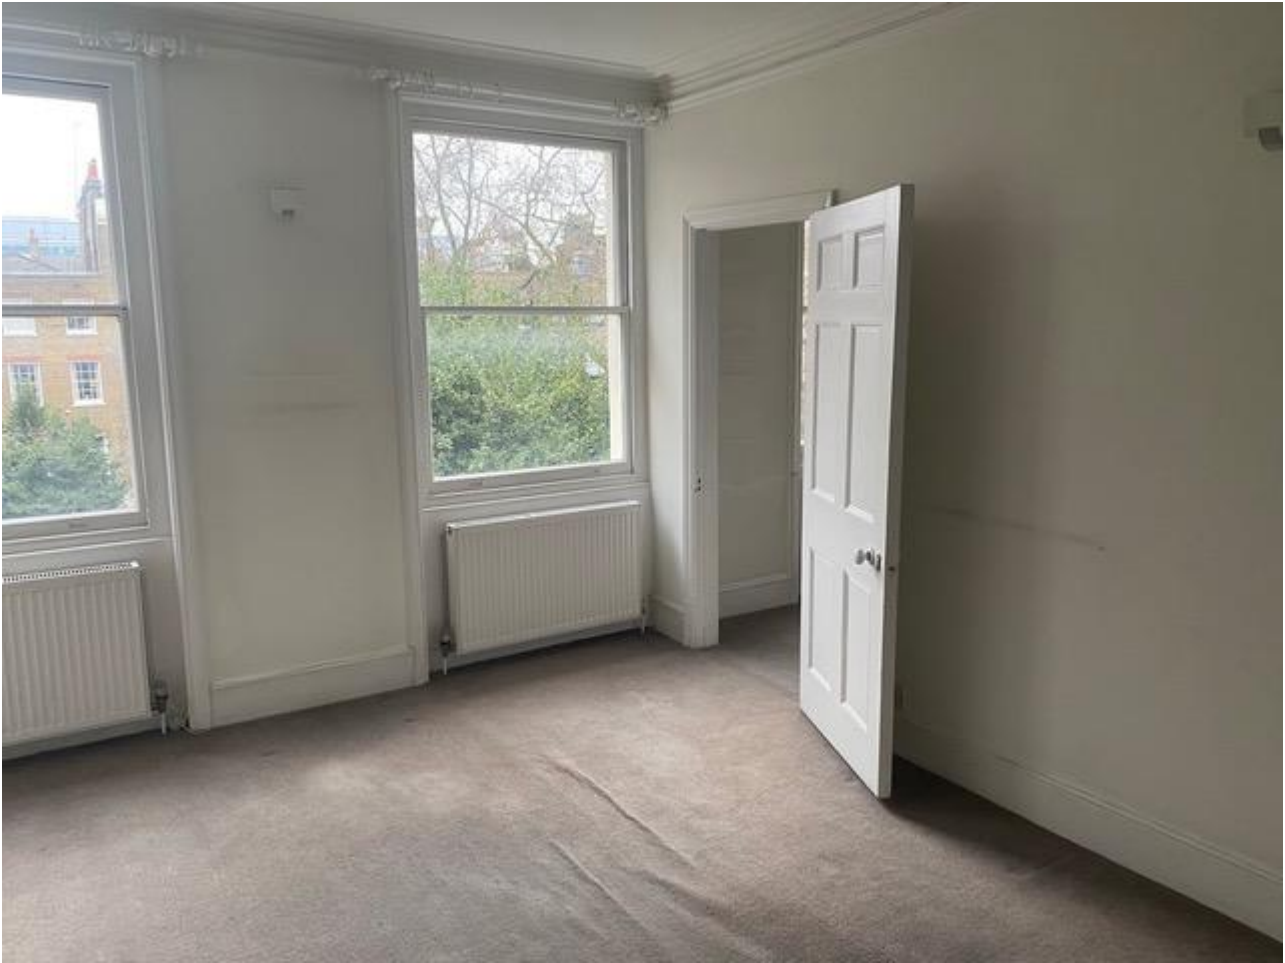
Figure 16 - Dividing wall between the large and small front room, third floor.

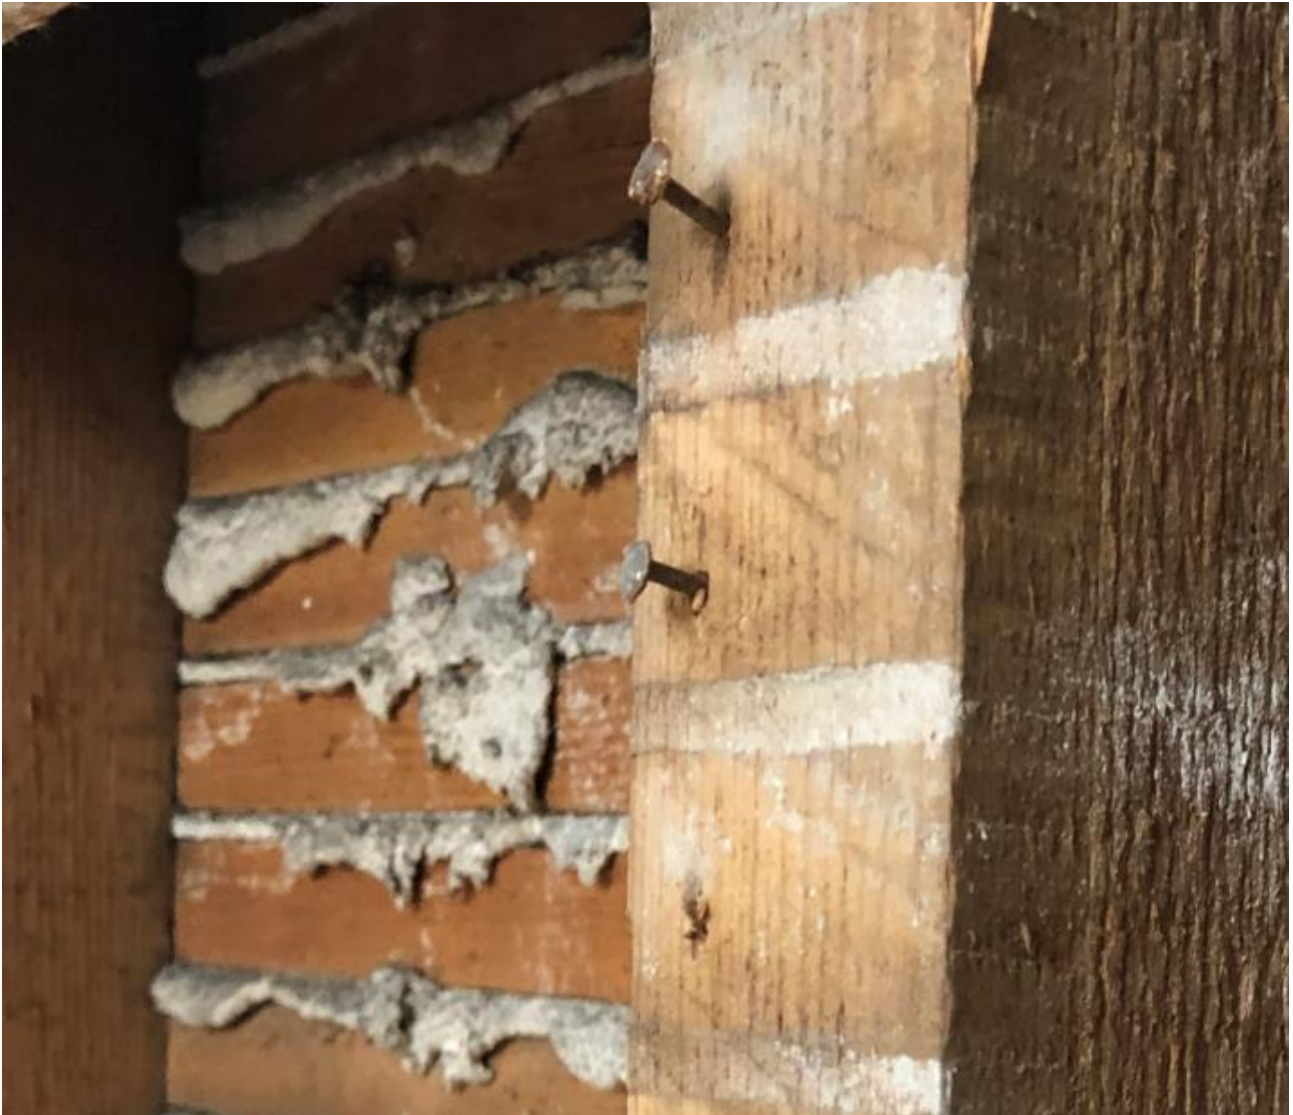
Figure 17 - Victorian-era machine made nails used to apply laths, third floor.
