# Heritage Impact Assessment

Flat 3, 40 Montagu  
Square, London

March 2021 | Project Ref 6604

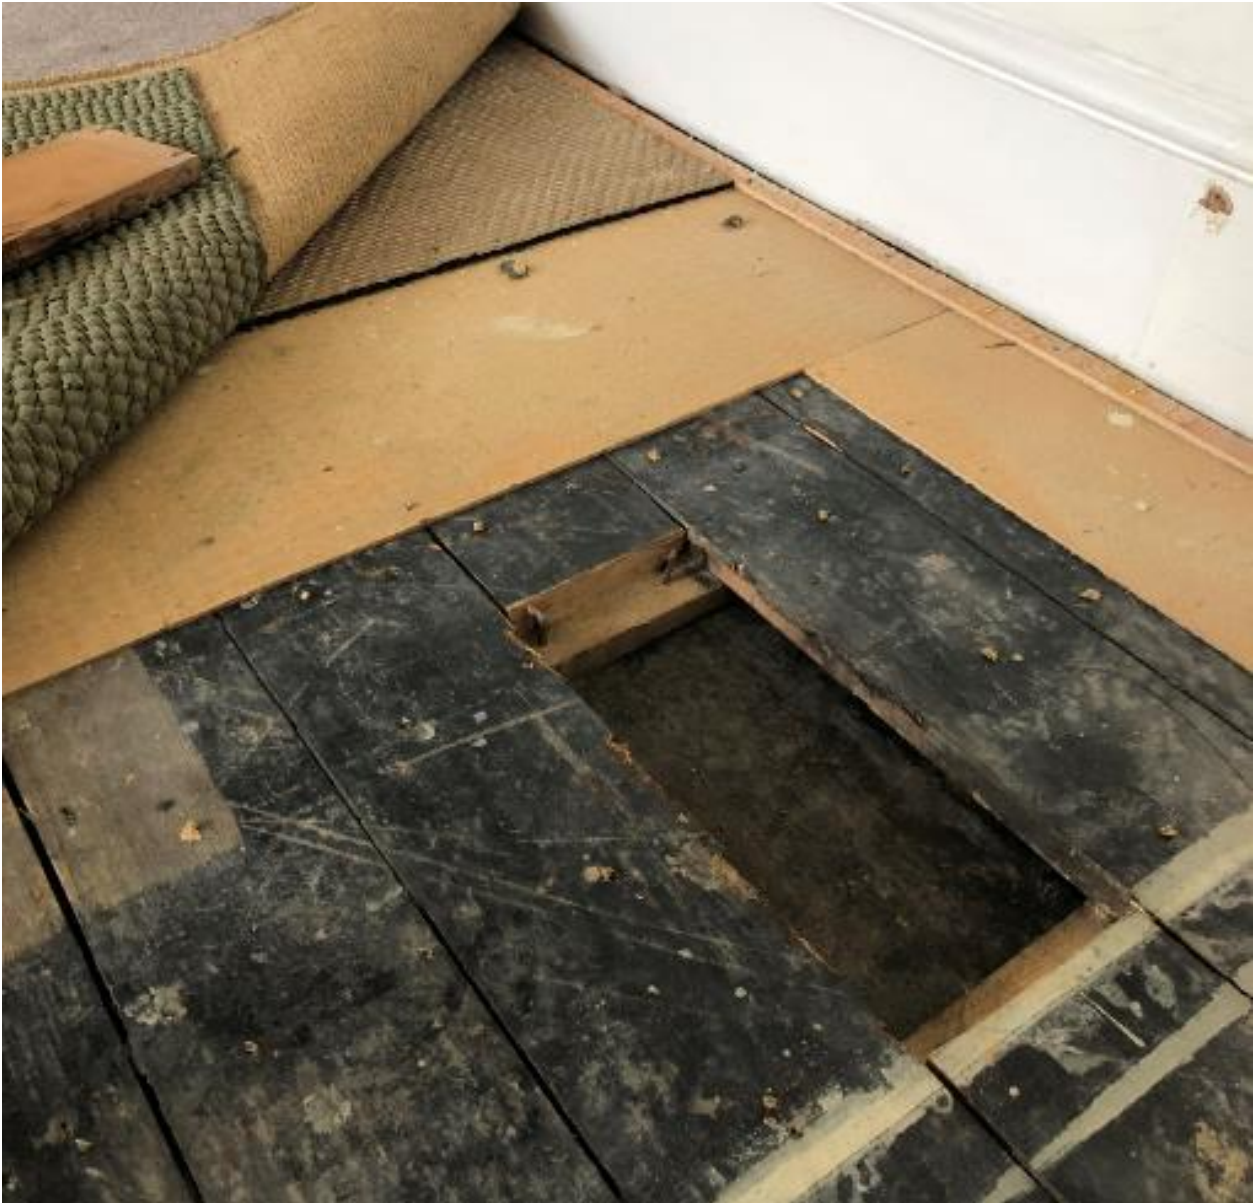
Figure 18 – Typical floor construction.

- 4.13** It is proposed to insulate and re-lay the floor, which will involve carefully taking up the floorboards and replacing them (Figures 18-20). It is intended that the height of the floor surface will remain unchanged.
- 4.14** Radiators will be provided, and gas fires will be overhauled within the existing fire surrounds (Figures 12 to 14).

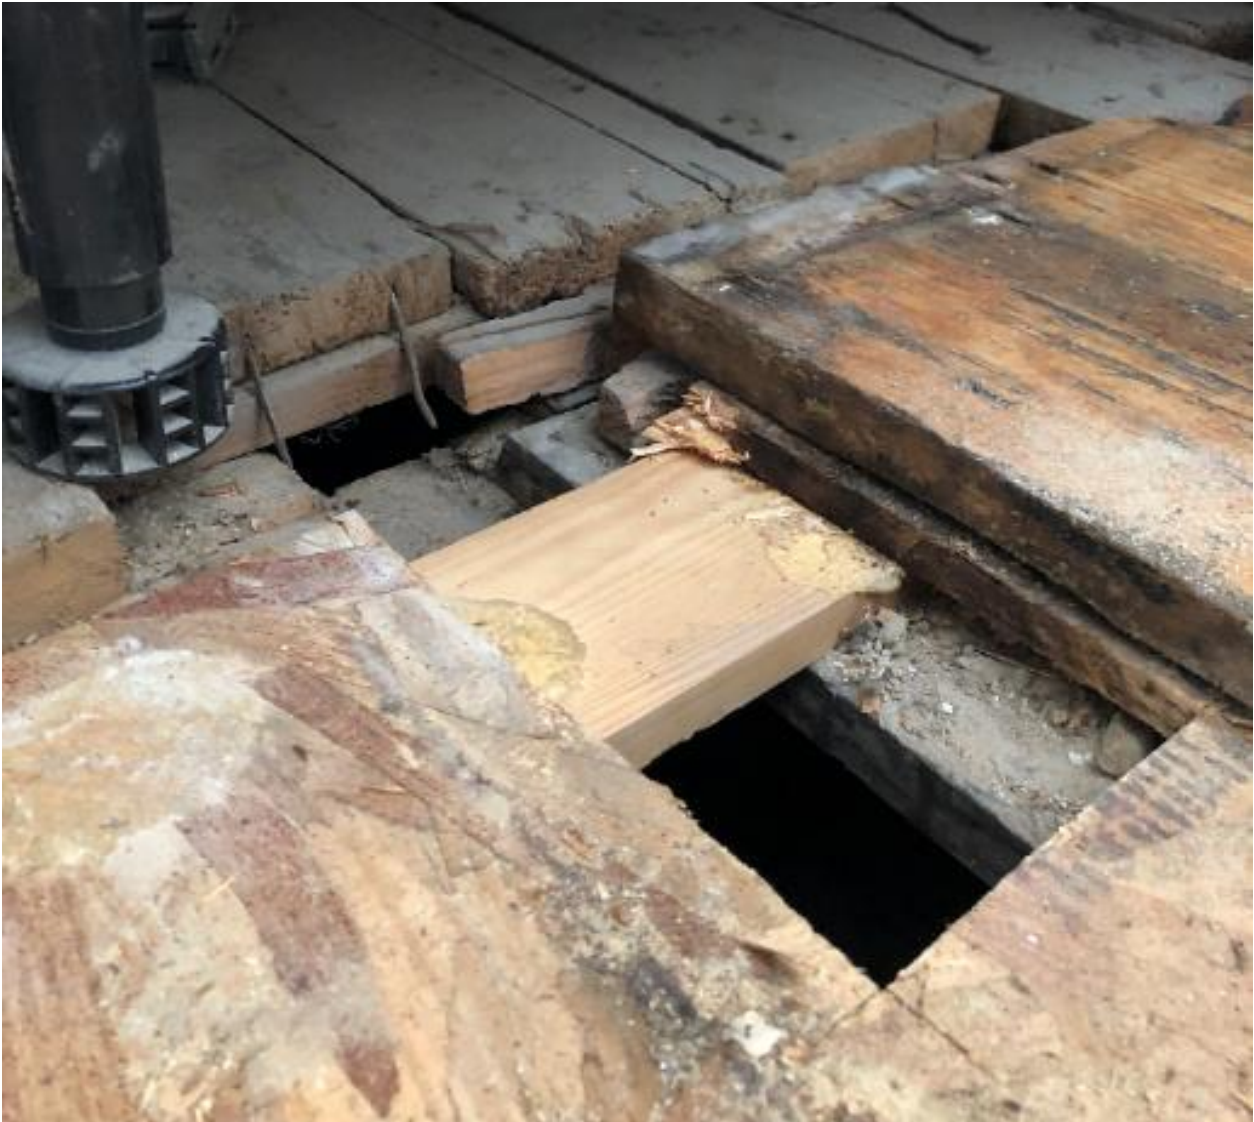
Figure 19 – Typical floor construction, kitchen.

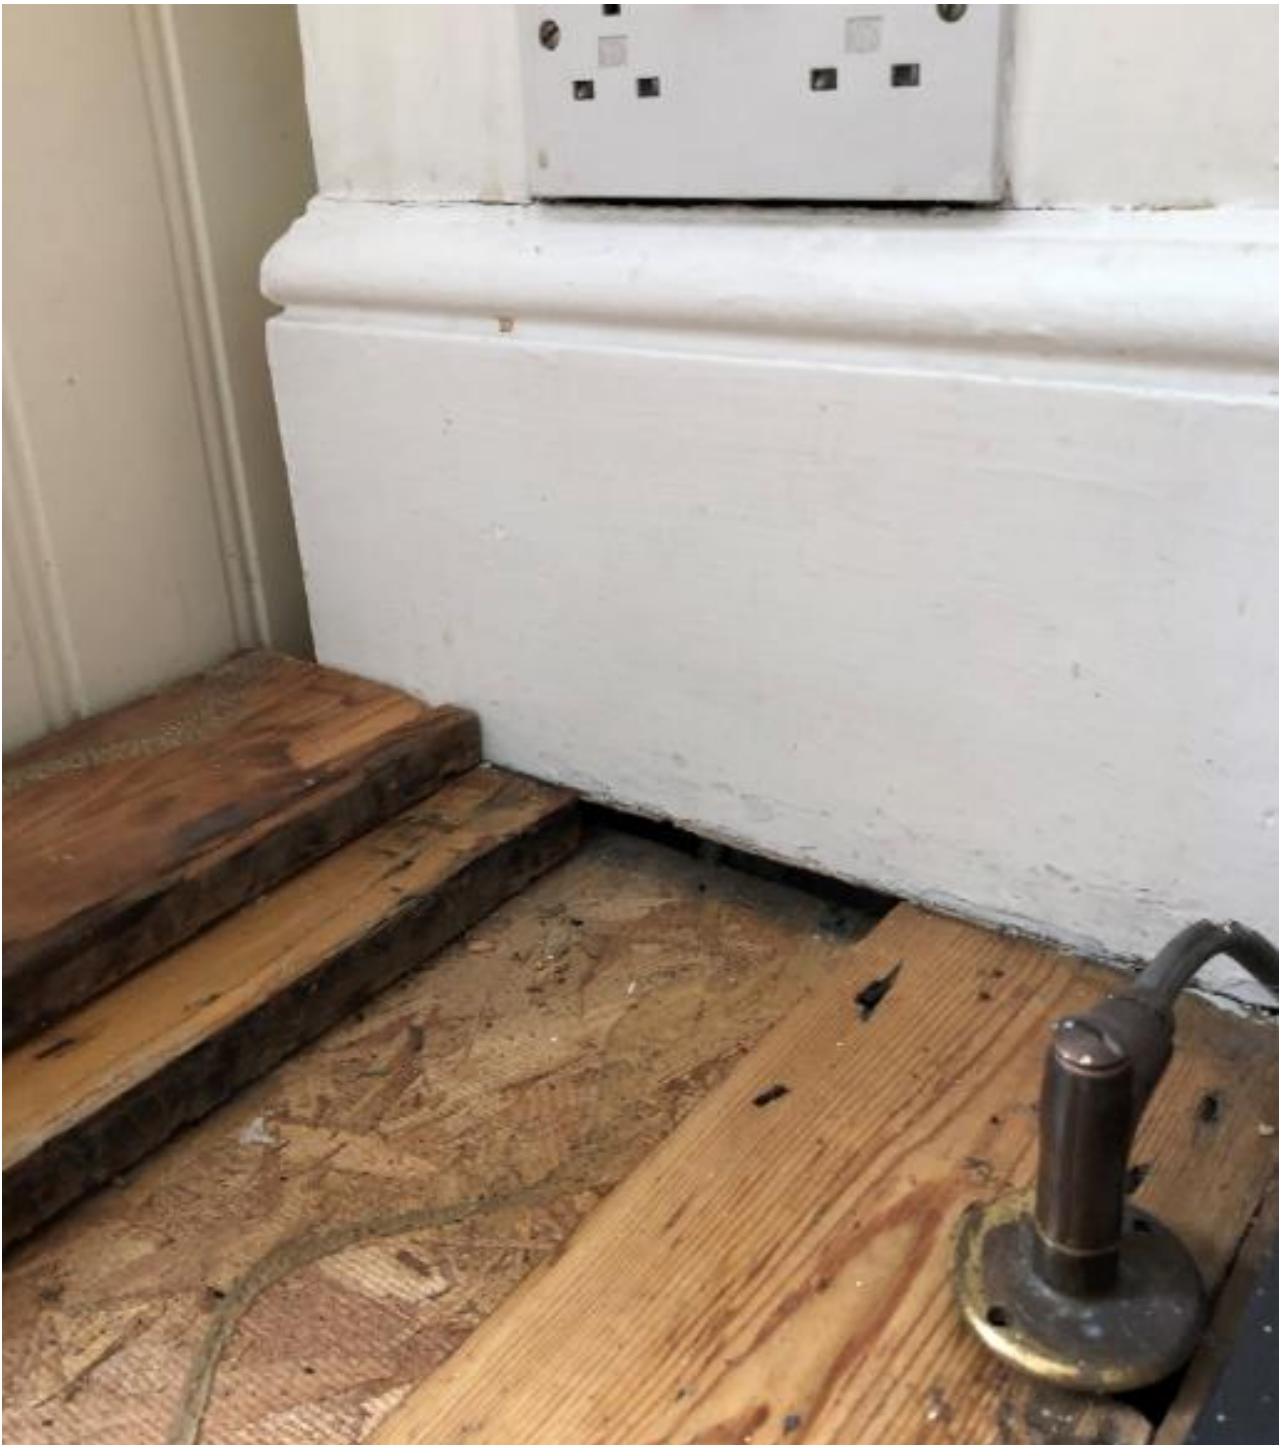
Figure 20 – Kitchen floor and skirting.
