Design and Access Statement

225 Bravington Road, London W9 3AR

Re-Roofing and Window Replacement Works

Arcus Consulting

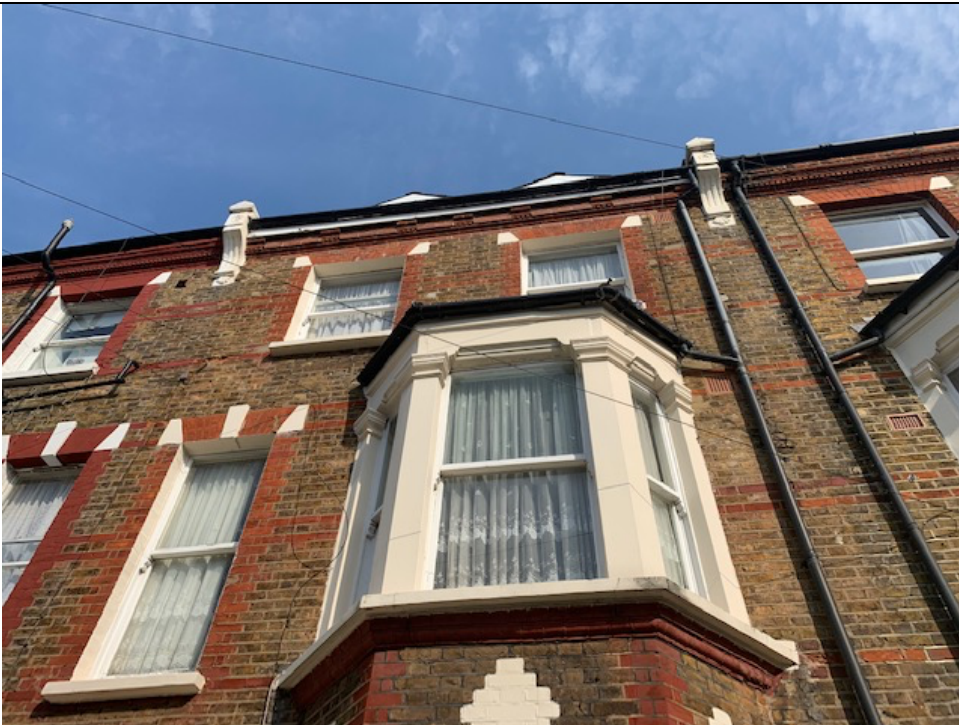
2. Close-up of front elevation showing bay window and timber sash window detailing.

- 3.2 The existing poor condition sash windows will be replaced with new double glazed UPVC windows to matching patterns and profiles, including traditional details such as sash horns. There are several examples along the street of UPVC windows having replaced the original timber sash windows; where these are done to emulate traditional sashes they appear in keeping, which is the intention with this property.

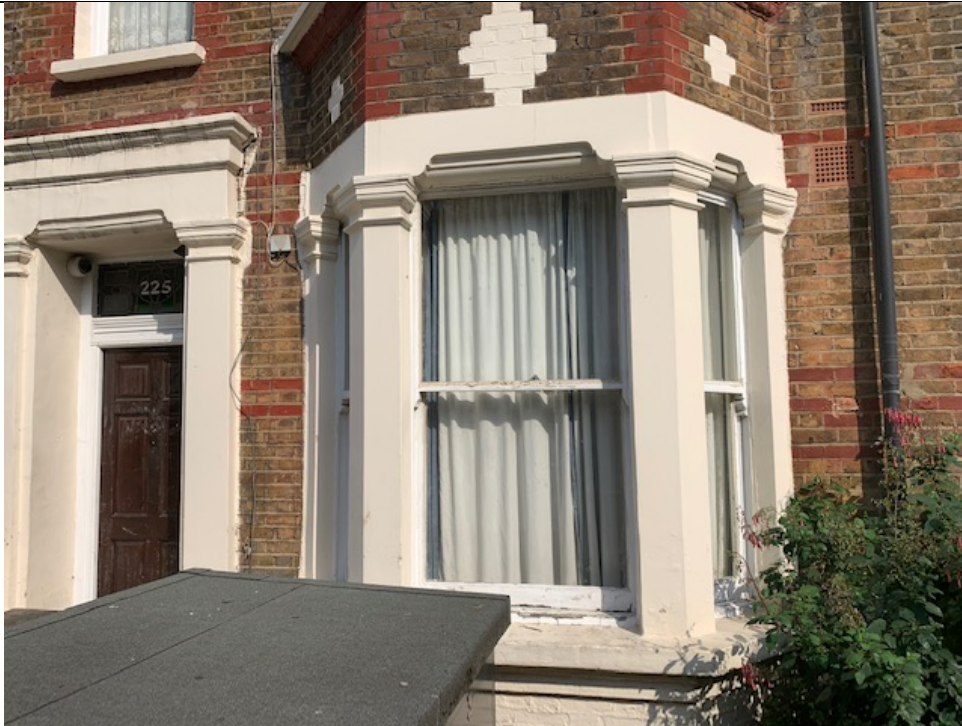
3. Close-up view of ground floor bay window with sashes, and front door.

- 3.3 The front door is to be replaced with a new doorset of near-identical design, being a fielded and panelled 6-panel Secured by Design composite doorset with a glazed fanlight above.

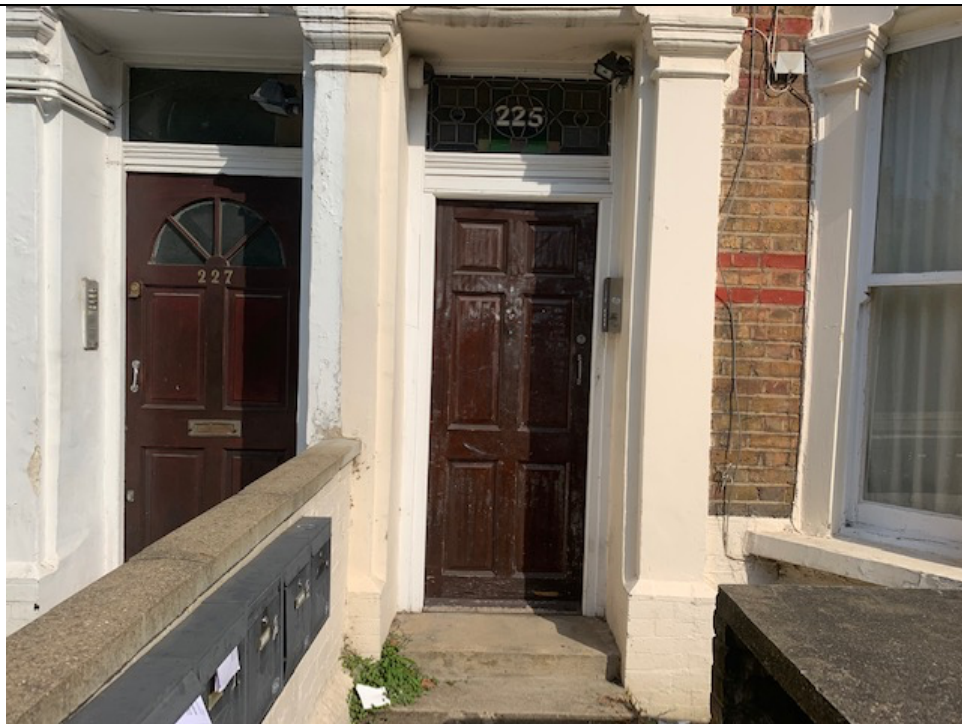
4. Front door is a traditional 6-panel solid timber door with a stained glass fanlight above.

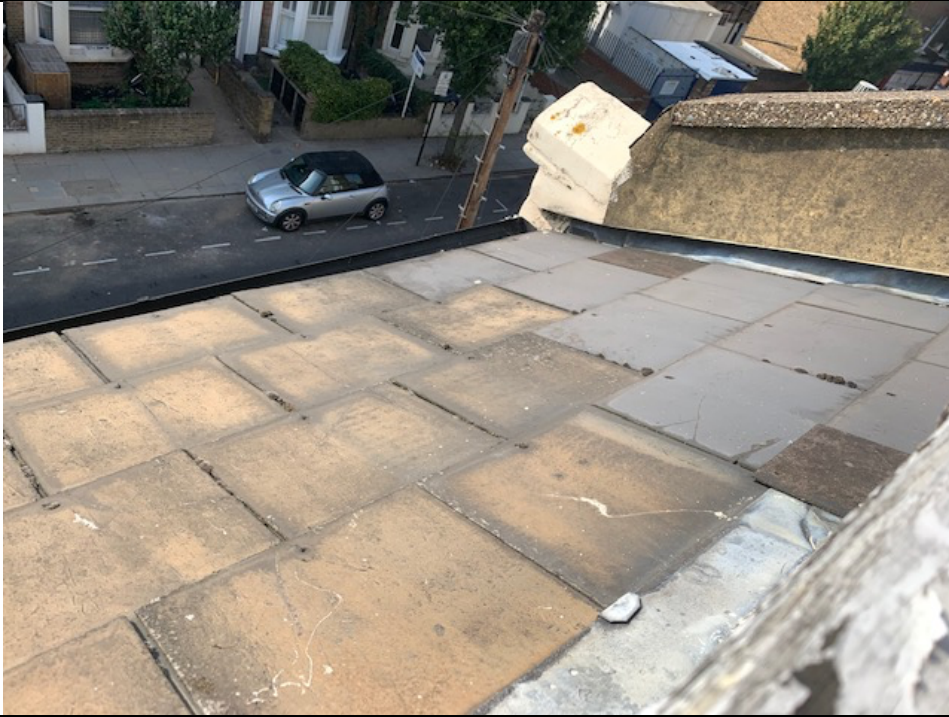
- 1.5 The subject property has had its roof previously re-covered using Eternit-type artificial slates with single hook fixings. The windows are timber sash but are in poor condition generally, and not suitable for the type of tenant and living arrangements provided by this property, either in terms of operability, internal conditions or forward maintenance.

5. Pitched roofs are covered with artificial slates with hook fixings.

- 3.1 The proposal for the main roof is to strip the main slopes of their slates, fixings and battens down to the roof structure. The timbers will be treated, and new breather membrane laid on the rafters, and new treated softwood battens and then re-cover the roof in new Britmet LiteSlate tiles. These are synthetic slate tiles with a riven appearance to make them appear like natural slate. The intention is to improve the appearance of the roofs by doing so, whilst working within budget, using a quality synthetic product from a respected manufacturer. The dormers will be re-covered using a lead substitute proprietary product, also from Britmet, with LiteSlates used on the cheeks (sides). The slate colour will be grey, to emulate natural slate. Material samples are available for inspection and approval, should this be required.

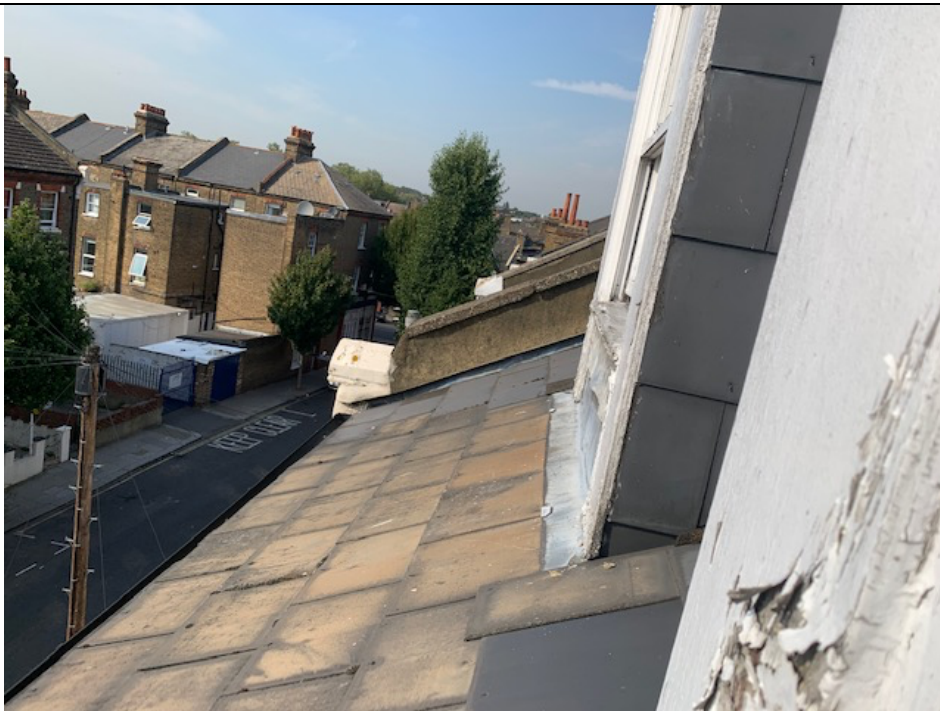
- 1.6 The roof has two dormer windows set into the front slope, which are a later addition. These have lead roofs and cheeks.
- 1.7 The rear extensions have felt coverings to the roofs, but these are not visible from street level at the front. They are in good condition.

6. Dormers also have artificial slates to their cheeks (sides).

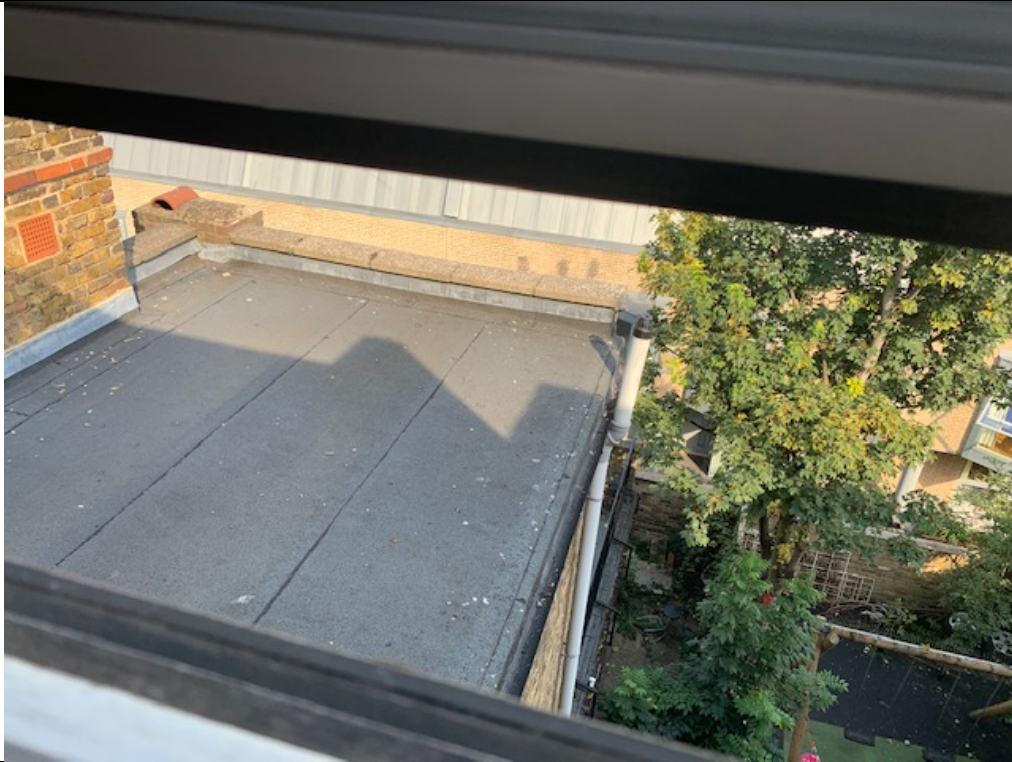
7. Rear wing/extensions have flat roofs and felt coverings.

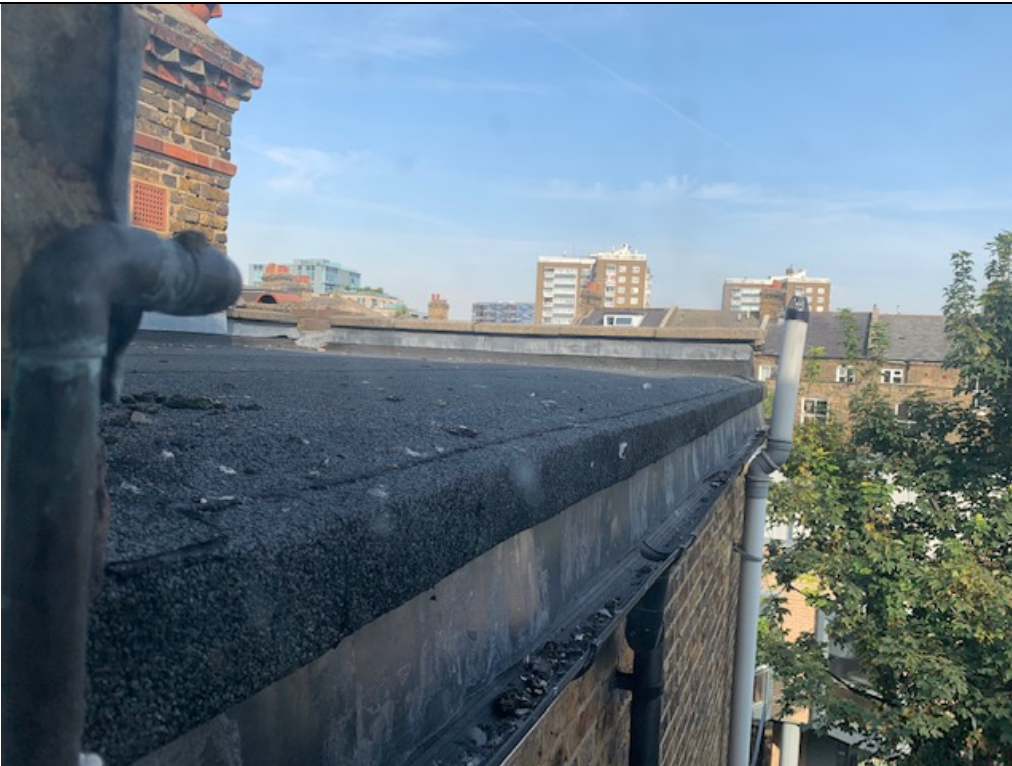
8. Close-up of felt-covered flat roof. To have new liquid coating from Kemper System or similar.

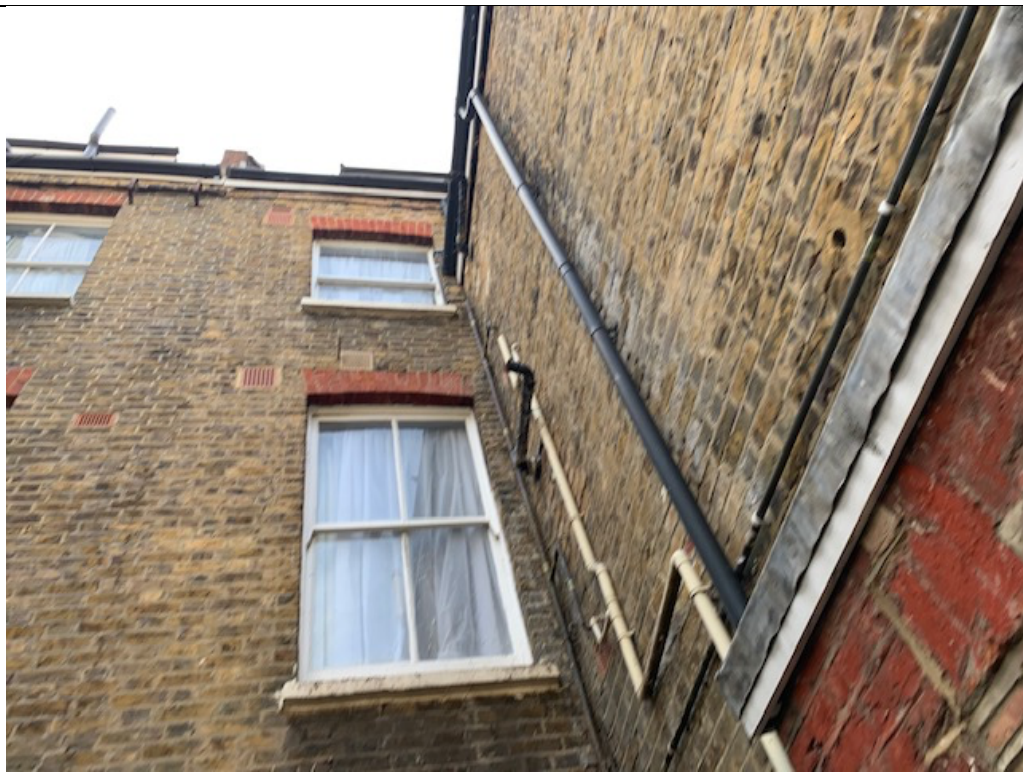
10. Close-up of rear elevation showing sash windows.

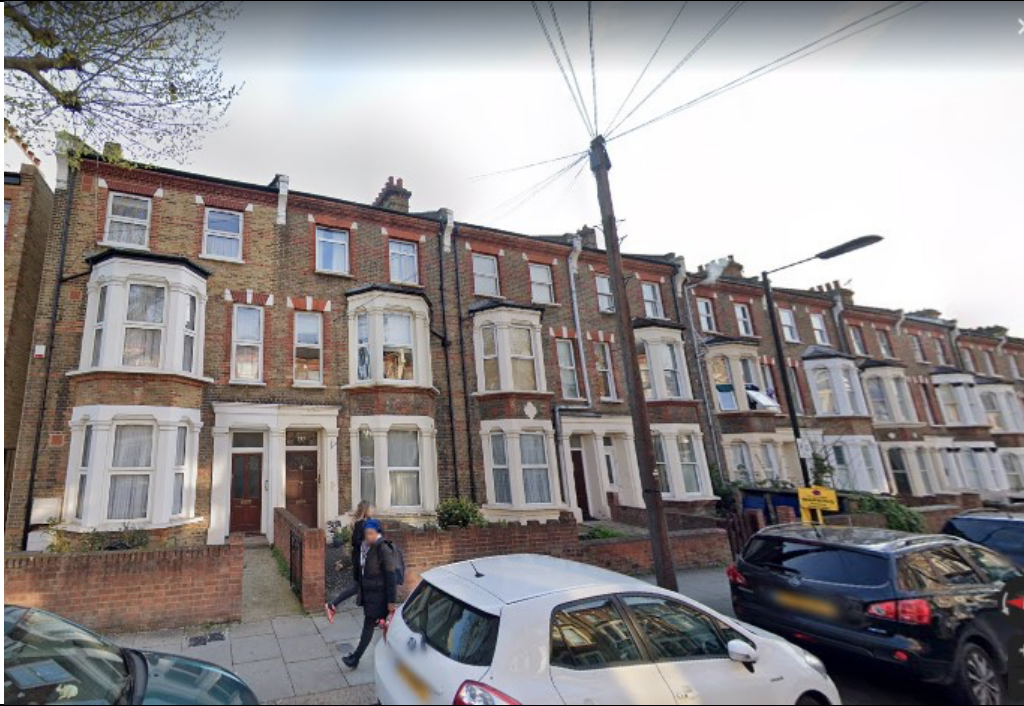
- 1.4 Many of the properties on the street and indeed in the local area have had their original sash windows replaced with UPVC, and natural slate roofs replaced with artificial or concrete tiled roofing materials. The uniformity of the street has therefore already been lost and the precedent set for other properties to replace/modernise their roofs and windows accordingly.

11. A number of other properties on this street have been fitted with UPVC windows.
