239945-PUR-00-00-DR-A-3008

**PROJECT** Reuben College

**TITLE** Reuben College External Elevations Remedial Works  
 Temporary Works for Support Scaffolding Above Museum Store

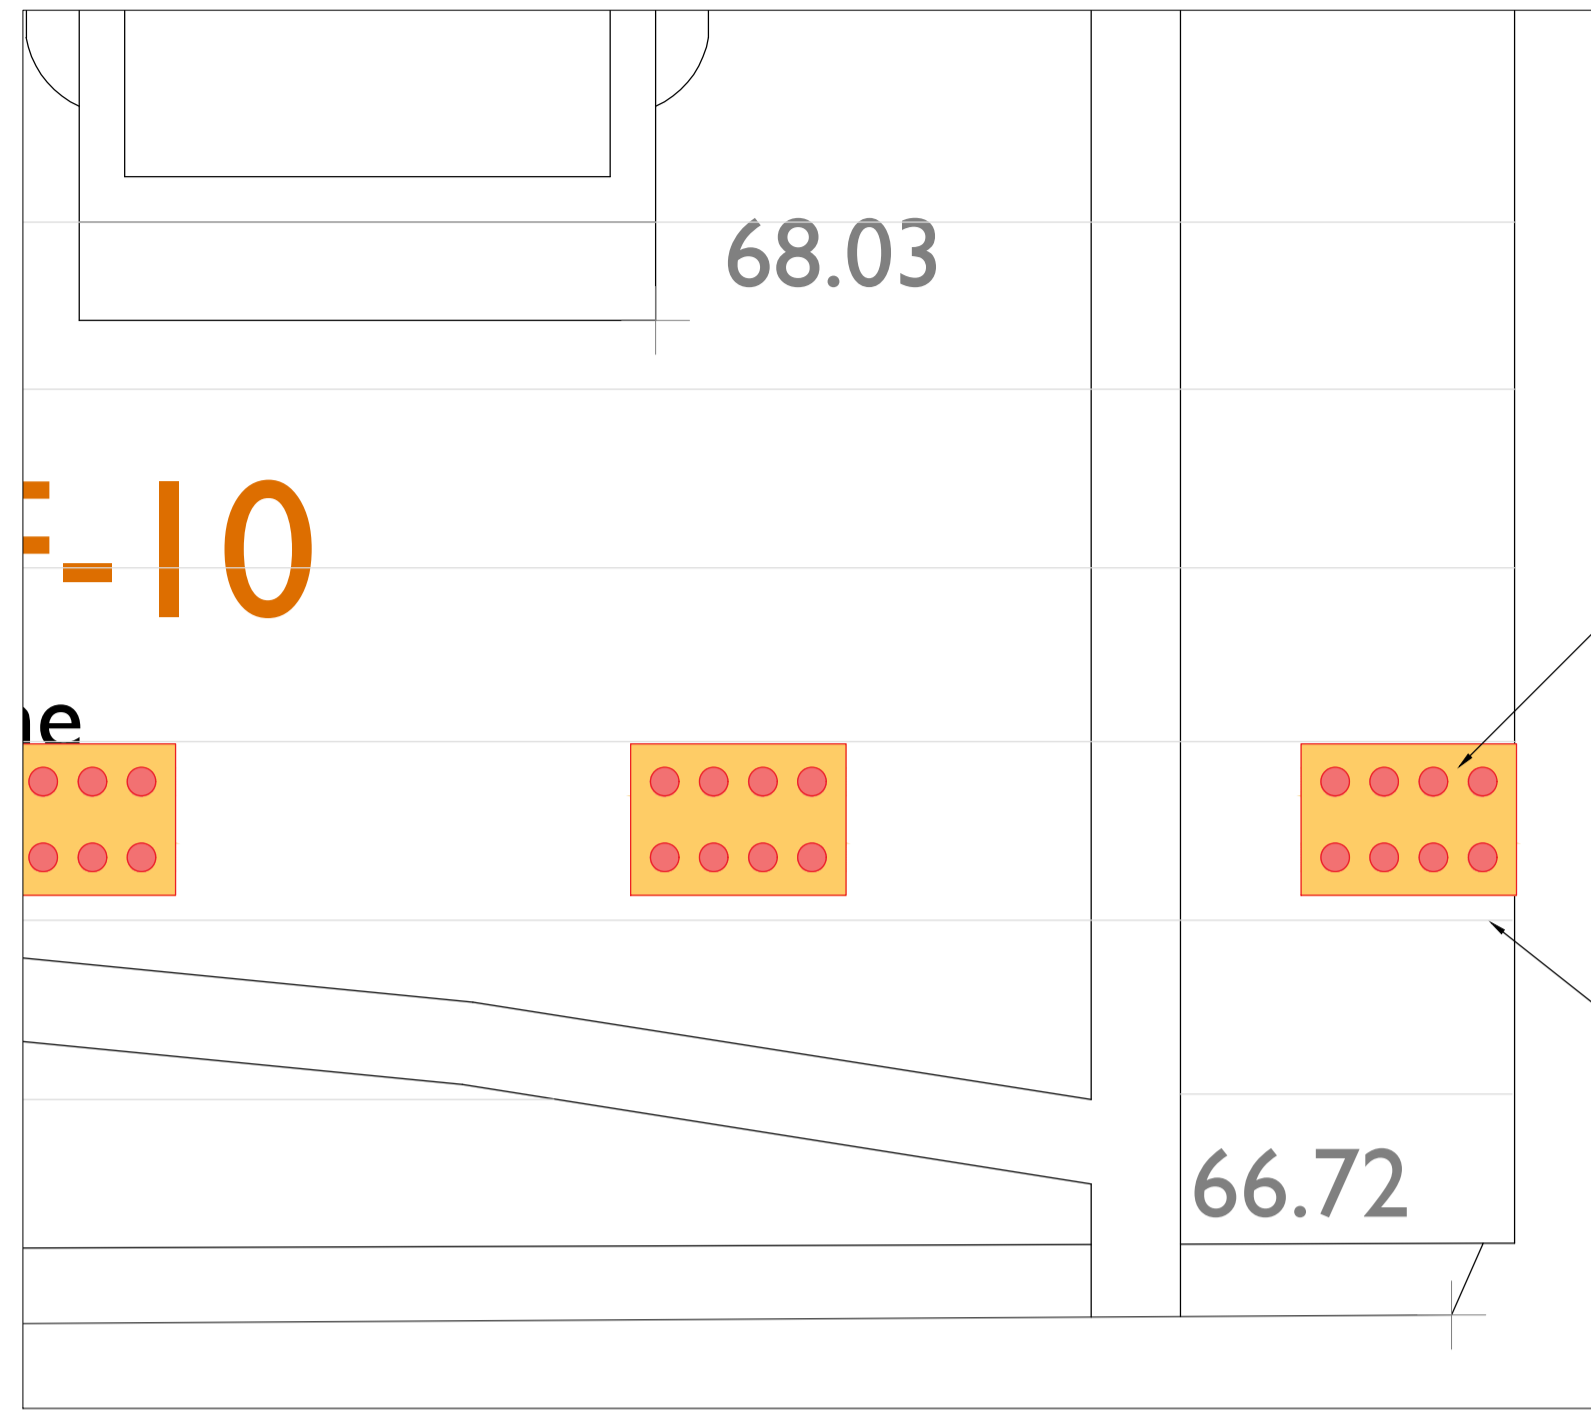
Limit openings to the extent of the anchor penetrations. Stone to be carefully cut out to limit damage to adjacent stone. Make good any damage around opening. Reinststate matching stone following Purcell specification clause F10.665

Refer to Stantec drawing no 48961-STR-TW-SK006 for location and details of structural steel. If possible, during the bracket installation, align wall penetration with stone courses and avoid damage to multiple stones. Consult the structural engineer for structural strategy ahead of remedial works.

**KEY**  
 Extent of wall penetration to be limited to the extent of the anchor penetrations. Stone to be carefully cut out to limit damage to adjacent stone. Make good any damage around opening. Reinststate matching stone following Purcell specification clause F10.665
