Revisions	Comments	Date
Client		12/11/2000
M:One Studios		
Project North Block, Chatham Mill		
Application Nos - 12875/FO/2000 & 12875/O/2000		
	Drawn PJK	
	Approved ??	
	Scale 1:100@A3	
Drawing title As Existing Floor Plan	Job No. 10059	
	Dwg No. 1 (v2)

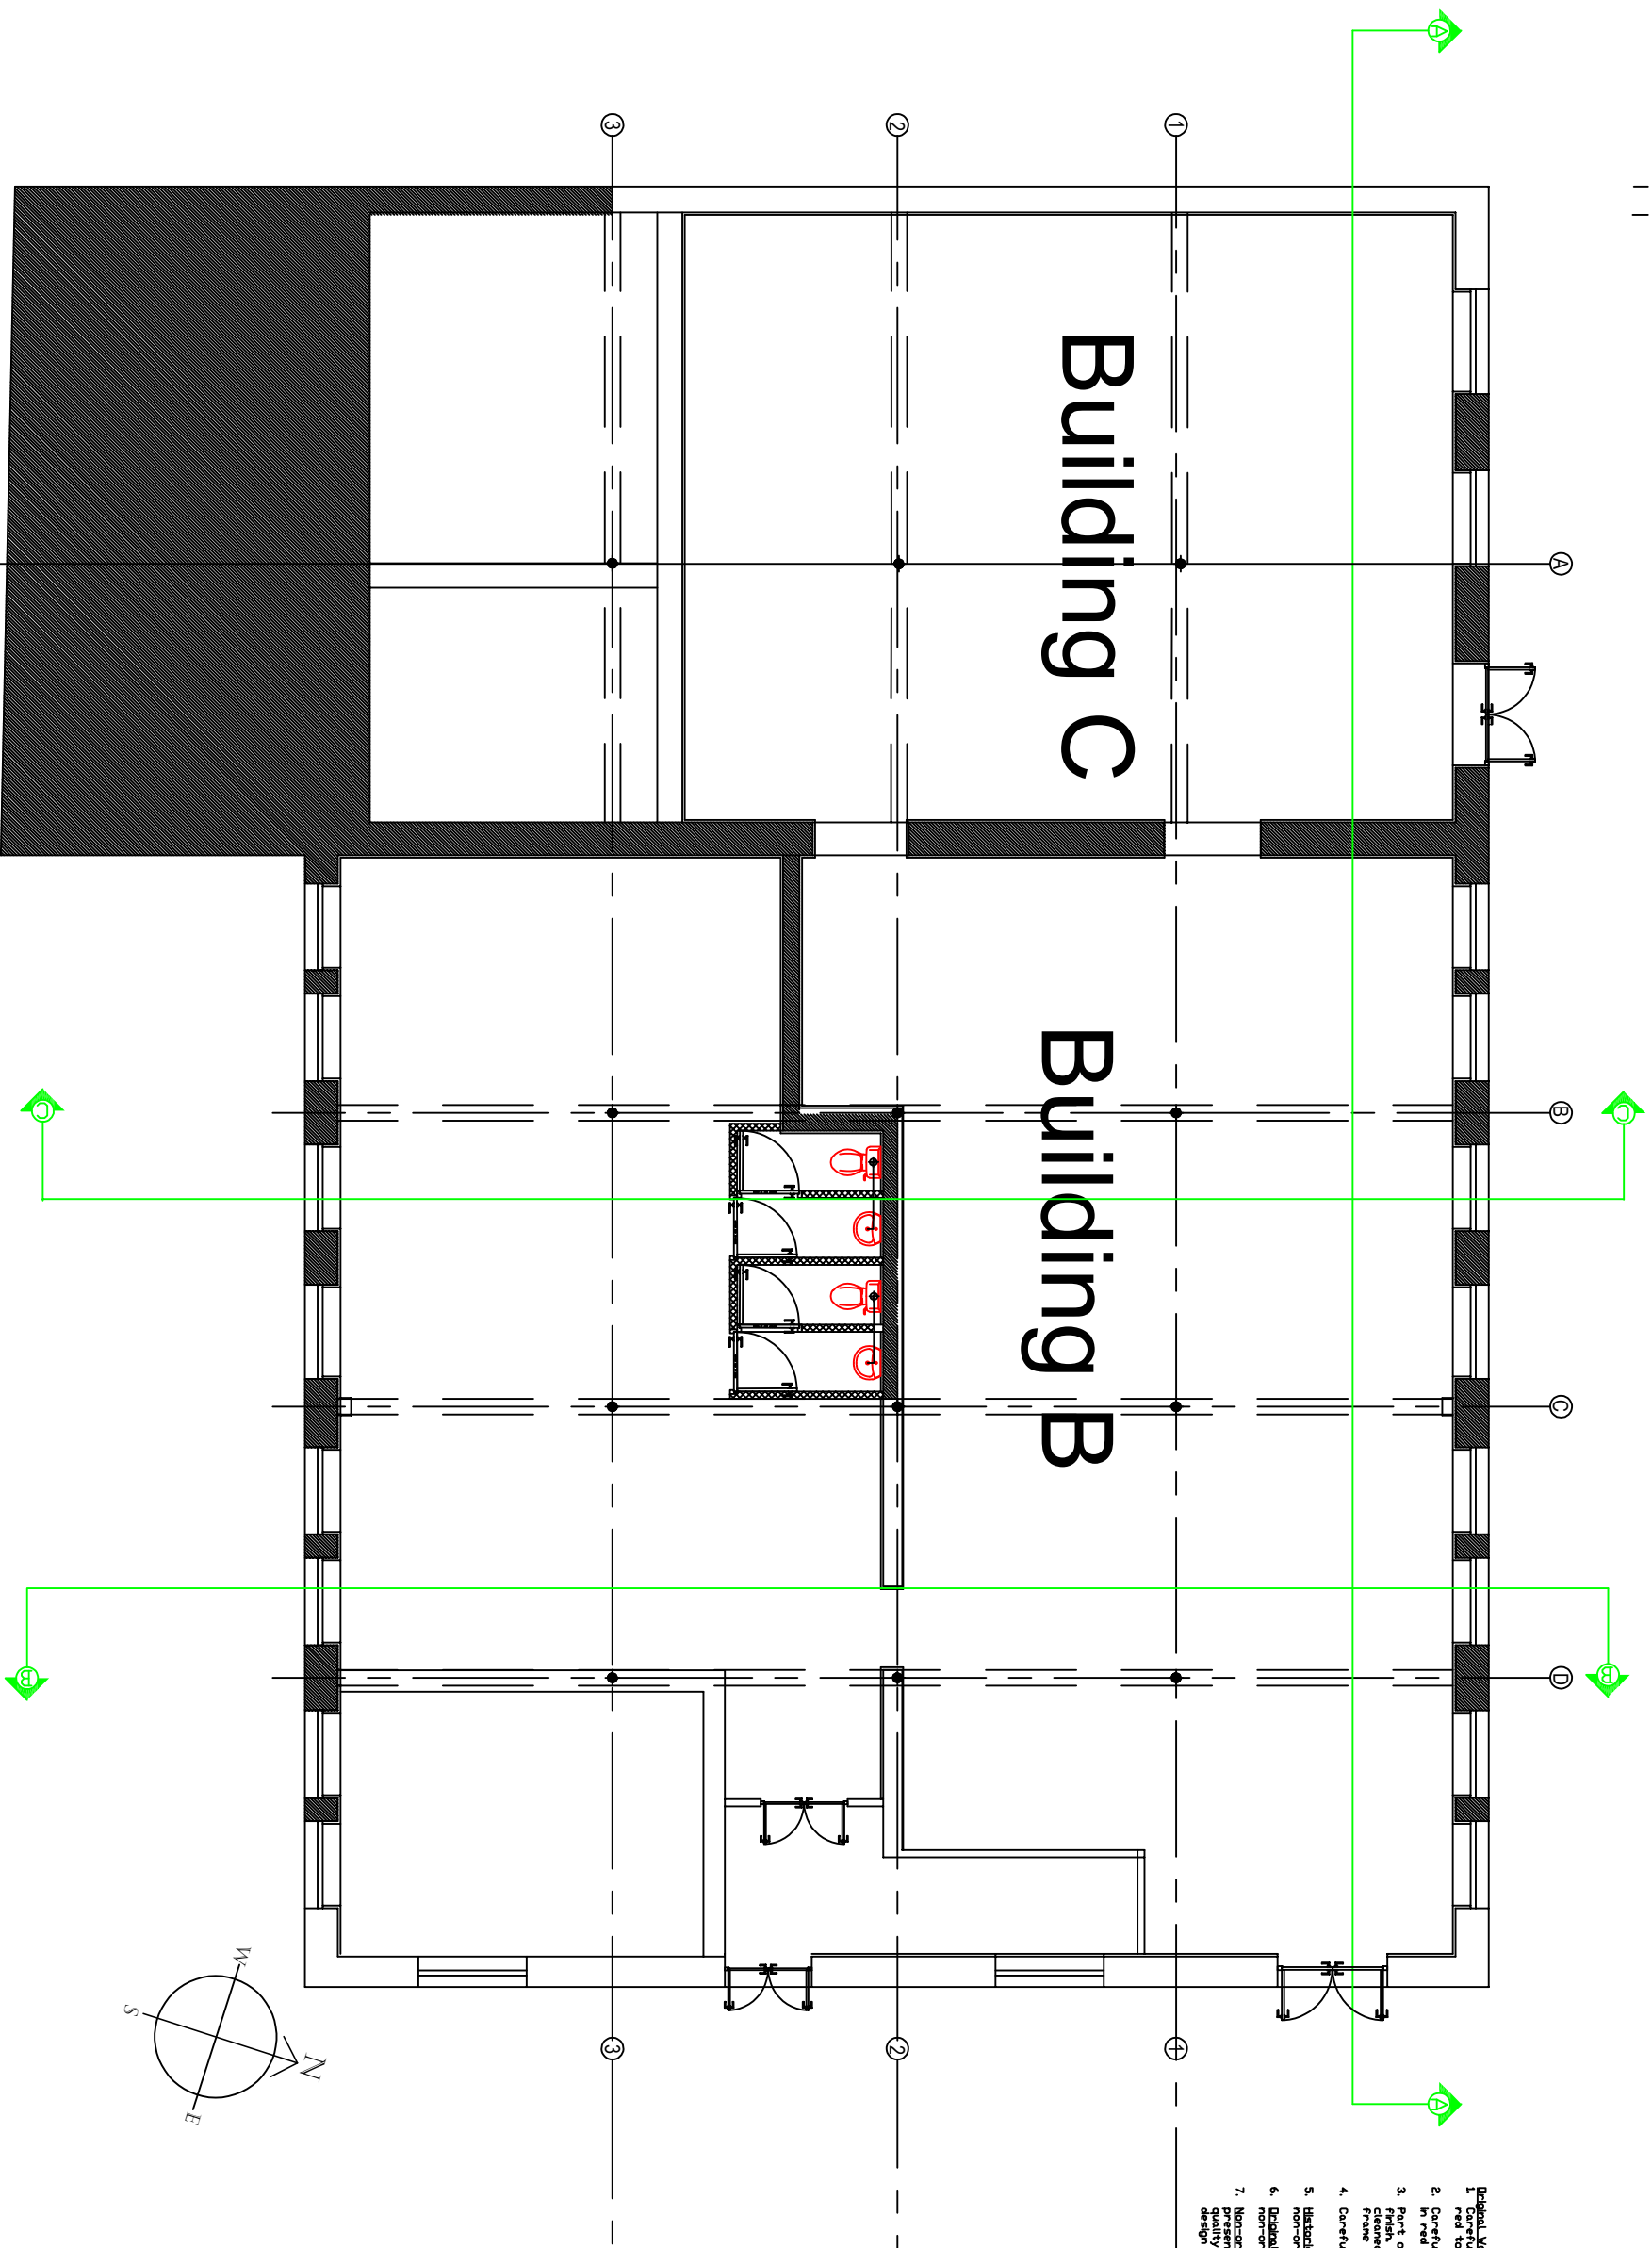
1. **Dedband Walls:** Carefully remove and rub back non-original plaster marked red to reveal original brick.
2. Carefully strip out non-original block partition walls marked in red
3. Part of the internal and perimeter walls have a ceramic tiled finish. These walls are to be removed and replaced with brickwork cleaned and where necessary protected by internal steel frame lining
4. Carefully strip-out non-original non-structural block wall
5. **Historic Windows:** Carefully, ease and overhaul all non-original windows and repair with subject dense only.
6. **Dedband Doors:** Carefully ease and overhaul retained non-original doors
7. Non-original and Non-tinted Ceiling: Suspended ceiling are present to areas indicated red. They are non-original of low quality, asbestos containing material and with no historic or design value. It is proposed to remove them in all places
