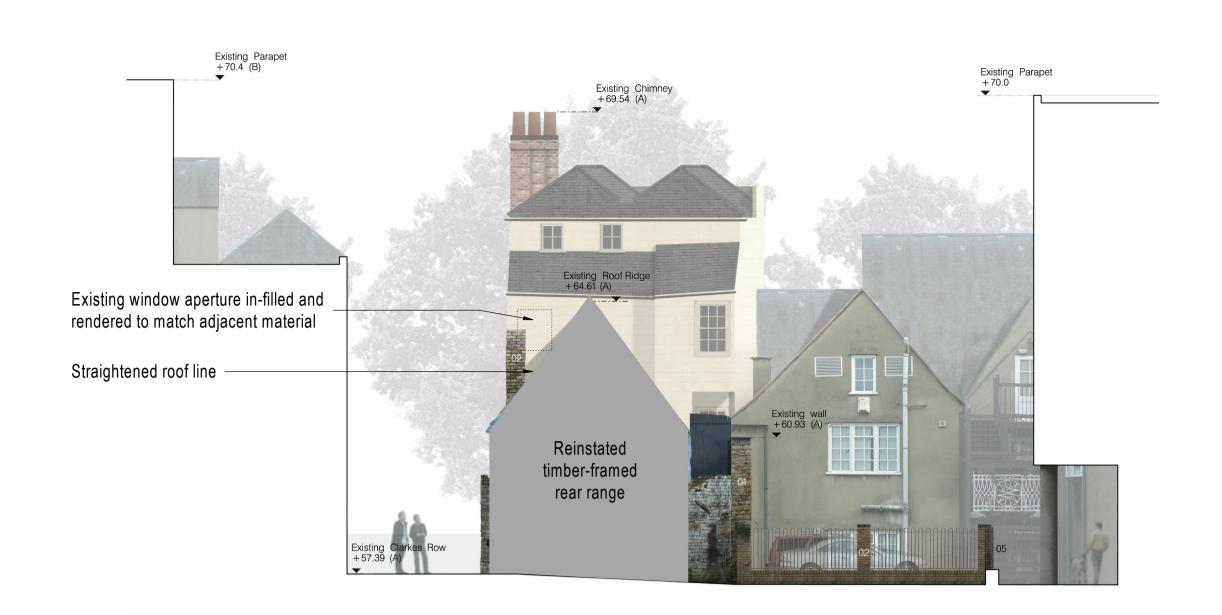
West - Proposed

New sash window inserted to replace the in-filled one on the west elevation, to match the unit below in terms of materials and detailing
