Preliminary Roost Assessment

Traigh Mhor, Drummygar, Carmylie

Grid ref. NO552438

Survey Date: 19 February 2021

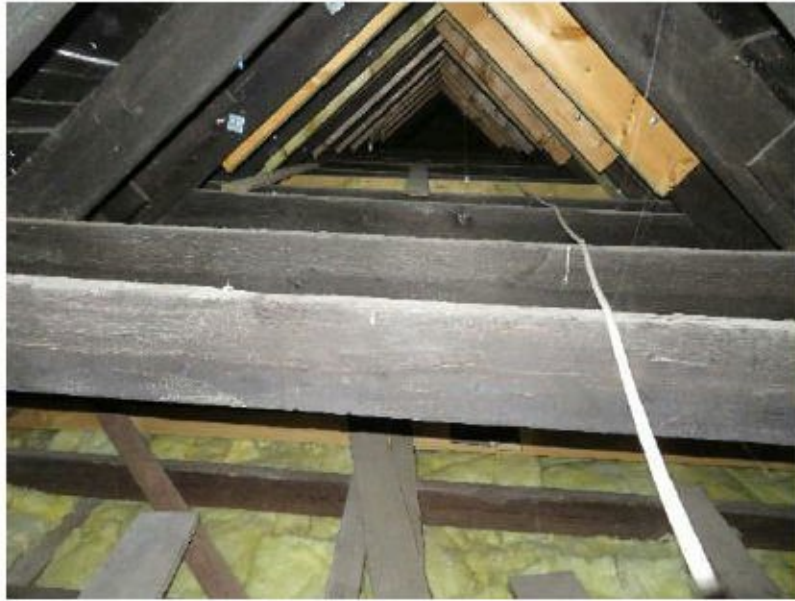
Attic

The cottage is in good condition and has been completely renovated following a fire some years ago. Much of the roof timber is covered in soot and charred in places. There is membrane under the slates and glass fibre insulation in the attic. On the exterior of the house, all wall heads are well sealed and the slates are in good condition with no obvious gaps suitable for bats. No signs of bats were found anywhere in or around the house.

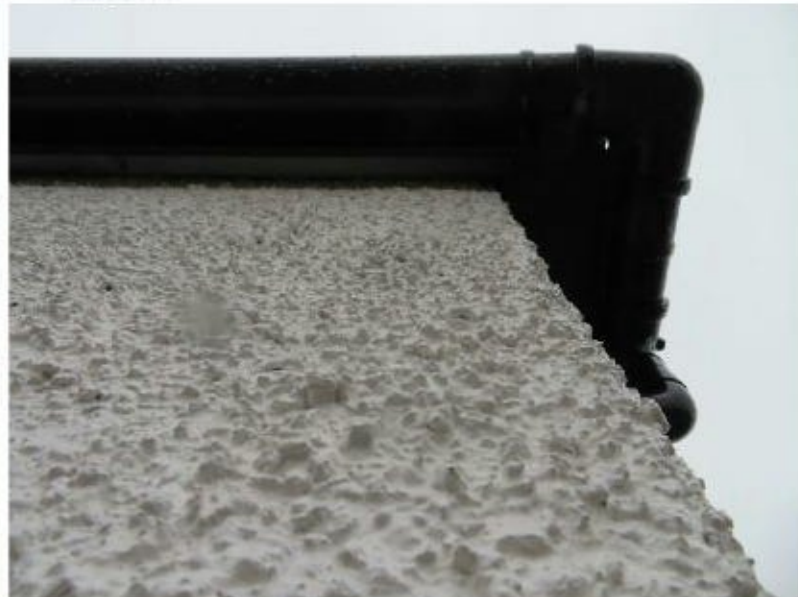
Wallhead

This cottage has little potential for bats because of its condition with fire damaged timbers in the attic, well sealed wall heads and poor surrounding habitat. There are very few records of bats in the area. No signs of bats were found in to around the house. No further surveys are required.
