HERITAGE STATEMENT
Nos 1 & 2, HILLSIDE COTTAGES
MAIN ROAD, NEWBRIDGE
ISLE OF WIGHT PO41 0TX
ISLAND COTTAGES LIMITED
DATE: 25.01.2021
2566-ERMC-00-00-HS-A-001

Document Title	HERITAGE STATEMENT
Client	ISLAND COTTAGES LIMITED
Project Description	PROPOSED ALTERATIONS AND EXTENSION

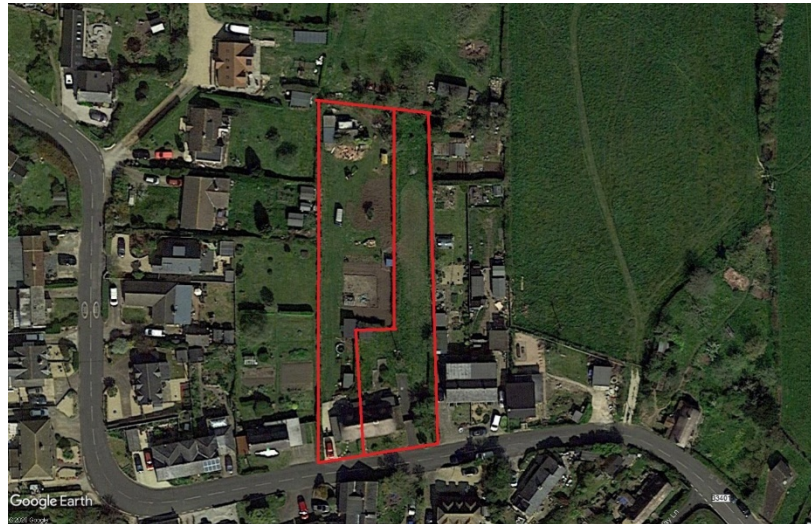
Current Site Demise

The cottages would have originally been three in number but at this time the three original cottages have been made into two cottages. The below Google Earth image shows the land outline and boundary between the two current properties.
