Project Title  
**NEP  
The Northern Estate Programme**

Building  
Norman Shaw North

Drawing Title  
West Elevation - Fabric Removal and Alteration

Drawing No.  
00NSN- 2131- BDP- 90- ZZ- T- AR- EL- 20268

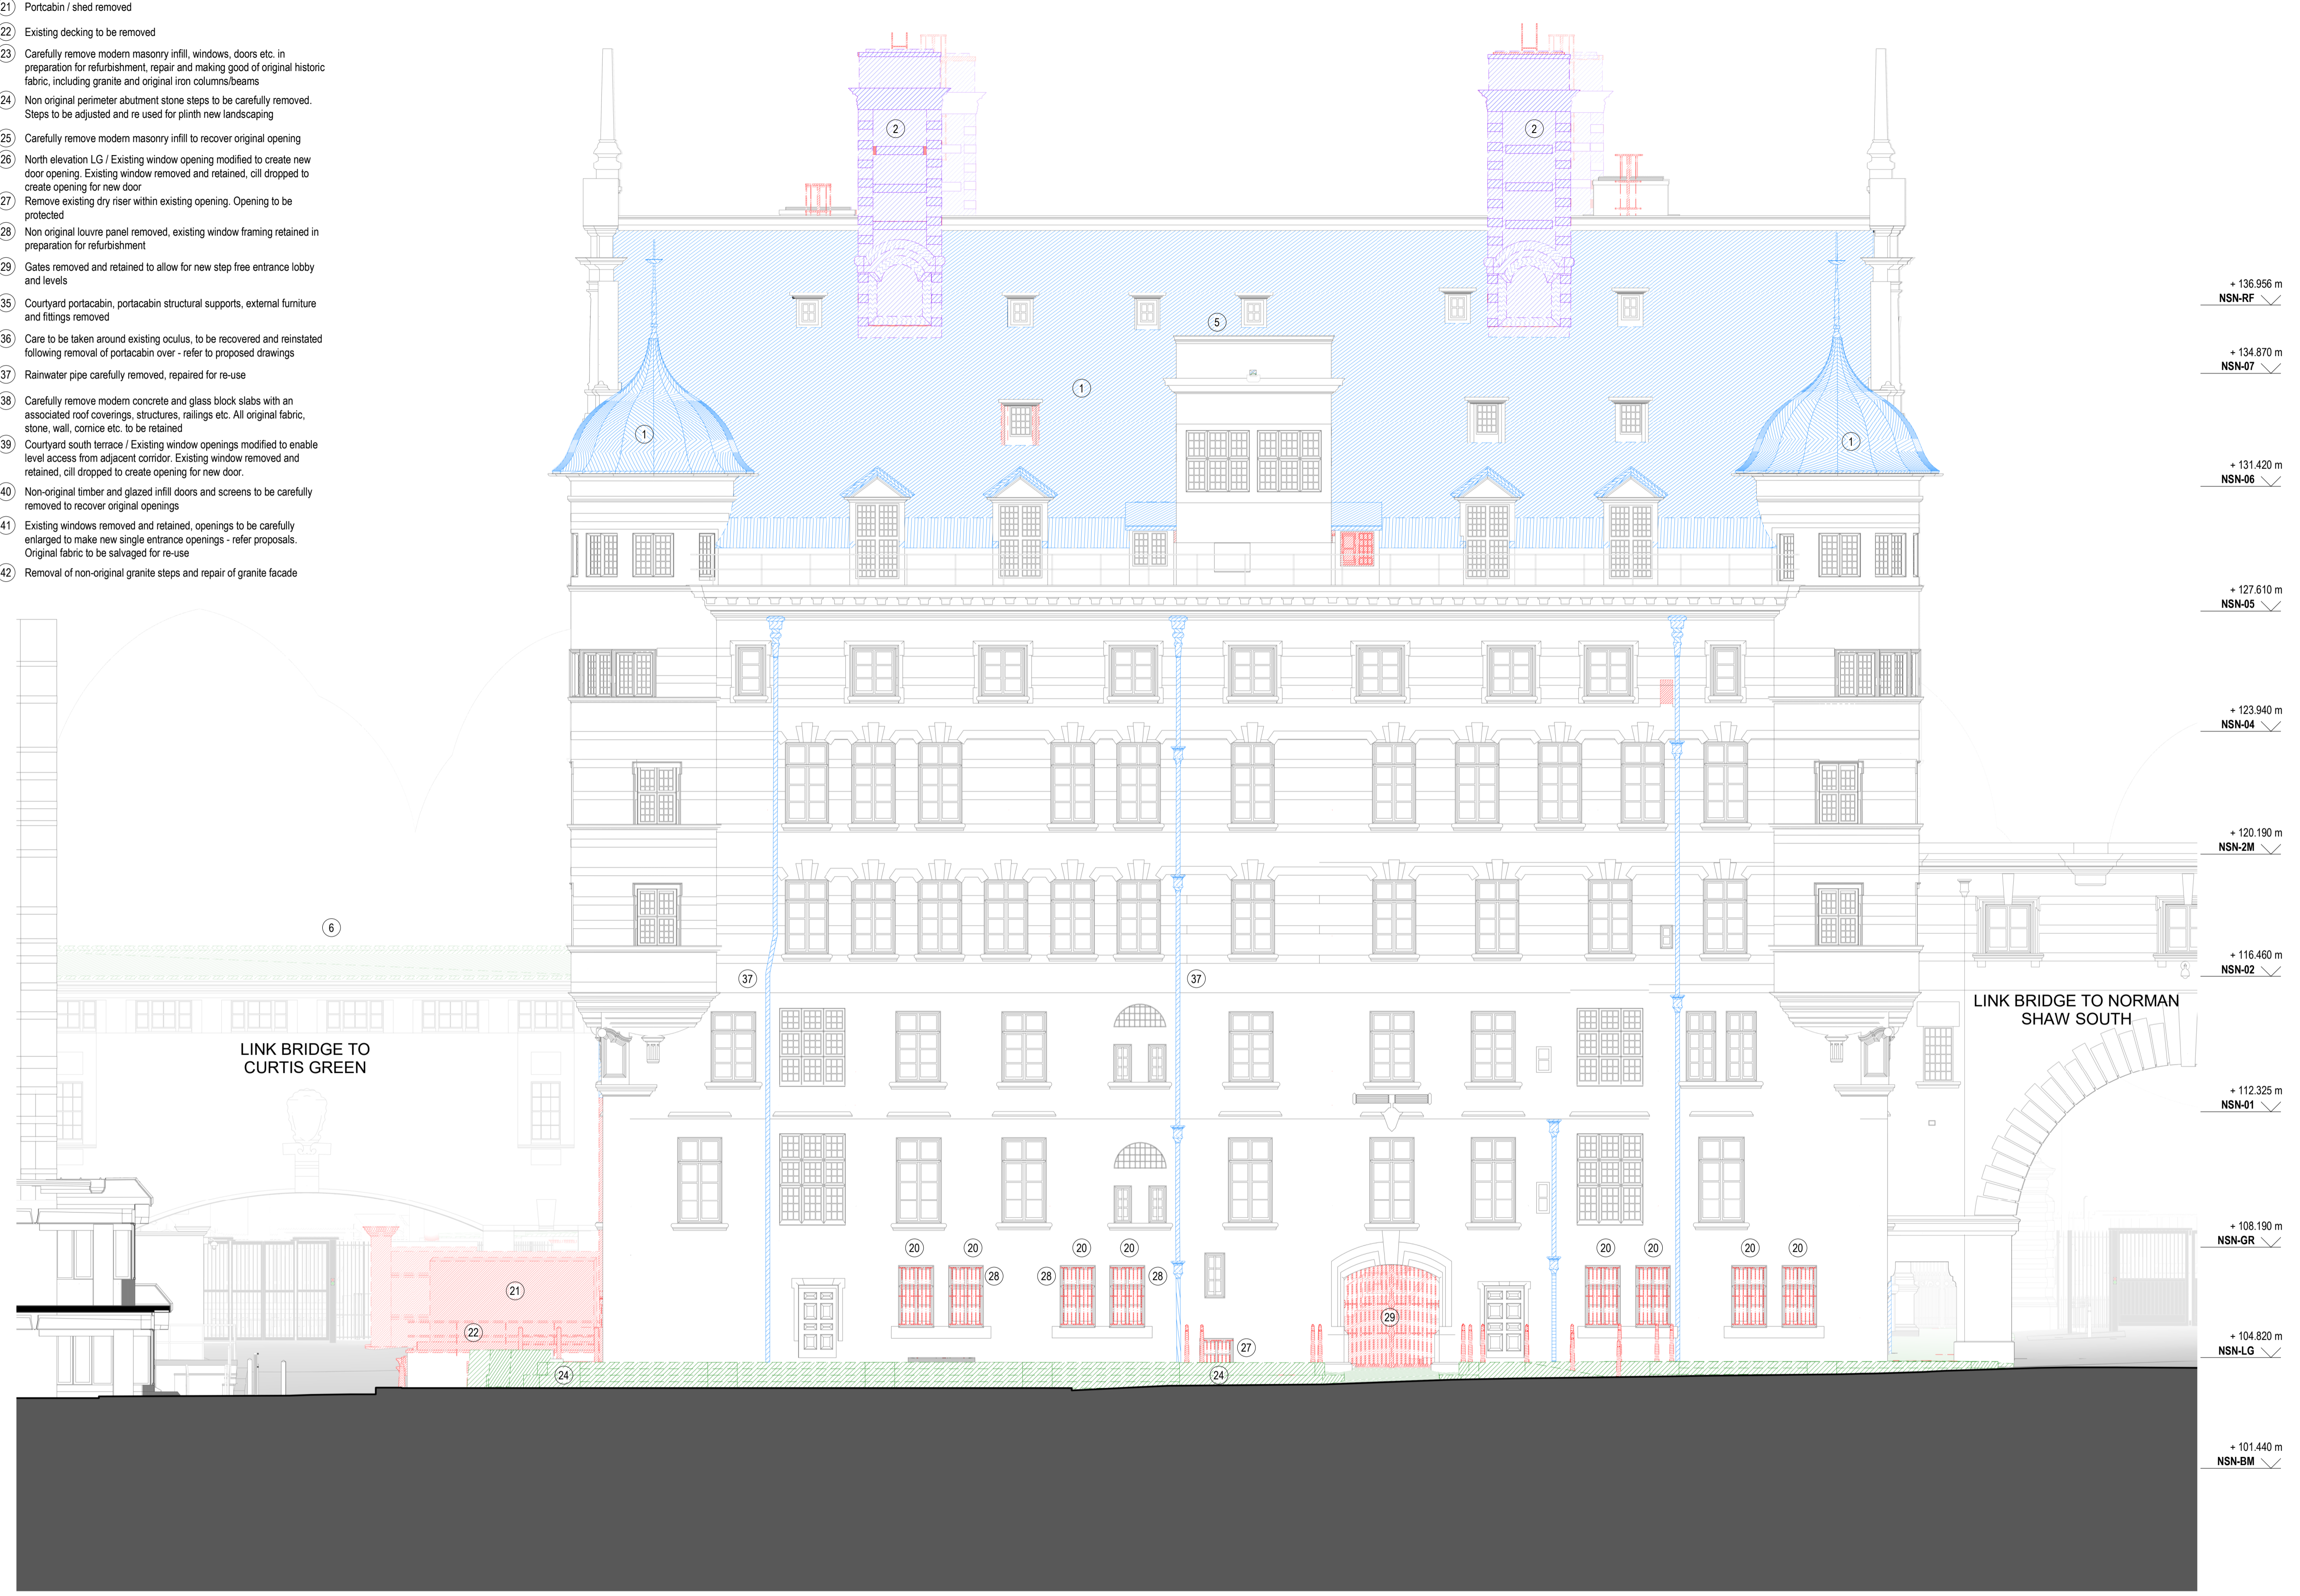
- ROOF**
- ① Existing original slates to be carefully taken down, assessed and stored for re-fitting. Underlying roof substrate to be assessed for extent of repairs and making good required. Existing fabric to be retained as far as practical. Original slates to be fitted with any new - to match existing

- ② Reconstruction of existing chimneys. Careful removal of brickwork and stonework, to be stored for later reinstatement
  - ③ Original slates, flashings and roof substrate removed in preparation for new ventilation louvre detail - refer proposed

- ④ Existing dormer to be adapted to provide maintenance access. Roof below to be carefully taken back - slates to be salvaged for use in repair elsewhere. Casement windows to be taken out in preparation for new doors

- ⑤ Falling 1950s roof removed in preparation for new code-compliant lead finished roof
  - ⑥ Existing corrugated roof and substrate to be removed in preparation for new lead roof - refer proposals

- ⑦ Existing lead roof and substrate to be removed in preparation for new lead roof - refer proposals

- ⑳ Non original gates and screens to be carefully removed. Existing fabric to be made good as required.
- ㉑ Portacabin / shed removed
- ㉒ Existing decking to be removed

- ㉓ Carefully remove modern masonry infill, windows, doors etc. in preparation for refurbishment, repair and making good of original historic fabric, including granite and original iron columns/beams

- ㉔ Non original perimeter abutment stone steps to be carefully removed. Steps to be adjusted and re used for plinth new landscaping
- ㉕ Carefully remove modern masonry infill to recover original opening

- ㉖ North elevation LG / Existing window opening modified to create new door opening. Existing window removed and retained, cill dropped to create opening for new door

- ㉗ Remove existing dry riser within existing opening. Opening to be protected
- ㉘ Non original louvre panel removed, existing window framing retained in preparation for refurbishment

- ㉙ Gates removed and retained to allow for new step free entrance lobby and levels
- ㉚ Courtyard portacabin, portacabin structural supports, external furniture and fittings removed

- ㉛ Care to be taken around existing oculus, to be recovered and reinstated following removal of portacabin over - refer to proposed drawings
- ㉜ Rainwater pipe carefully removed, repaired for re-use

- ㉝ Carefully remove modern concrete and glass block slabs with an associated roof coverings, structures, railings etc. All original fabric, stone, wall, cornice etc. to be retained

- ㉞ Courtyard south terrace / Existing window openings modified to enable level access from adjacent corridor. Existing window removed and retained, cill dropped to create opening for new door.

- ㉟ Non-original timber and glazed infill doors and screens to be carefully removed to recover original openings
- ㊱ Existing windows removed and retained, openings to be carefully enlarged to make new single entrance openings - refer proposals. Original fabric to be salvaged for re-use

- ㊲ Removal of non-original granite steps and repair of granite facade
