Hampden Insurance Holdings,
 Hampden House, Great Hampden, Bucks.
 Survey Plan

Hampden House Survey (Works) : Second Floor Plan

Hampden House Survey (Works) : Roof Plan

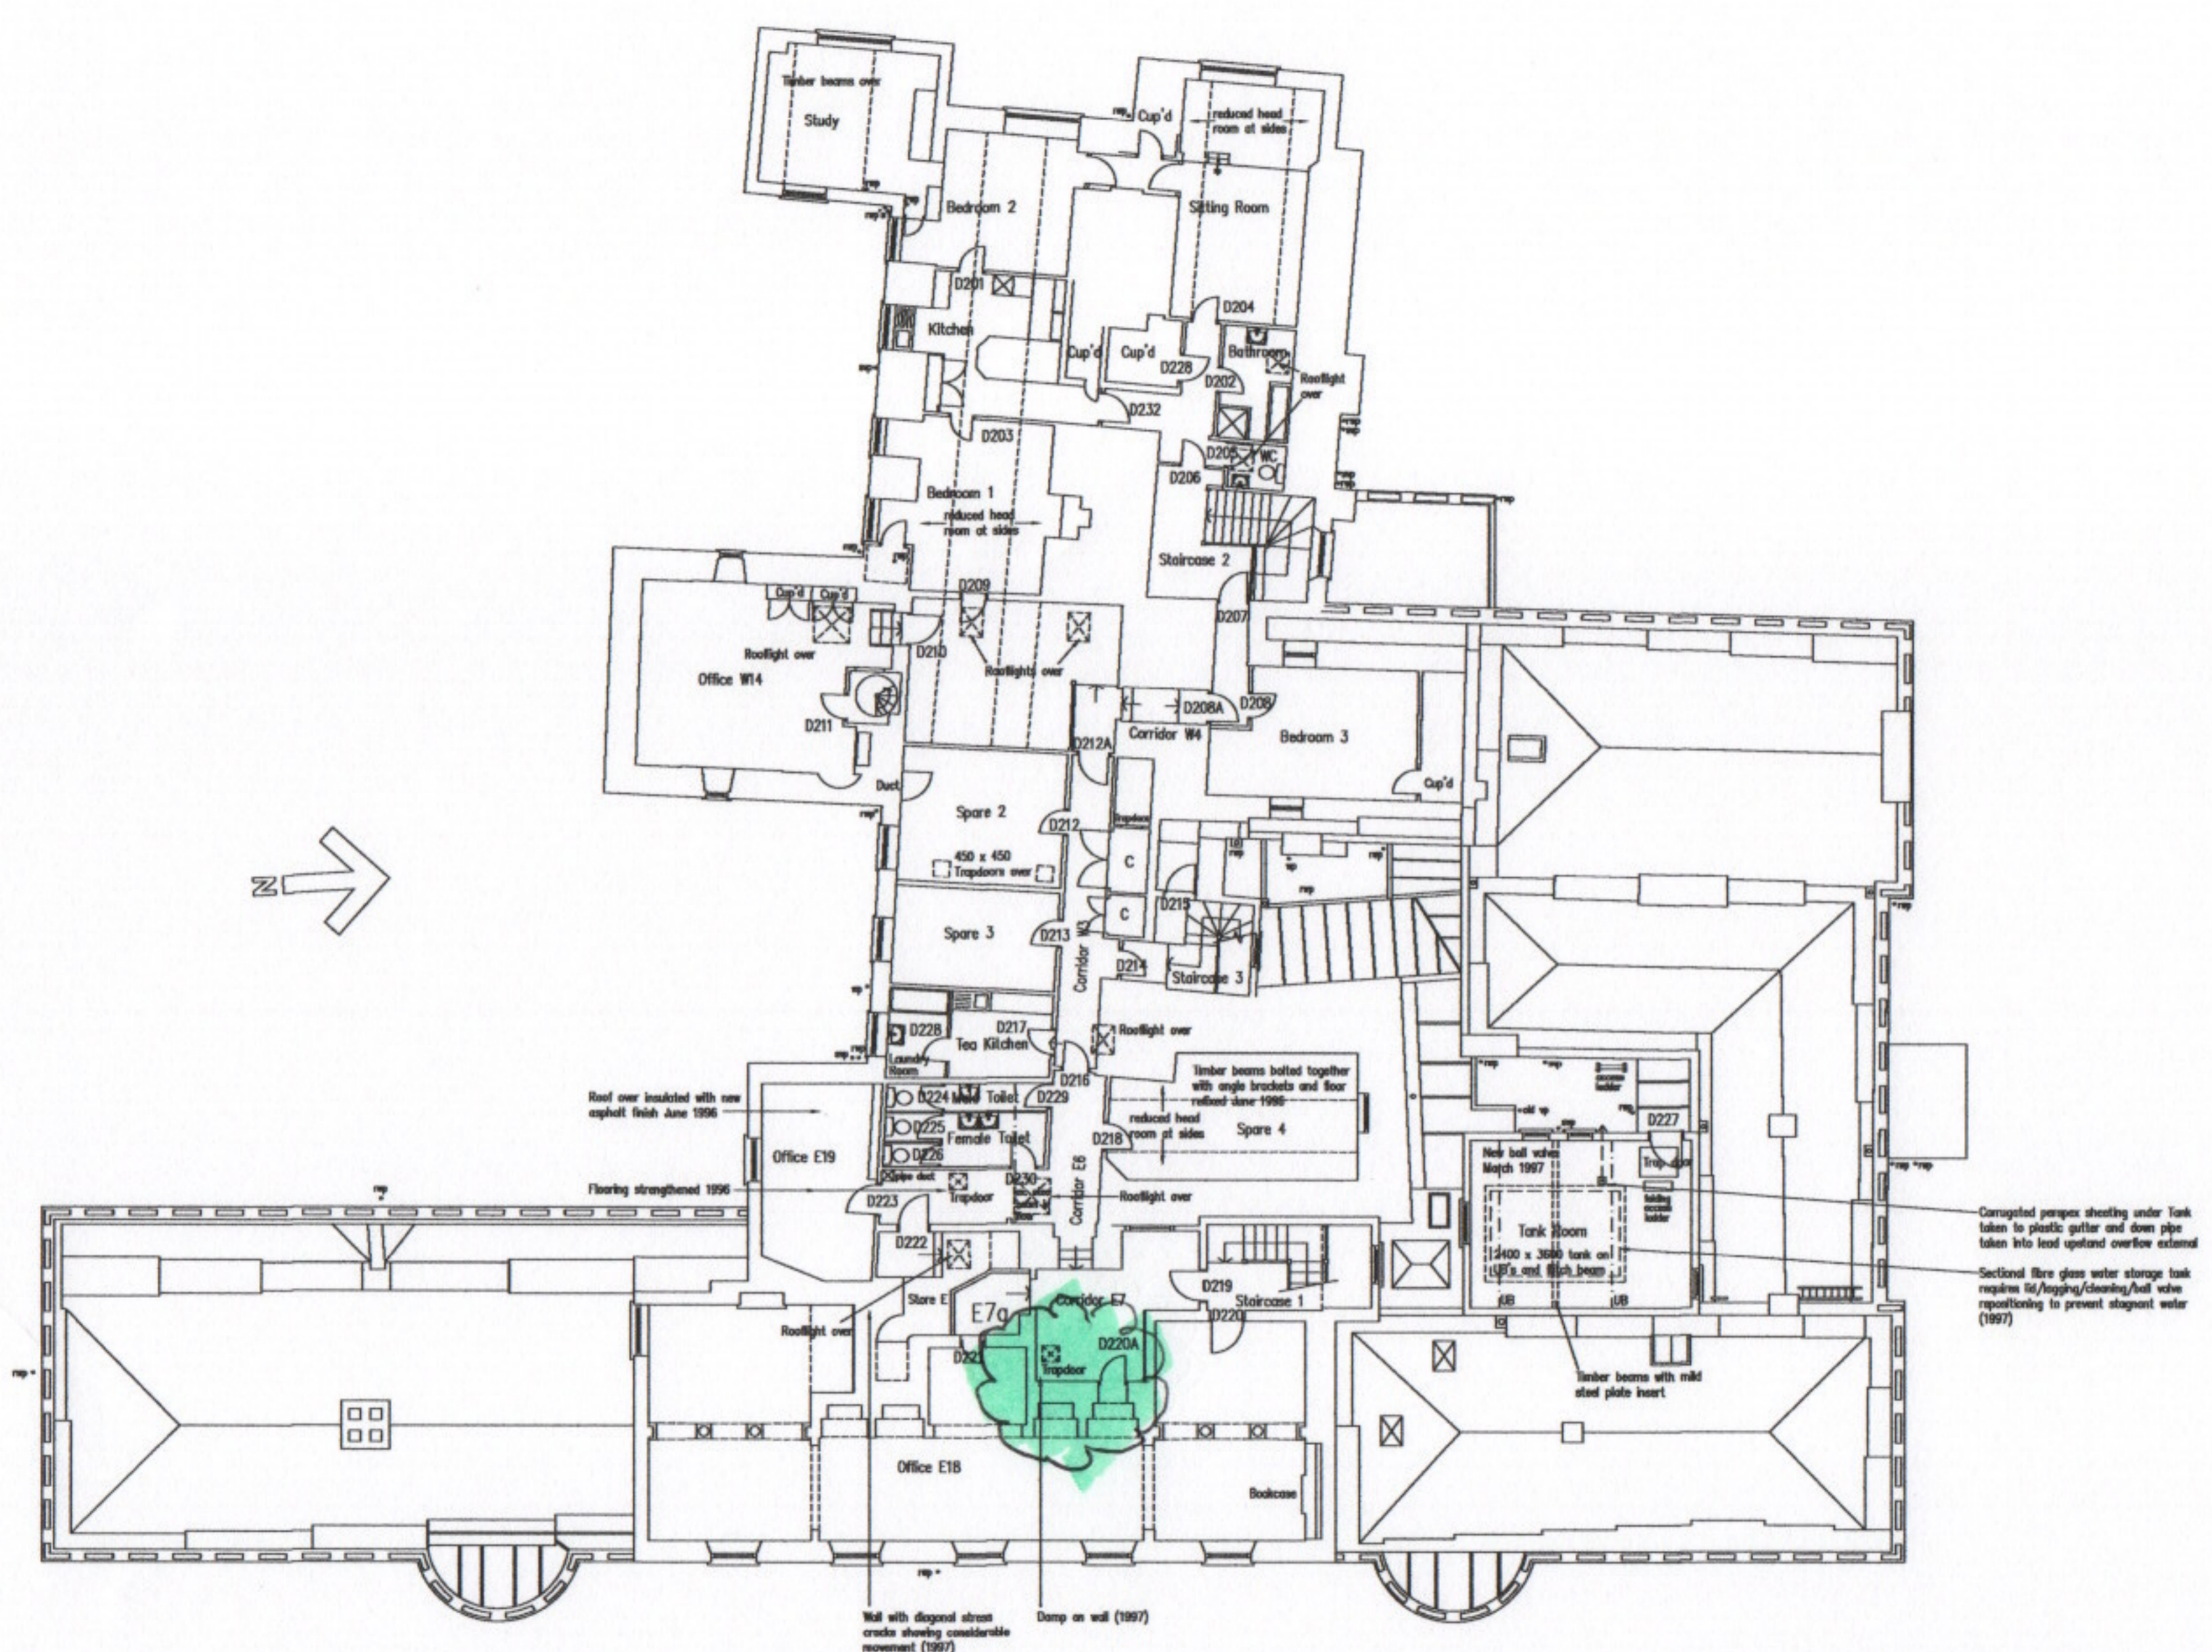
Corrugated parapet sheeting under Tank taken to plastic gutter and down pipe taken into lead upstand overflow external
 Sectional fibre glass water storage tank requires lid/lagging/cleaning/ball valve repositioning to prevent stagnant water (1997)

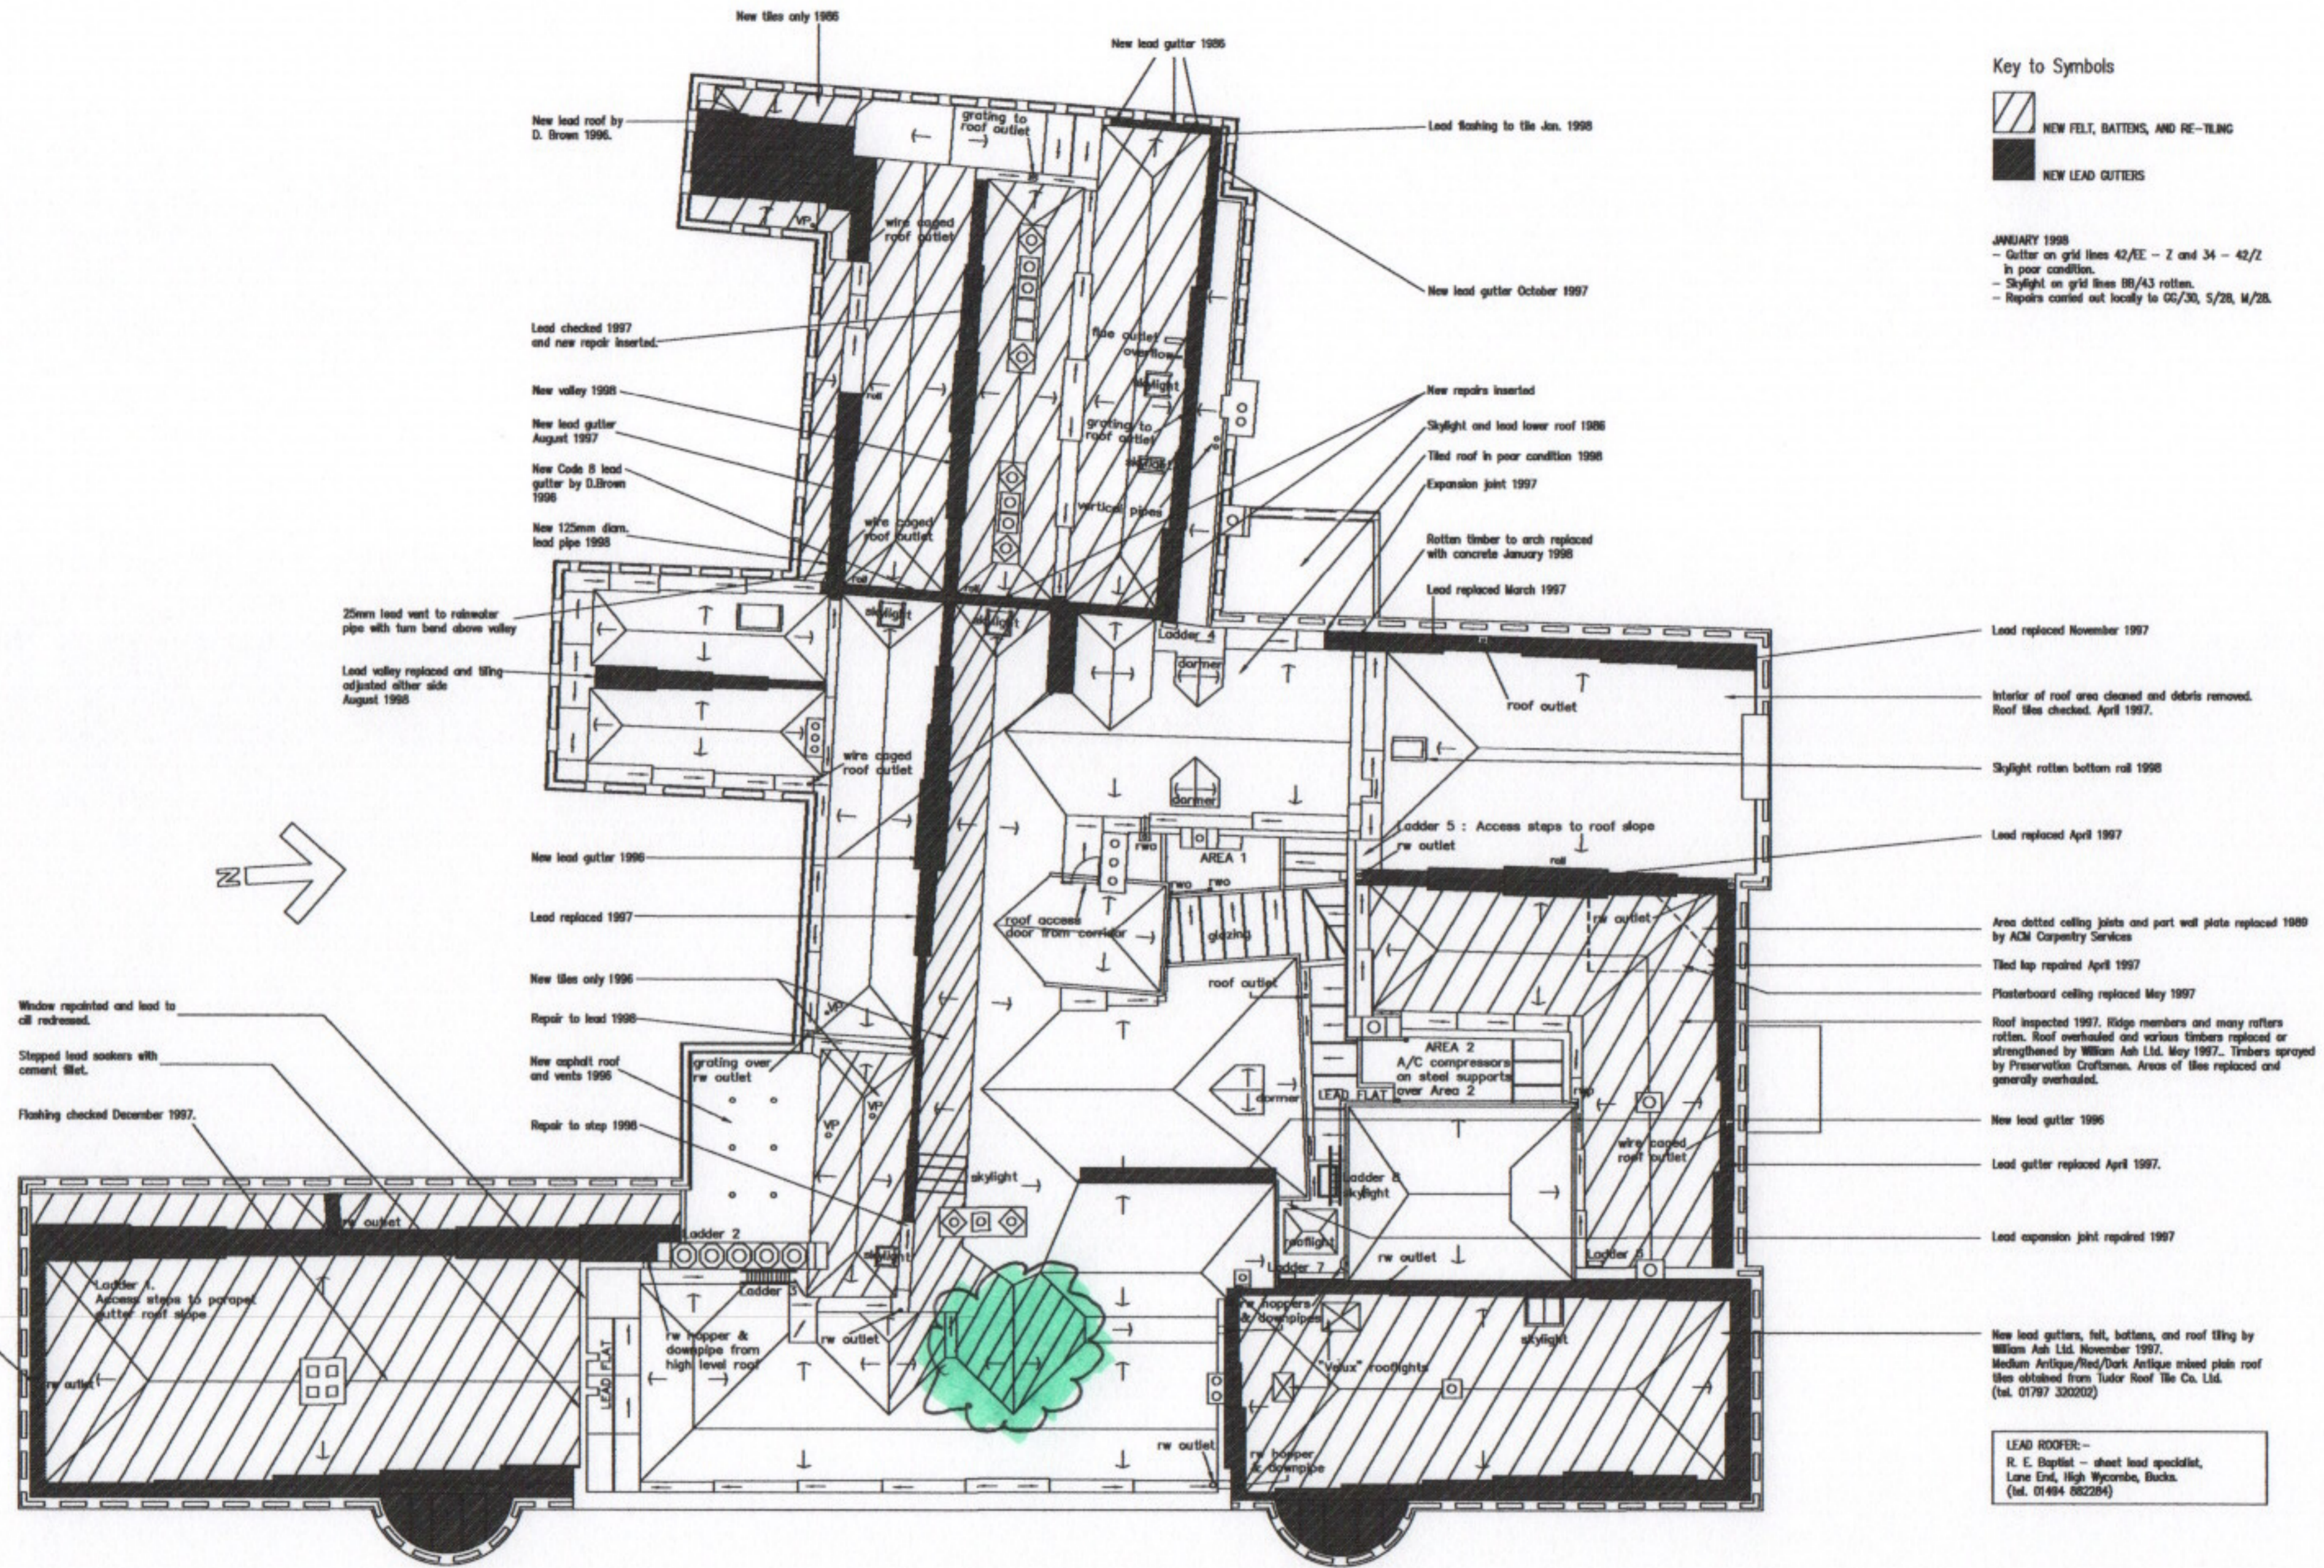
- Gutter on grid lines 42/EE - Z and 34 - 42/Z in poor condition.
- Skylight on grid lines BB/A3 rotten.
- Repairs carried out locally to GG/30, S/28, M/28.

- A-N/2-18 new lead valley and parapet gutters.
- M-N/2-20 new tiles.
- L/18-22 and D-K/18 rendering to wall.
- D-K/3-18 tiled roof refelted and battened.
- New Tudor tiles to East elevation only.
- Other areas existing revised, new lead flashing and tile cover to rendered wall.
- D/8-11 rotten wall replaced.
