Soakaway Testing at Denby House Farm

Date of Test 5th January 2017.

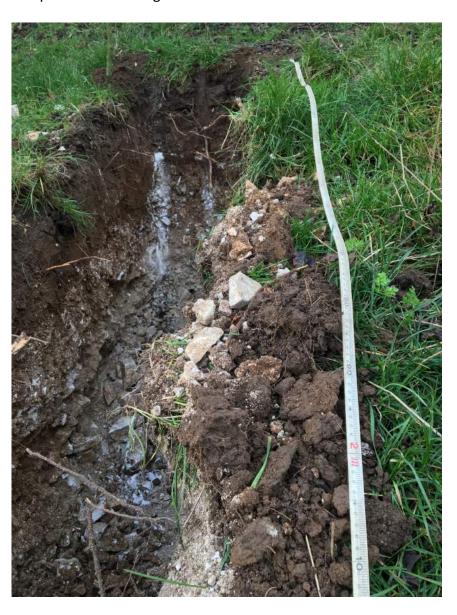
The photograph below show the underlying porous nature of the site being chalk.

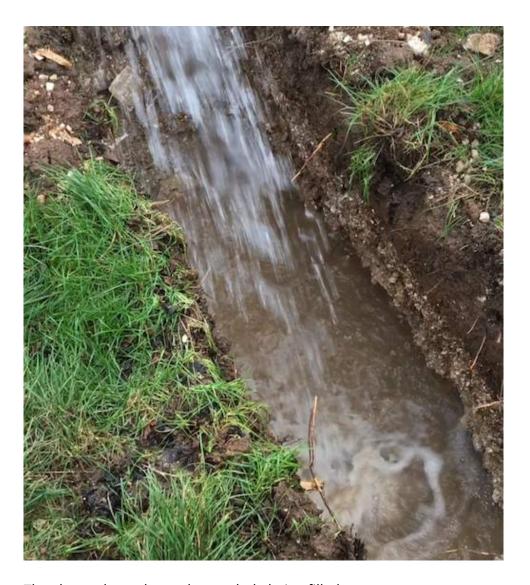
The above photo shows the test hole being filled.

1.1 cubic meters of water was discharged into the test hole three times. It took 8 minutes for 1.1 cubic meters of water to discharge from the IBC.

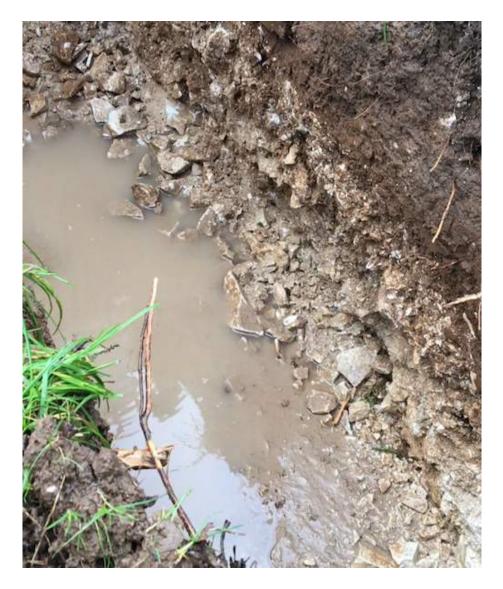
The above photo shows the test hole depth immediately following the completion of discharge of 1.1 cubic meters of water.

On all three occasions, the water had completely percolated within 3 minutes of the completion of discharge.
