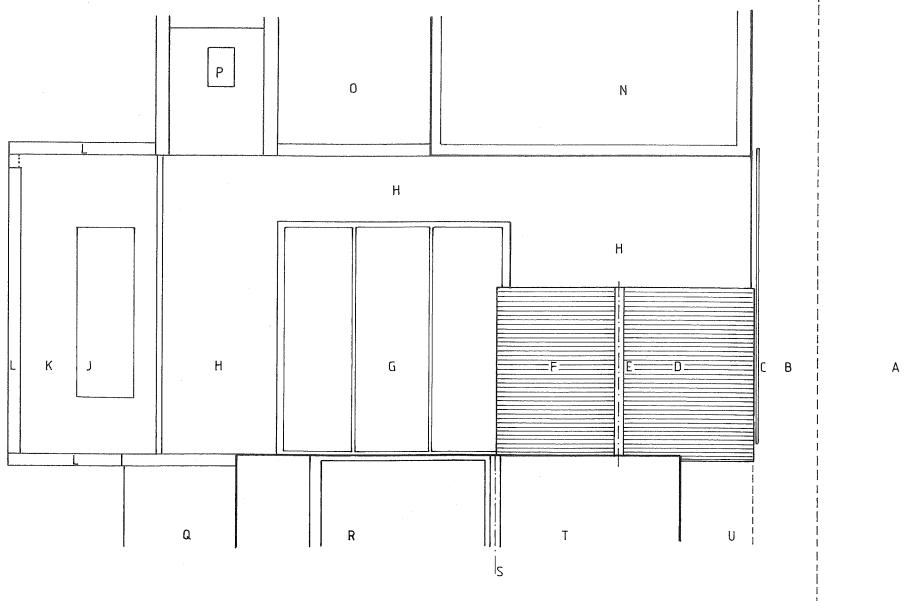
A Wolseley Road carriageway below B Northern kerb line below shown dashed C Wolseley Road Garage signage D Front pitched roof in corrugated metal cladding to the first floor office E Ridge line to the corrugated metal cladding roof F Rear pitched roof in corrugated metal cladding to the first floor office G Polycarbonate glazing to raised ceiling over main workshop area H Flat roofs J Rooflights over rear workshop area within flat roof K Rear flat roofed area over workshop L Side and rear parapet walls M Rear of No 70 Gloucester Road N Flat roof over three storey dwelling at rear of No 62 Gloucester Road O Rear lightwell to neighbouring dwelling screened by surrounding walls P Rooflight over redundant stairs within pitched roof Q Rear single storey element to the rear of the dwelling house at No 1 Wolseley Road R Flat roof to large rear dormer at second floor level over the rear of the neighbouring dwelling house at No 1 Wolseley Road S Half round ridge tiling at top of roof over the neighbouring dwelling house at No 1 Wolseley Road T Front pitch tiled roof over neighbouring dwelling house at No 1 Wolseley Road U Front garden below to the neighbouring dwelling house at No 1 Wolseley Road
