REV.	DATE:	DESCRIPTION:
MIDLANDS BUILDING CONSULTANCY		
PROPOSED LOFT CONVERSION; 1A SANDERLING RISE, BURNTWOOD, WS7 9NZ		
DRAWING TITLE: PLAN AND SECTION ON DRIVEWAY EXTENSION		
DATE:	Jan '21	SCALES: 1:50 & 1:100 @ A1
DRAWN:	DRG No.:	REV:
CHECKED:	9999-003-03	a

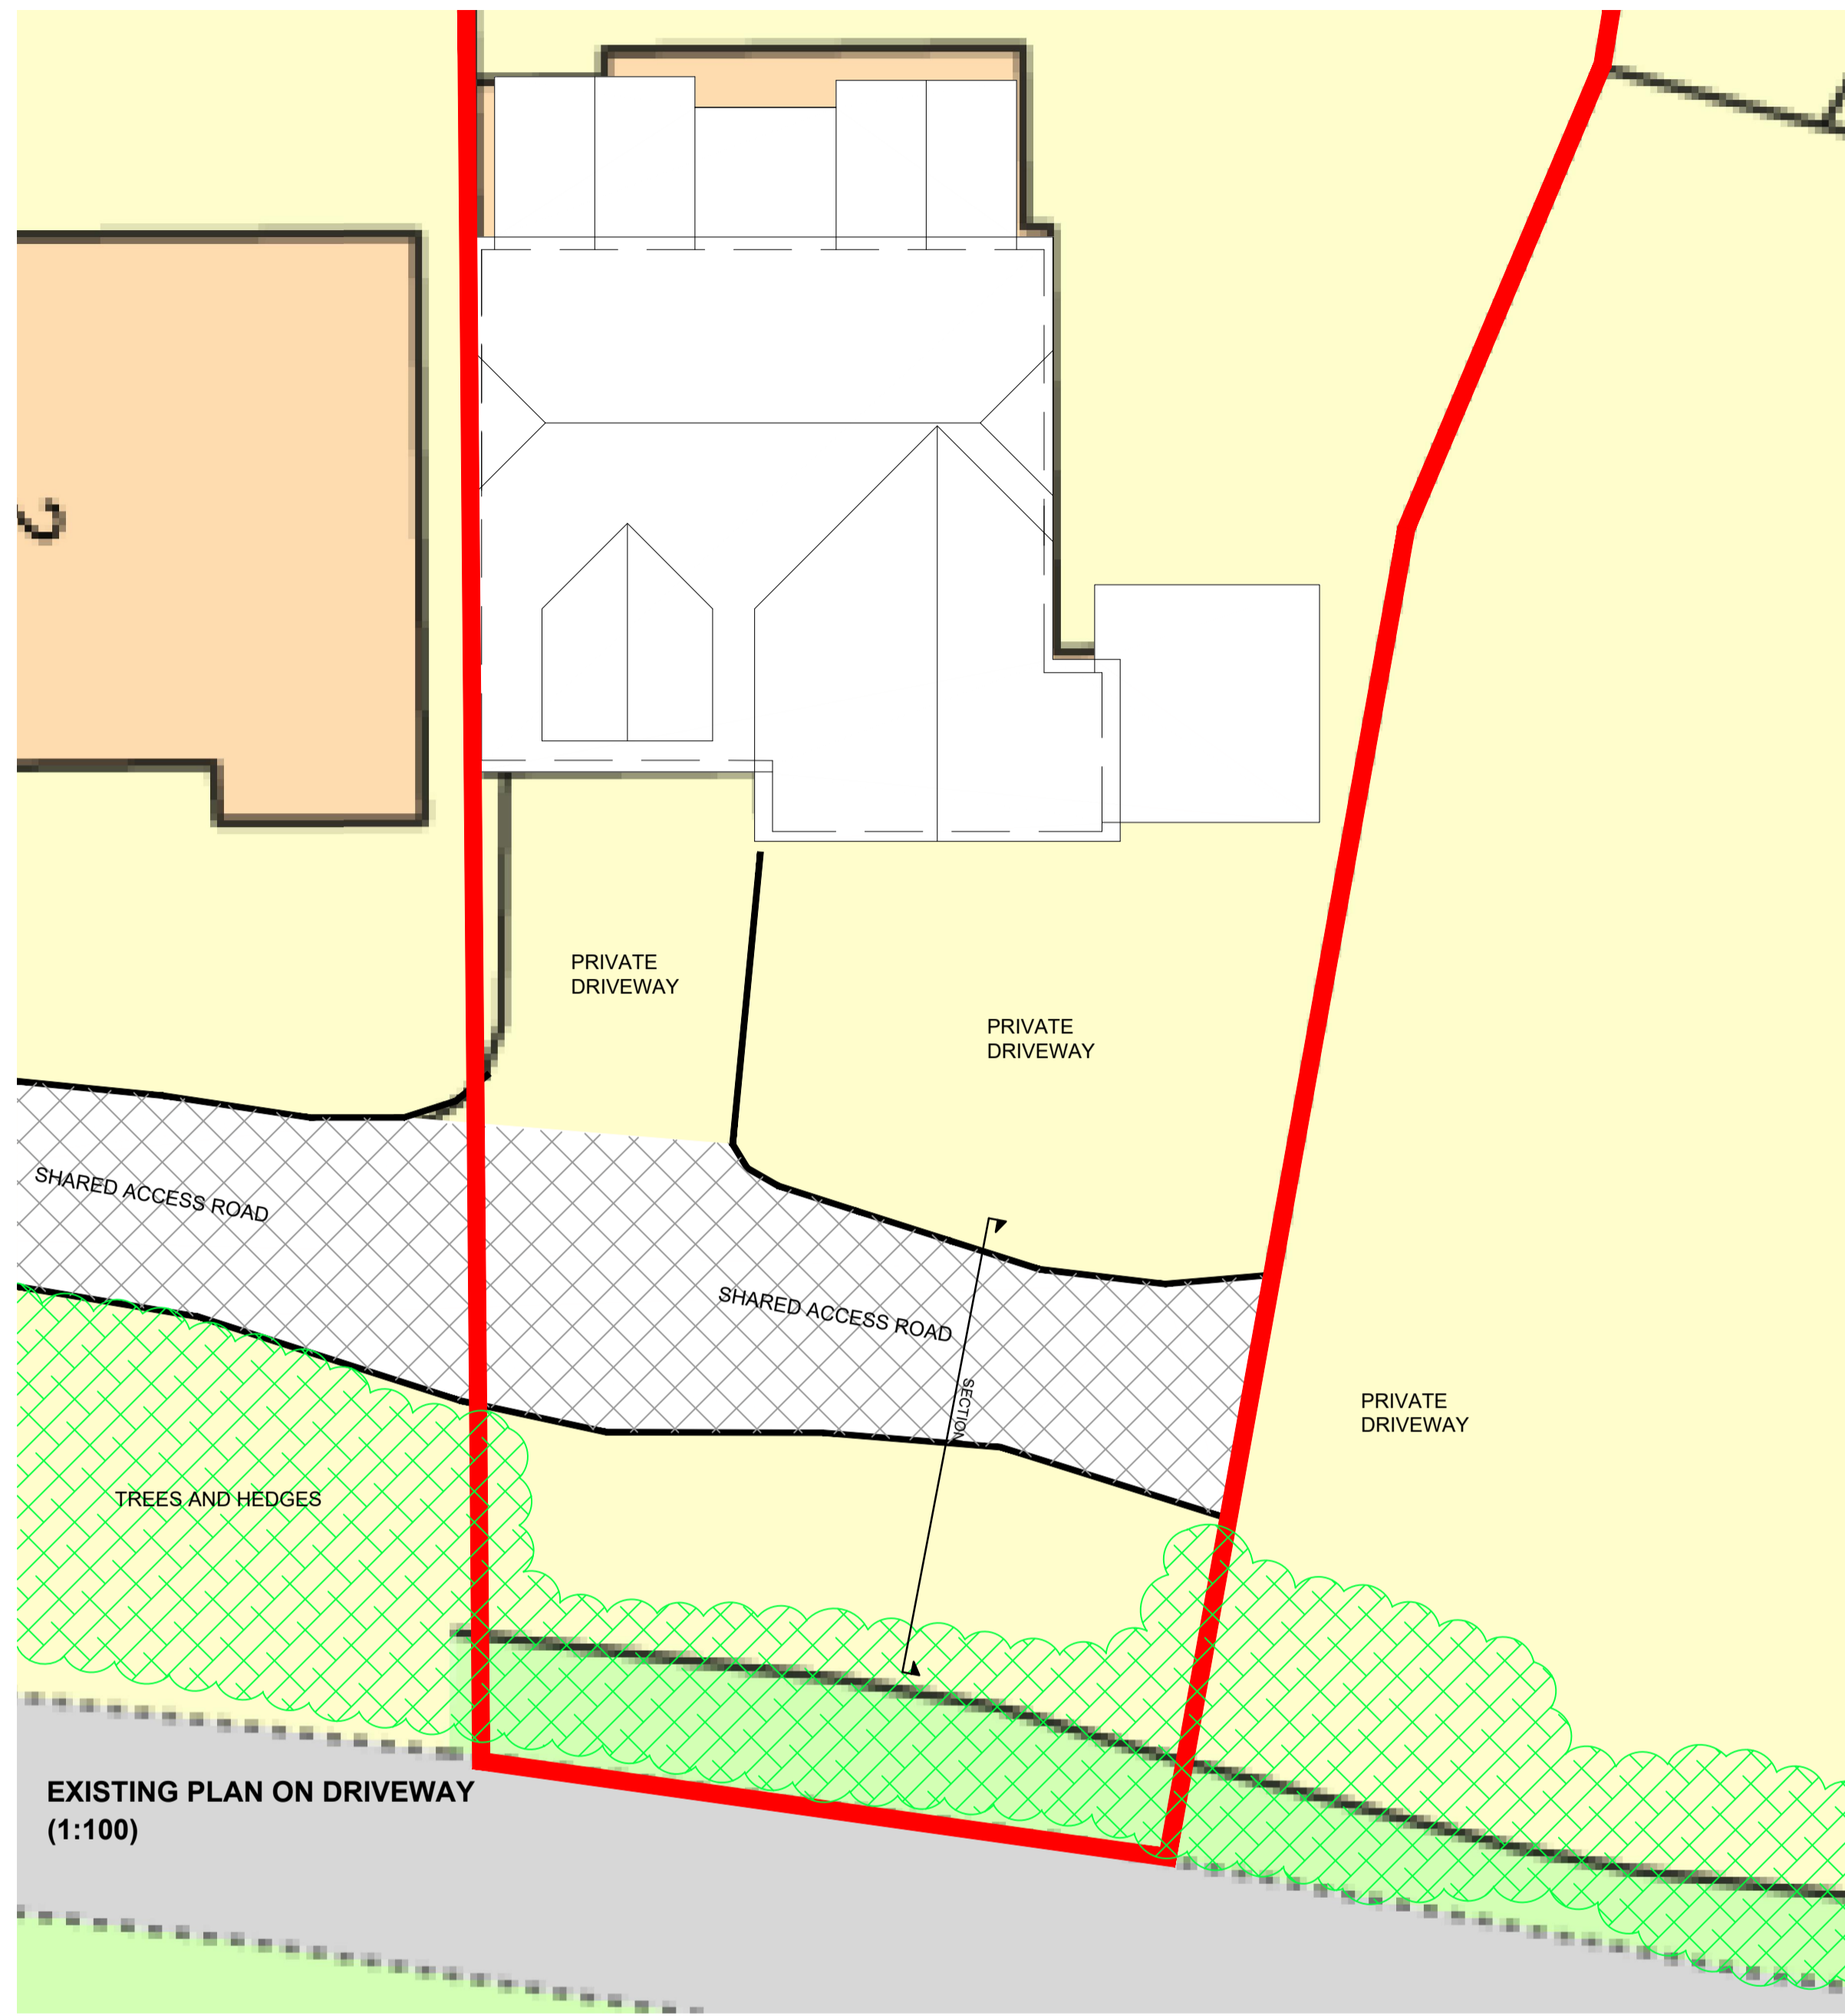
PHOTO OF DRIVEWAY EXTENSION AREA
Blue line indicates existing wall and red line indicates proposed location for new wall

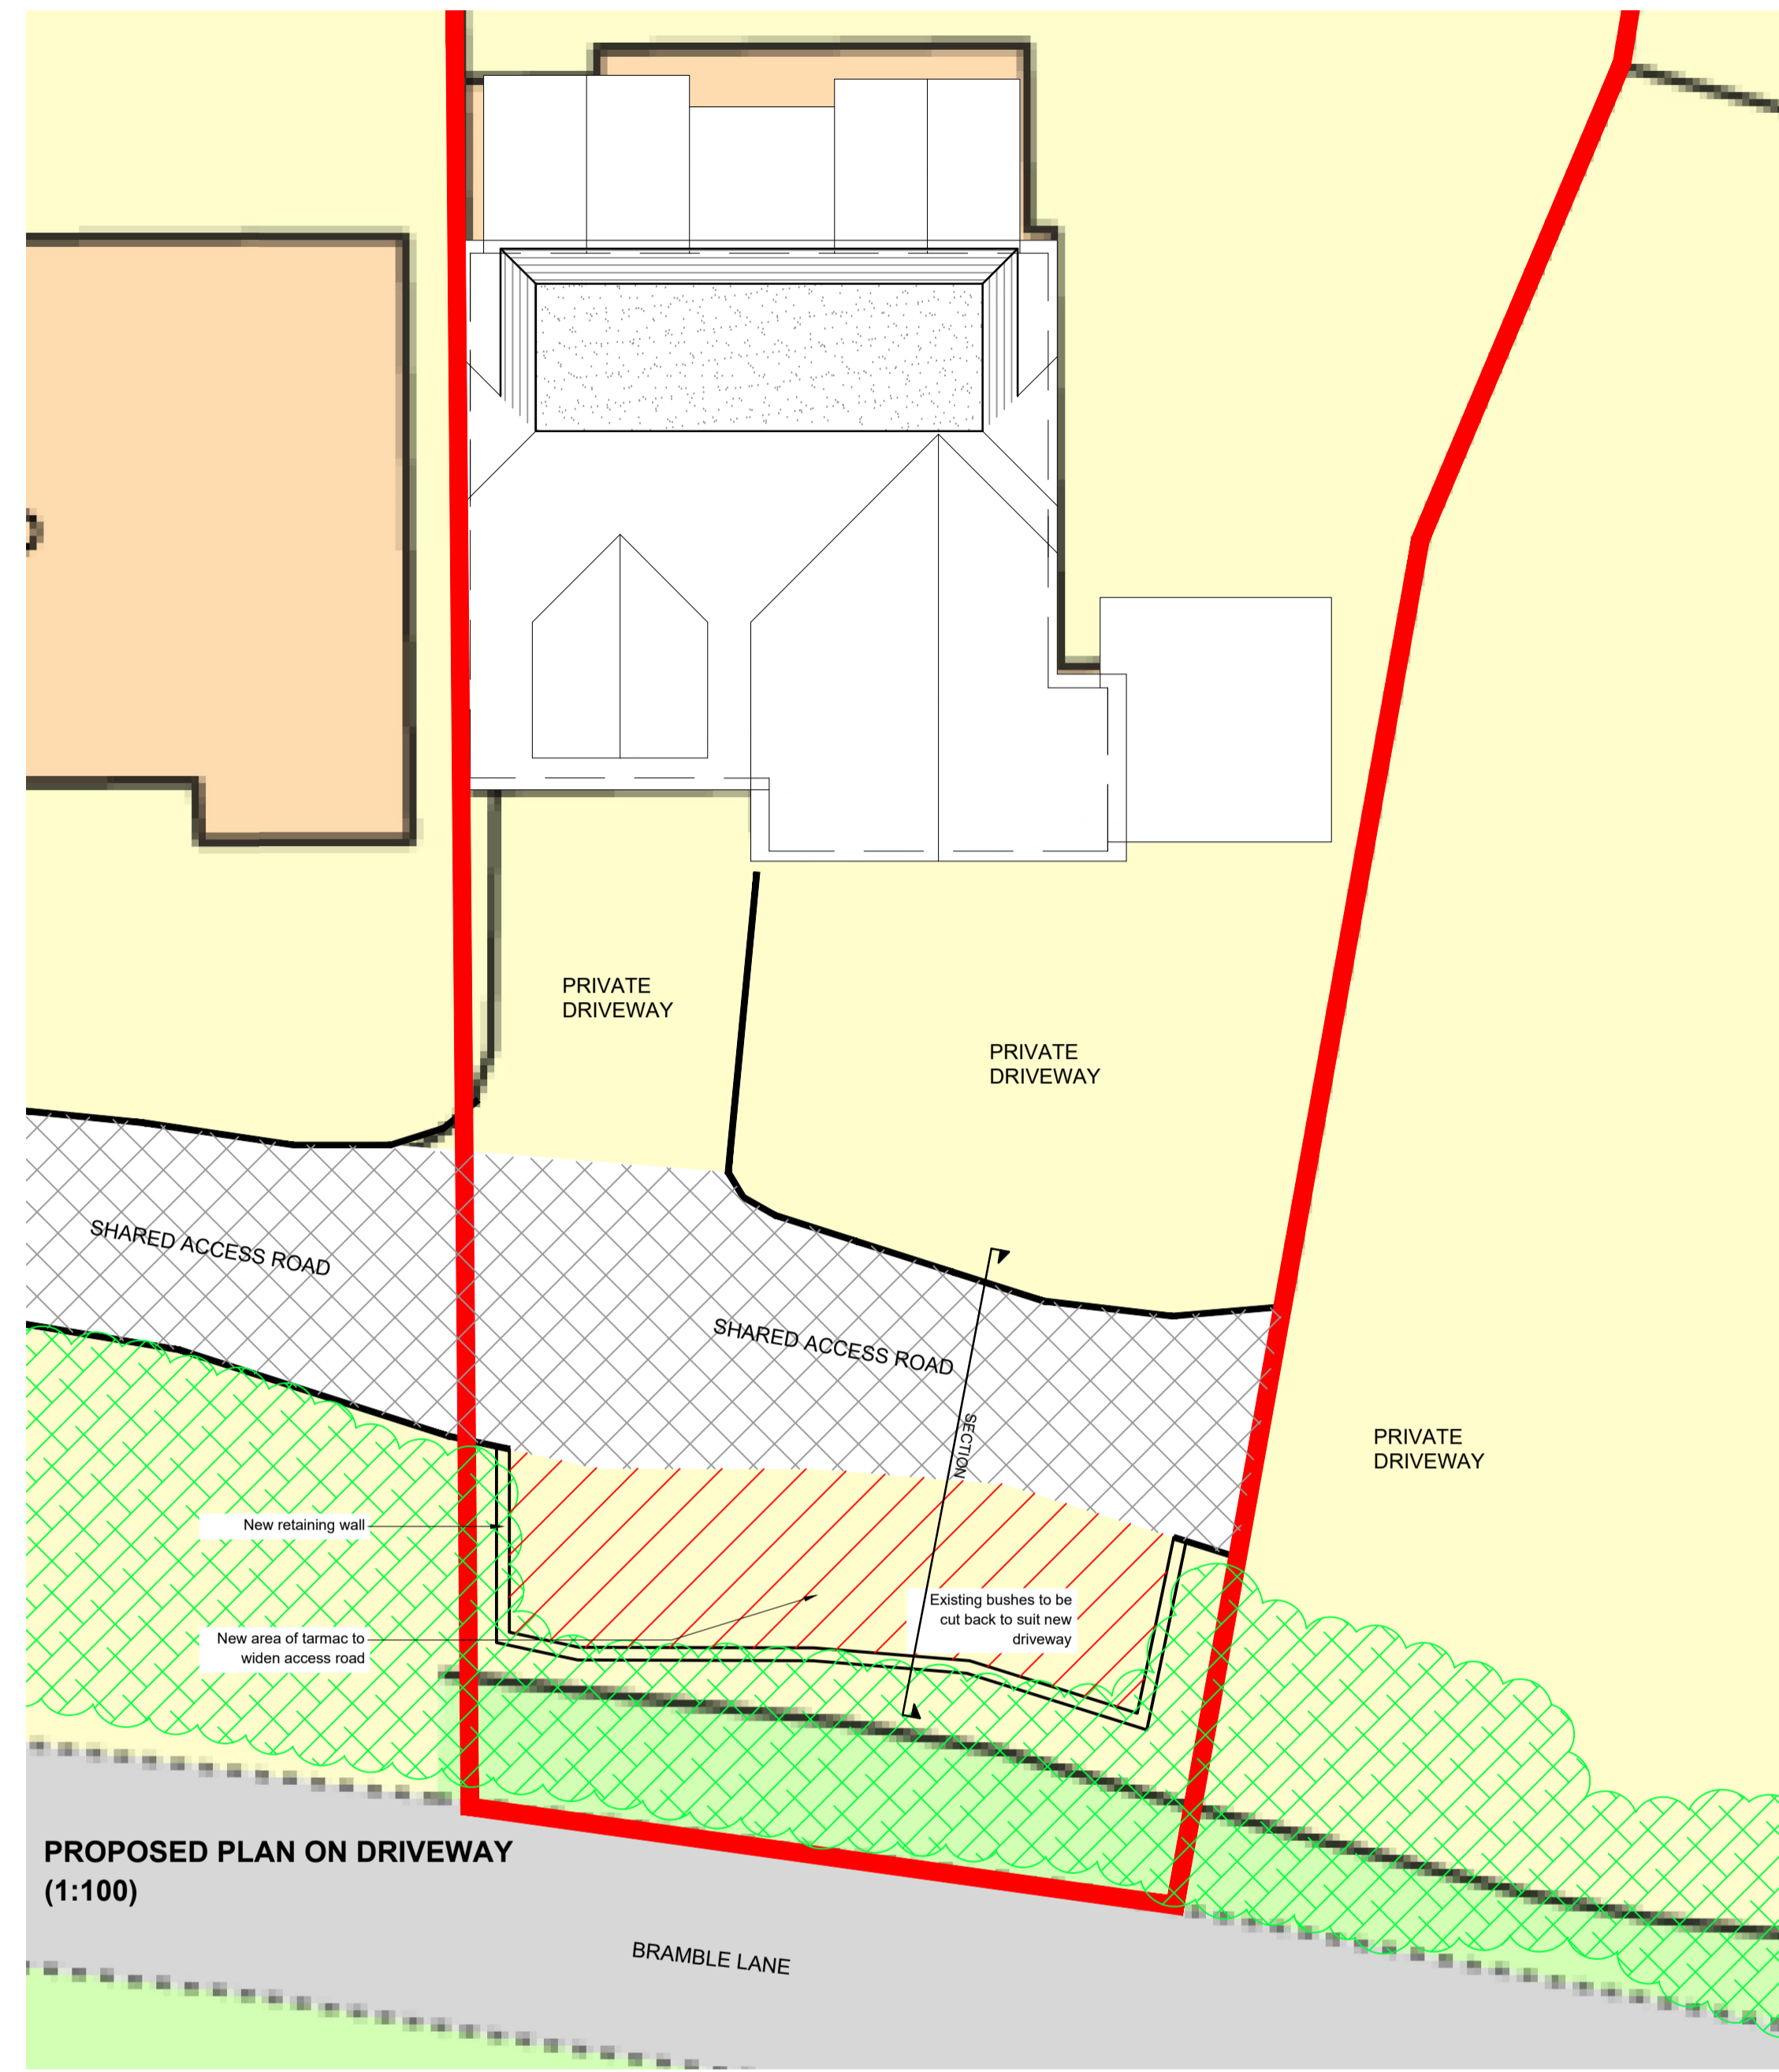
PHOTO OF RETAINING WALL
1A Sanderling rise shown in background. Existing wall is covered by trees and bushes. It is proposed to keep these to obscure the view of the proposed retaining wall

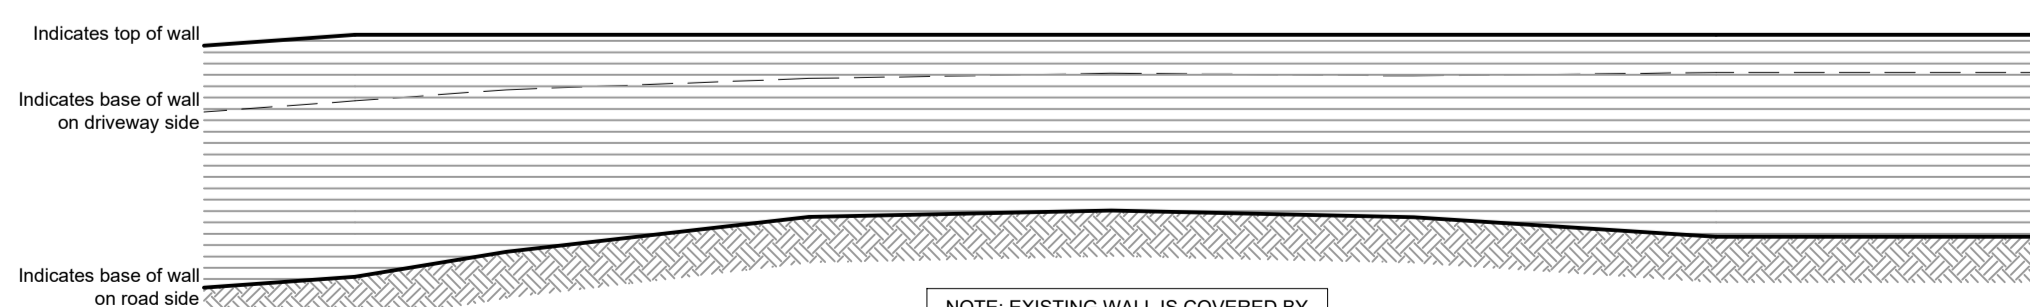
ELEVATION ON WALL AS EXISTING (1:50)

NOTE: EXISTING WALL IS COVERED BY TREES AND BUSHES. IT IS PROPOSED TO KEEP THESE TO OBSCURE THE VIEW OF THE PROPOSED WALL EXTENSION

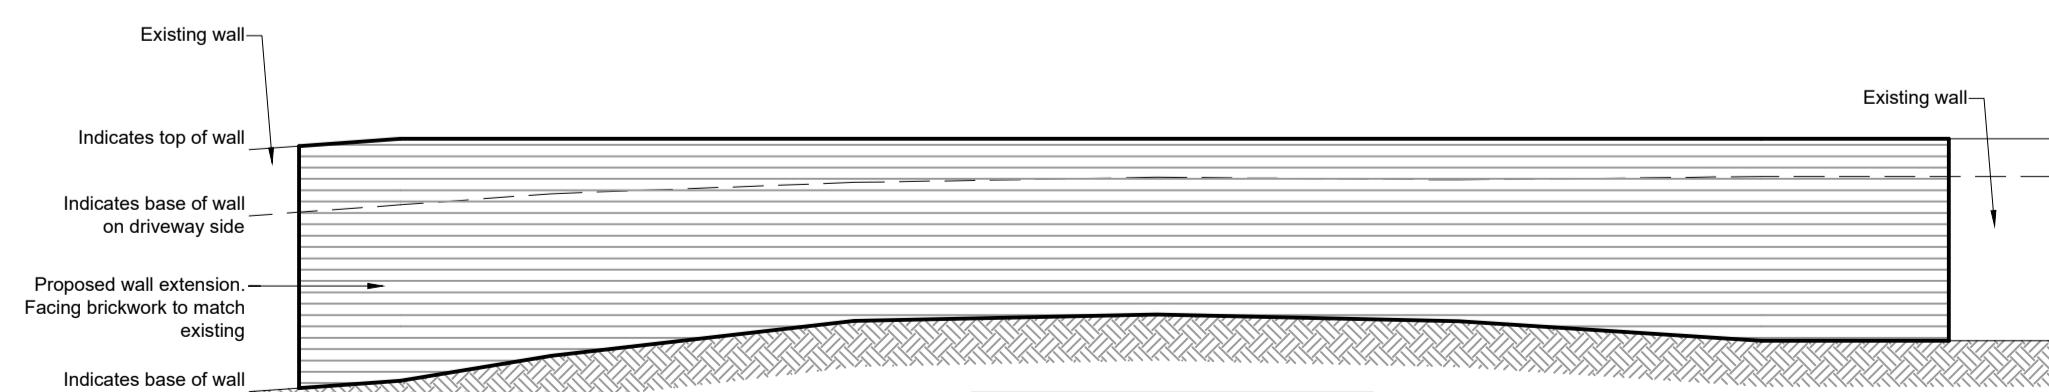
ELEVATION ON WALL AS PROPOSED (1:50)

NOTE: EXISTING WALL IS COVERED BY TREES AND BUSHES. IT IS PROPOSED TO KEEP THESE TO OBSCURE THE VIEW OF THE PROPOSED WALL EXTENSION
