Client
BURNTISLAND PLAYGROUP - ENTRANCE

Job	Description	Scale	Date
THE TOLL COMMUNITY CENTRE EAST TOLL PARK KIRKCALDY RD BURNTISLAND KY3 9HA	ENTRANCE AREA SKETCHES	NTS@A3	AUG 2020
	Drawing Number	Revision	
	940_(P)_006	-

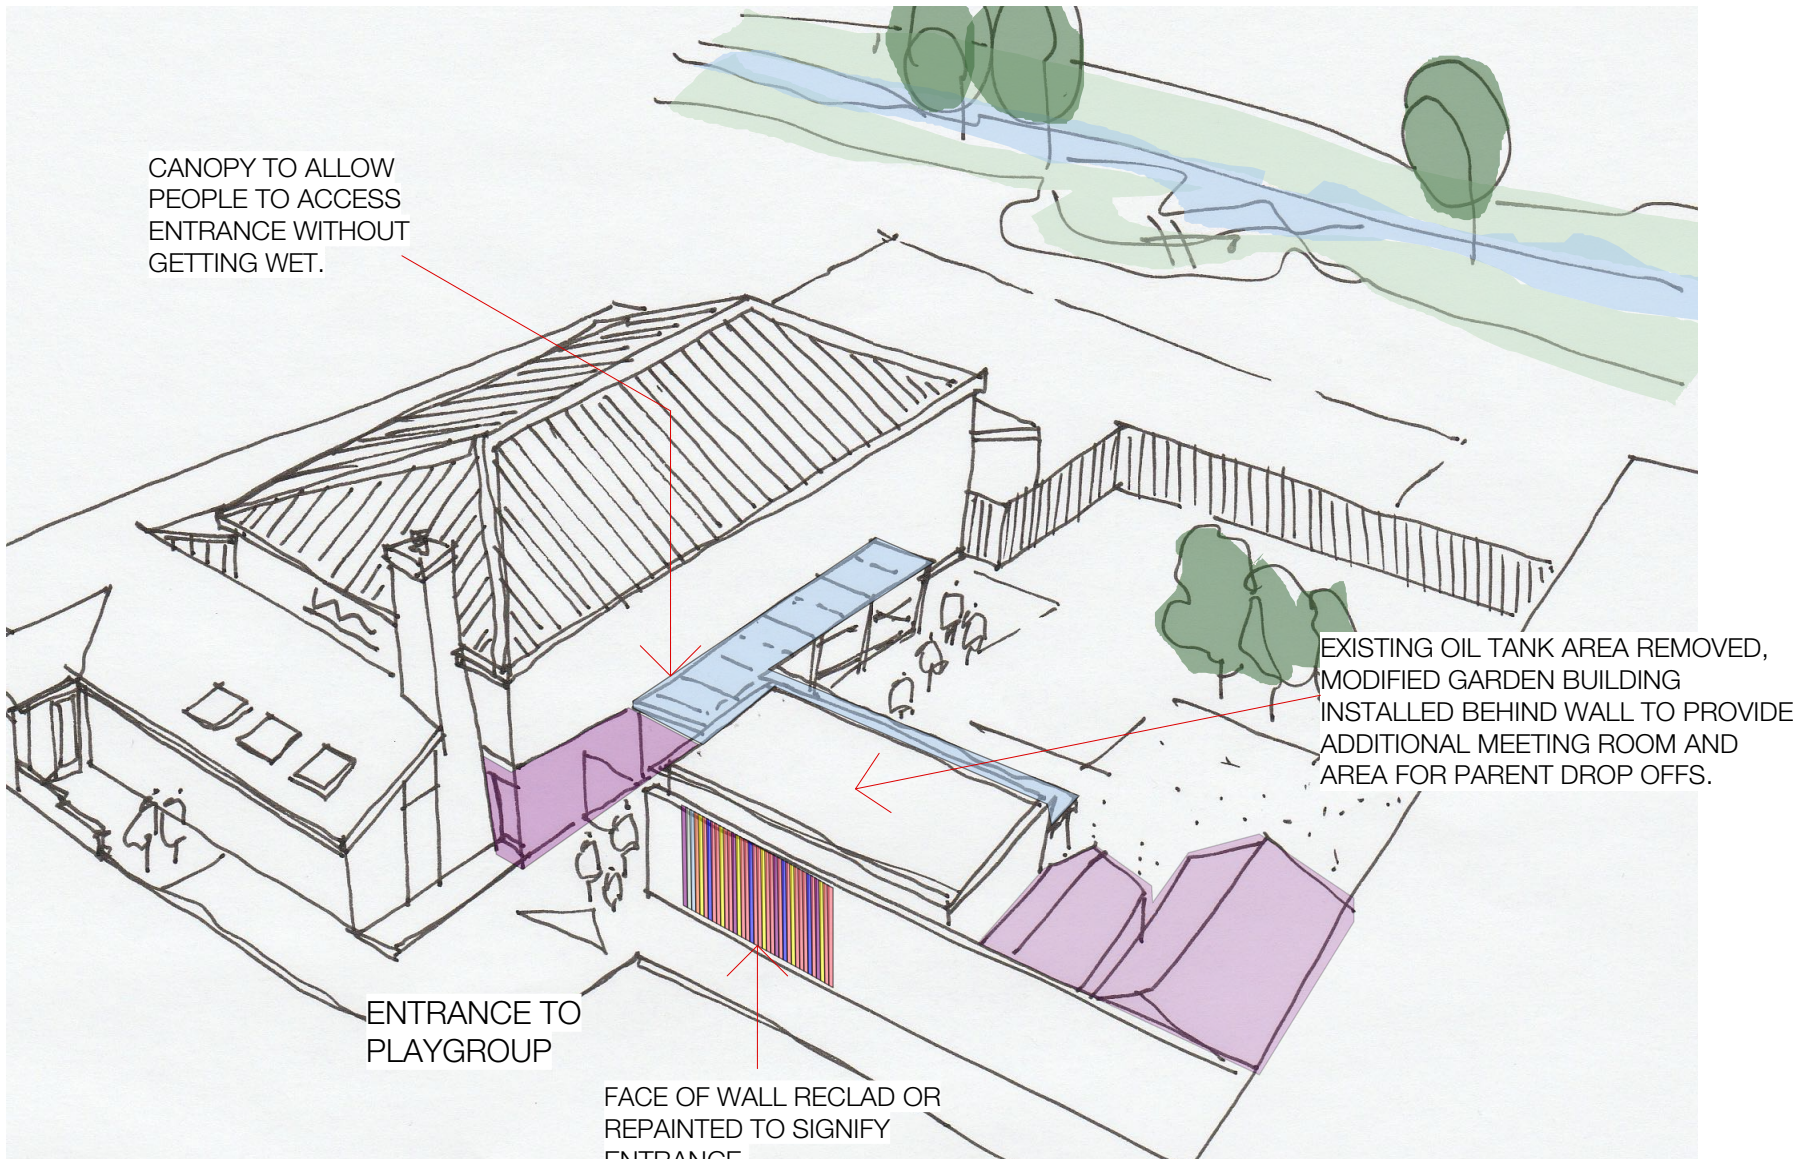
01_VIEW FROM ROAD

CANOPY TO ALLOW PEOPLE TO ACCESS ENTRANCE WITHOUT GETTING WET.

EXISTING OIL TANK AREA REMOVED, MODIFIED GARDEN BUILDING INSTALLED BEHIND WALL TO PROVIDE ADDITIONAL MEETING ROOM AND AREA FOR PARENT DROP OFFS.

ENTRANCE TO PLAYGROUP

FACE OF WALL RECLAD OR REPAINTED TO SIGNIFY ENTRANCE.

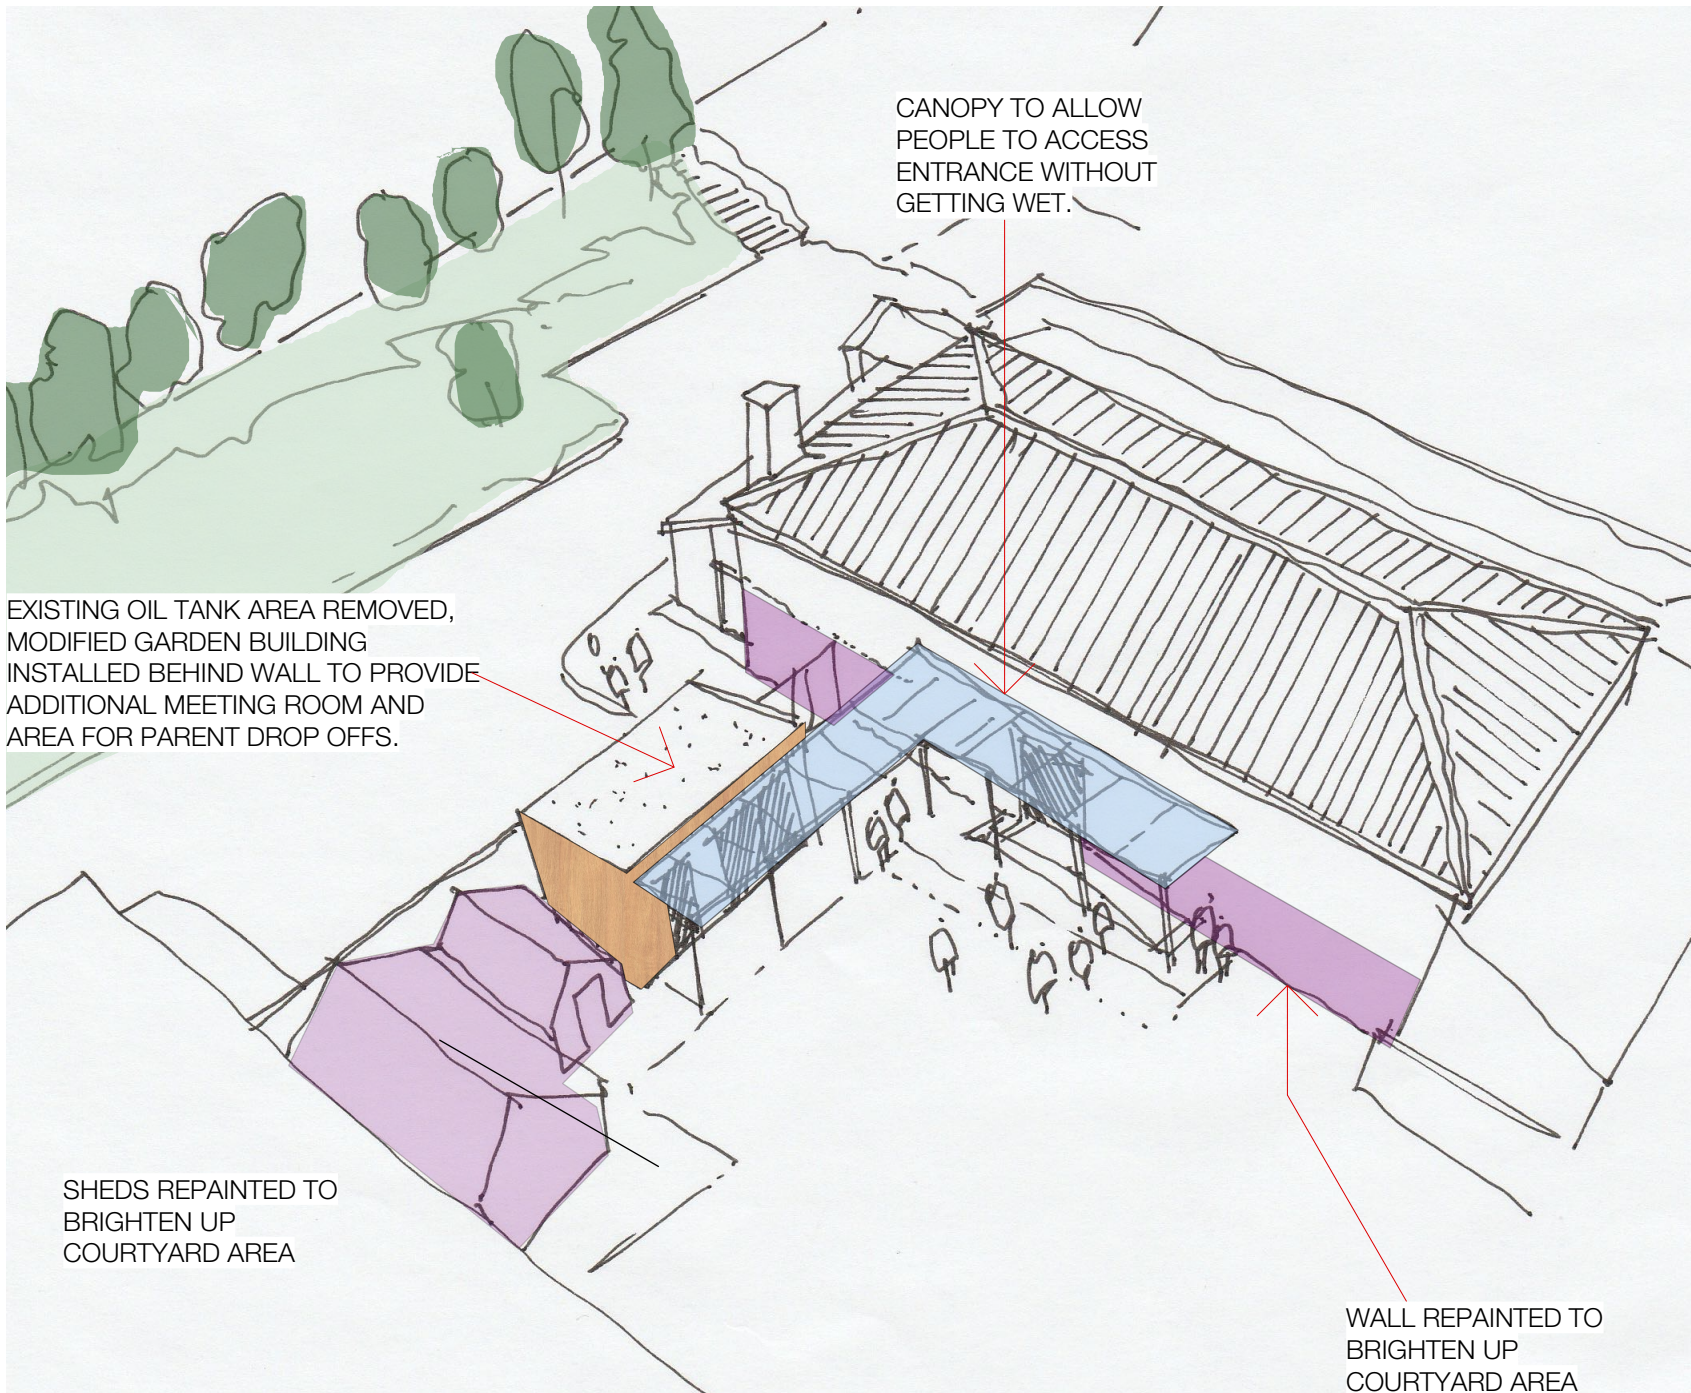
02_VIEW FROM GARDEN

CANOPY TO ALLOW PEOPLE TO ACCESS ENTRANCE WITHOUT GETTING WET.

EXISTING OIL TANK AREA REMOVED, MODIFIED GARDEN BUILDING INSTALLED BEHIND WALL TO PROVIDE ADDITIONAL MEETING ROOM AND AREA FOR PARENT DROP OFFS.

SHEDS REPAINTED TO BRIGHTEN UP COURTYARD AREA

WALL REPAINTED TO BRIGHTEN UP COURTYARD AREA
