WELLS BUBWITH ALMSHOUSE The Chapel of St Saviour

Archaeological Assessment

9 December 2019

Wells: Bubwith's Almshouse - a preliminary survey

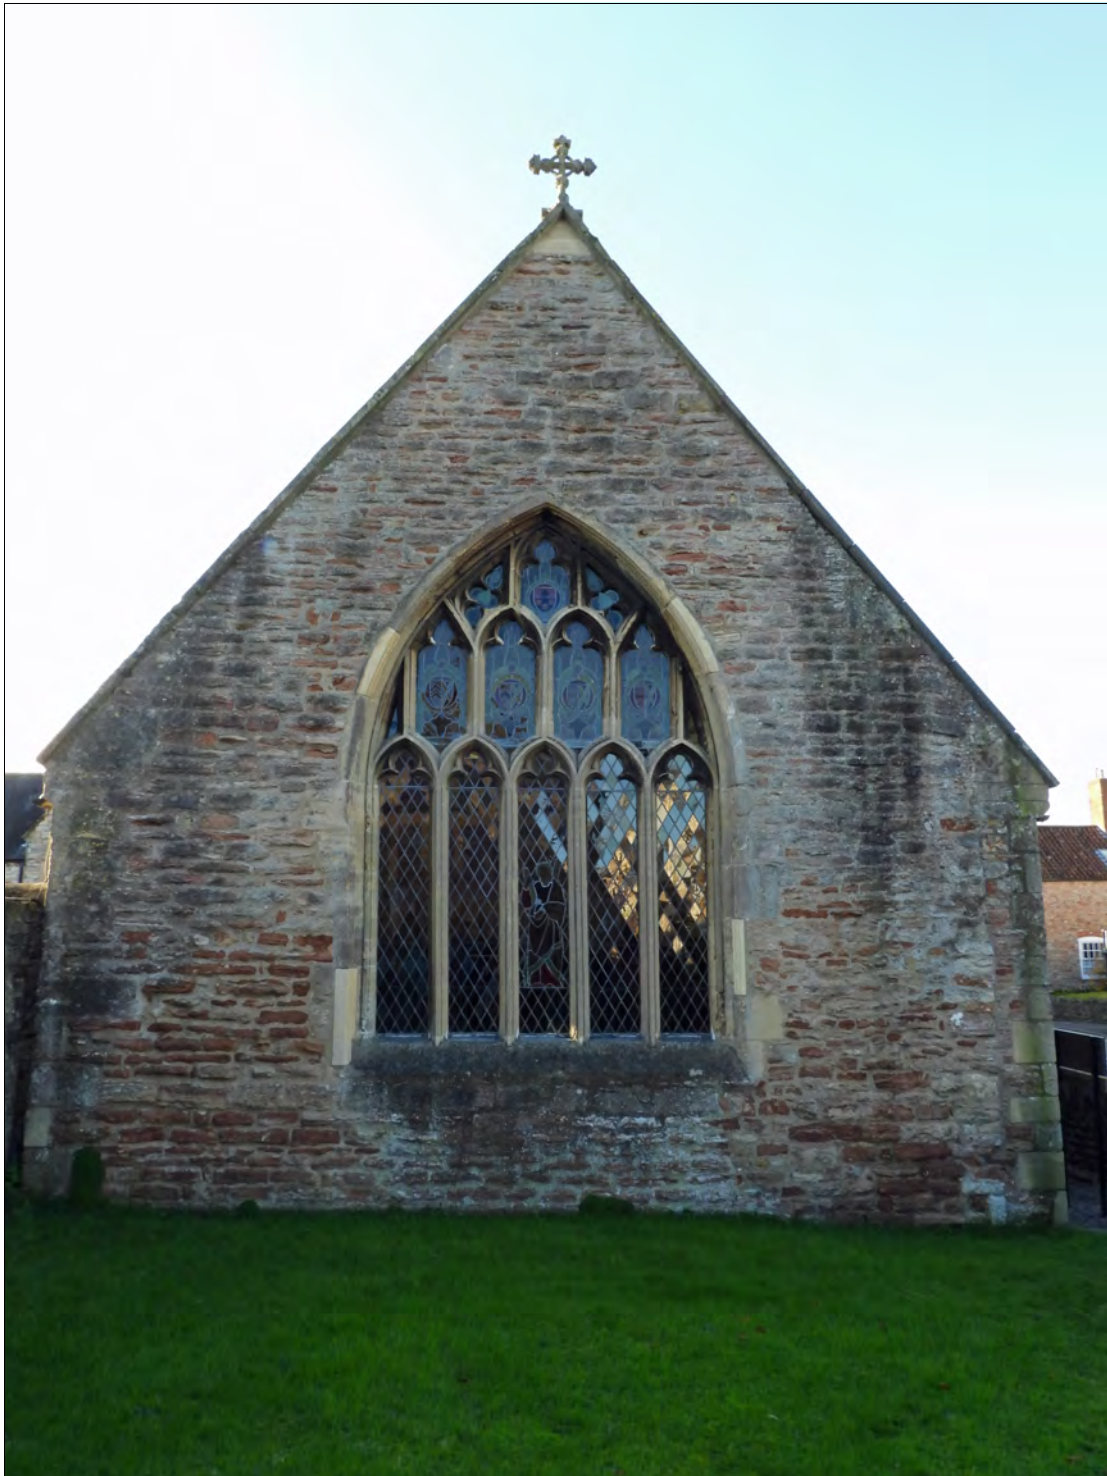
The East wall of the Chapel - the north-eastern quoin has been rebuilt - note the modern insertions around the window showing as paler blocks.

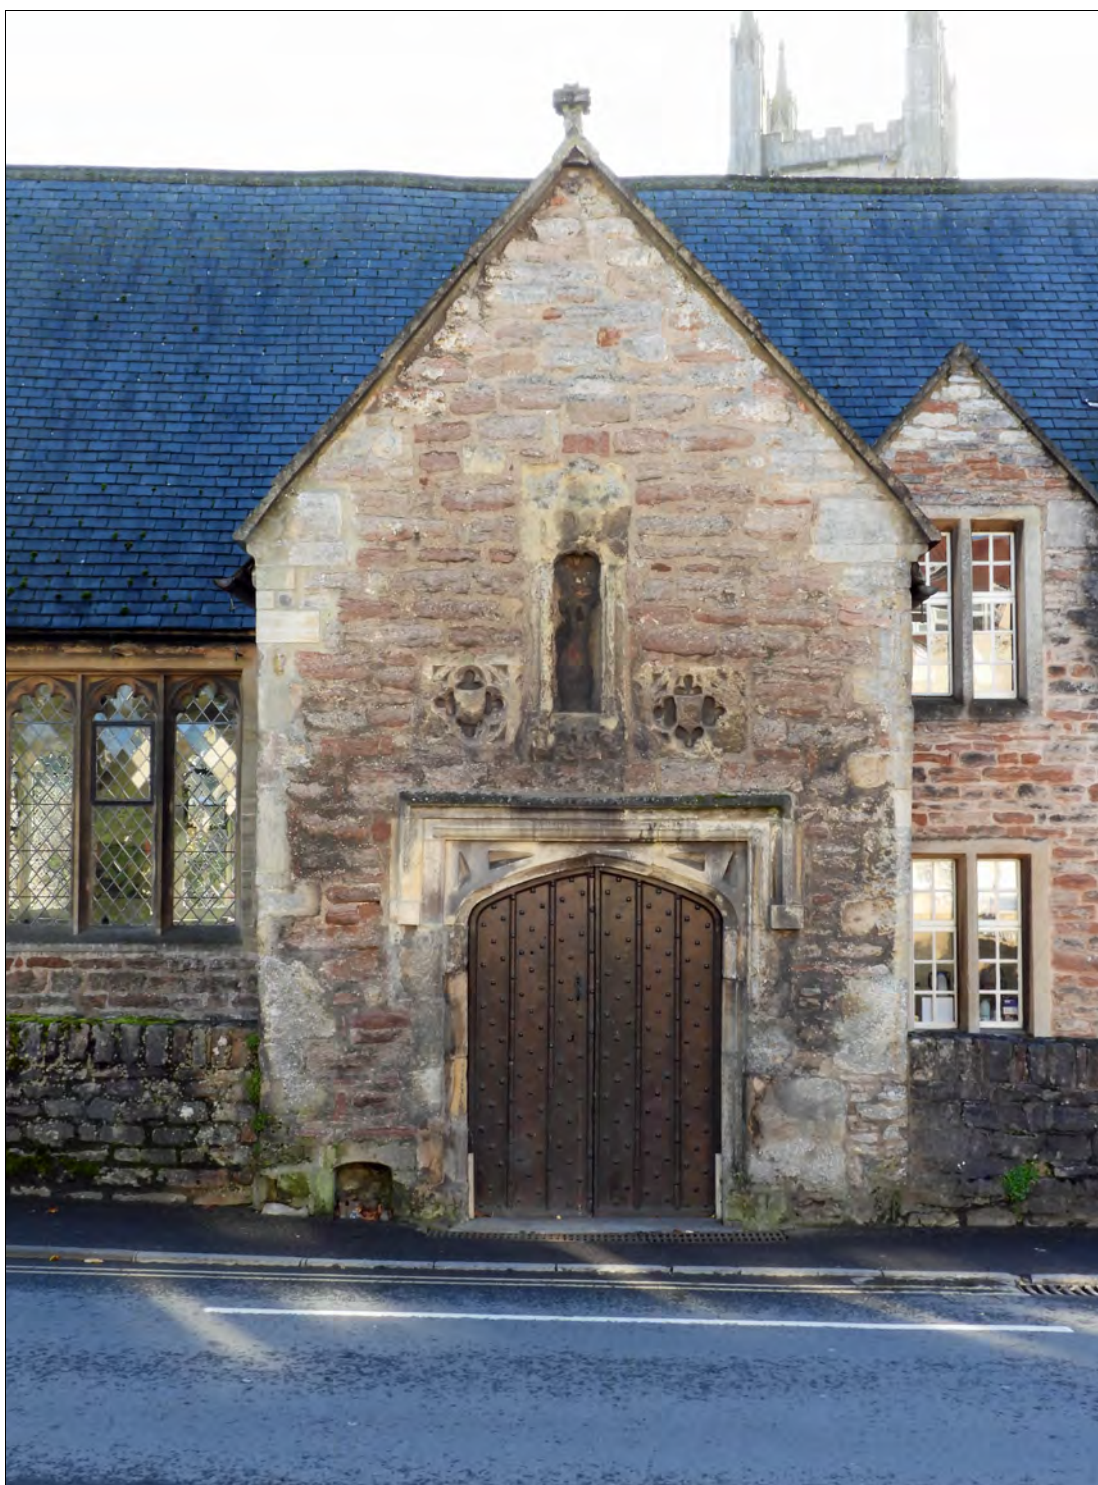
The north elevation of the north porch

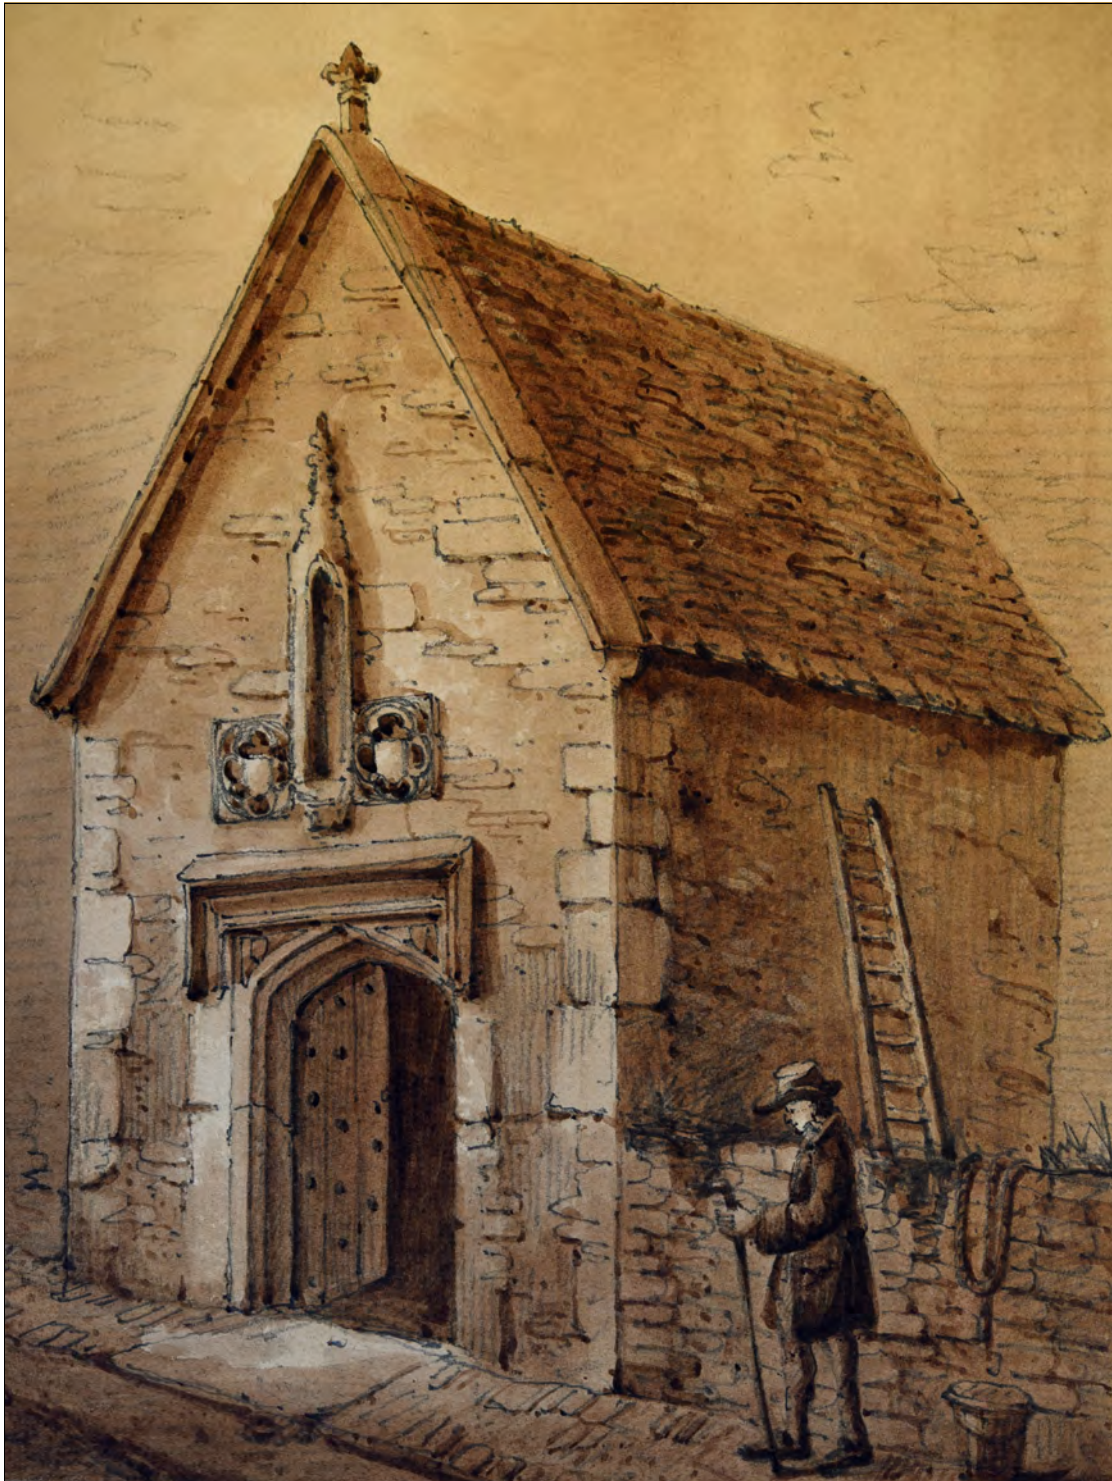
W.W. Wheatley watercolour of the North Porch painted in 1848 prior to the major restoration.

The corbel heads represented are those of the Bishop (south side, centre - though without the initials on the mitre), the queen (north side, western) and the king - though being parts of a composite composition all are small details.

Ephemeral as it is, one of the most interesting details of the watercolour is the area immediately to the south of the base of the east window, where there appears to have been an irregular of plastering. The form and position of this patch suggests that Wheatley was depicting a cut-back niche of the sort commonly found flanking east windows, and which would originally have held the southern of a pair of figure sculptures traditionally placed flanking the high altar.

However, the evidence of the 1848 Wheatley drawings suggests that heads are original, and there would be little incentive to have had them replaced during the mid-nineteenth century restorations.

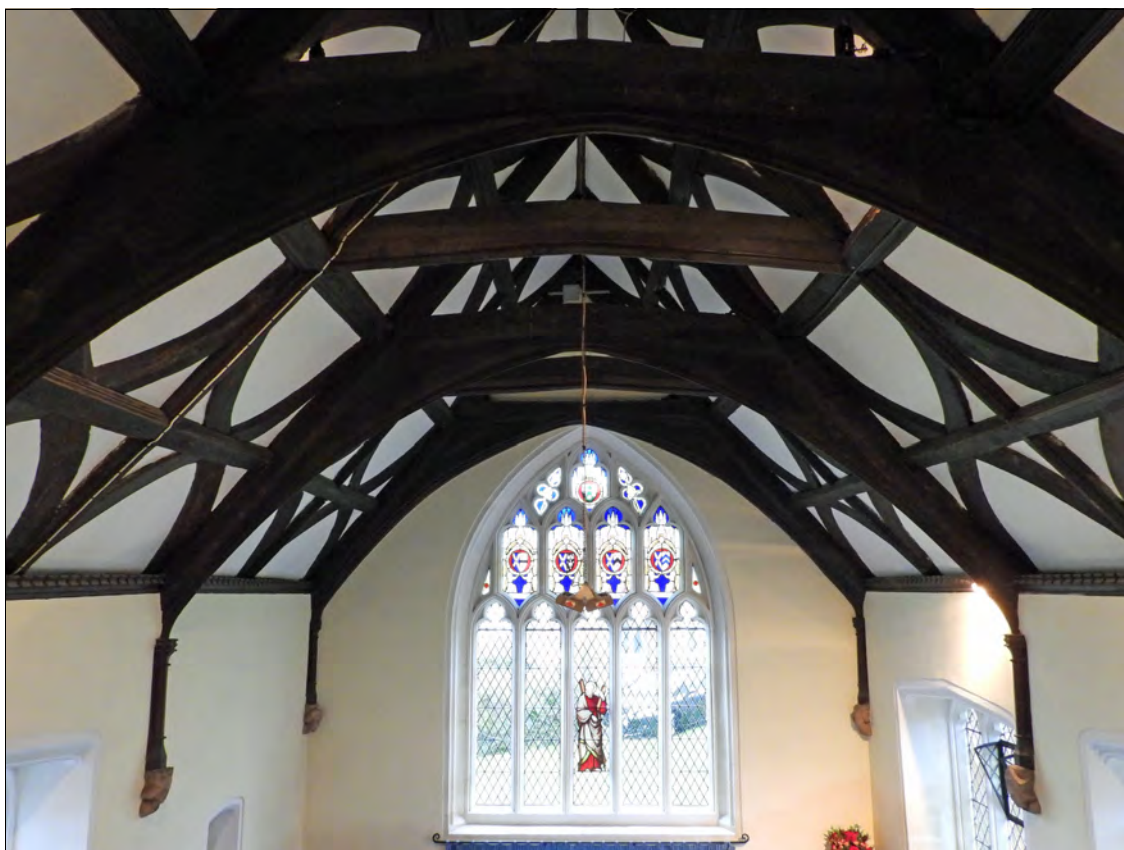
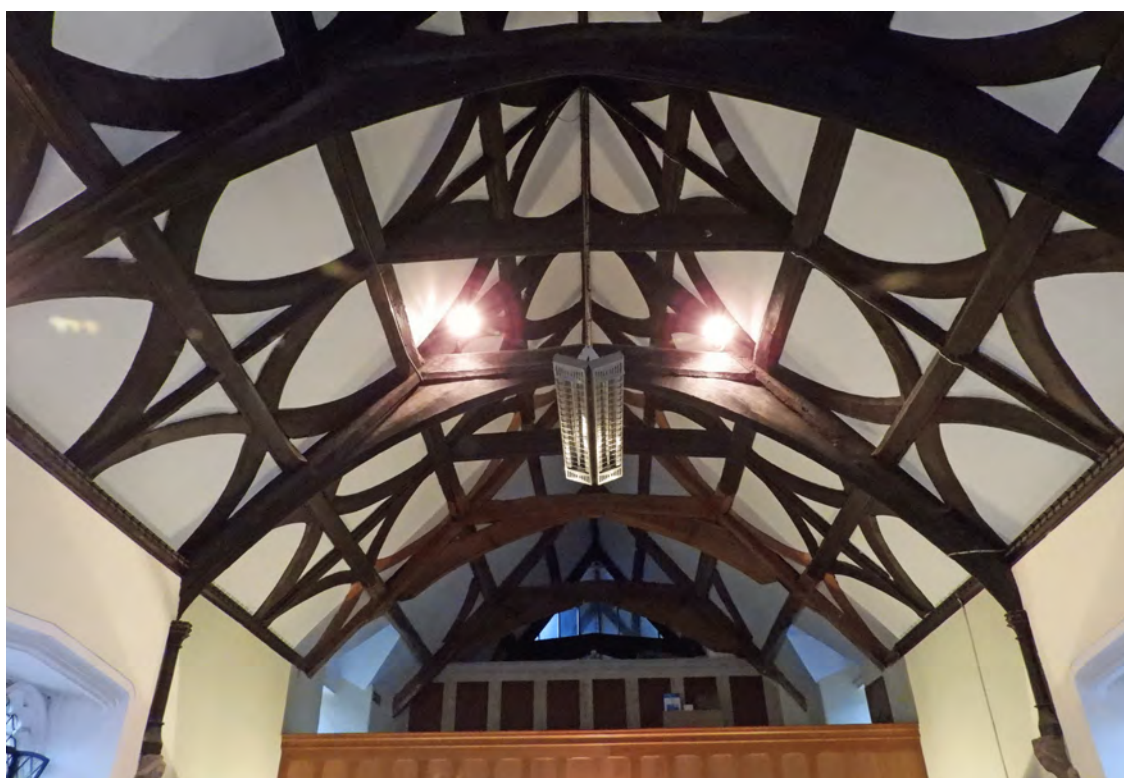
The Chapel roof looking east (top) and west

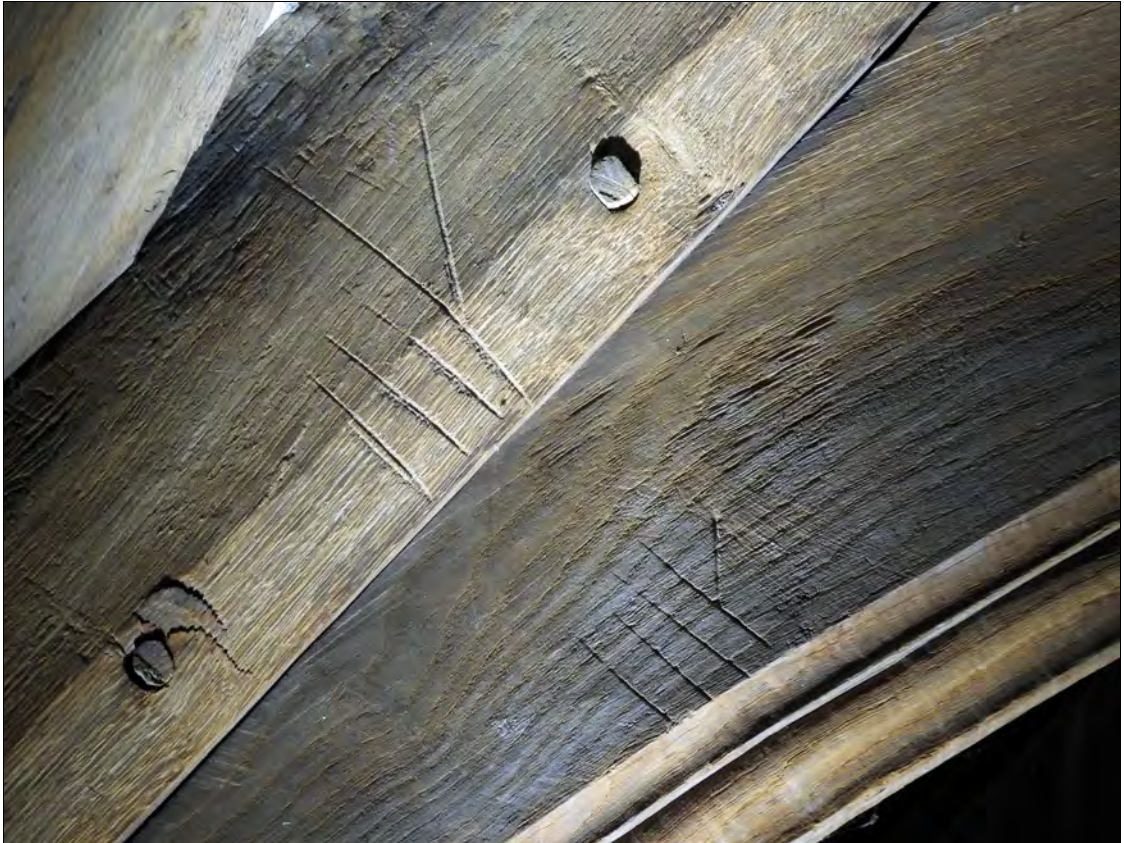
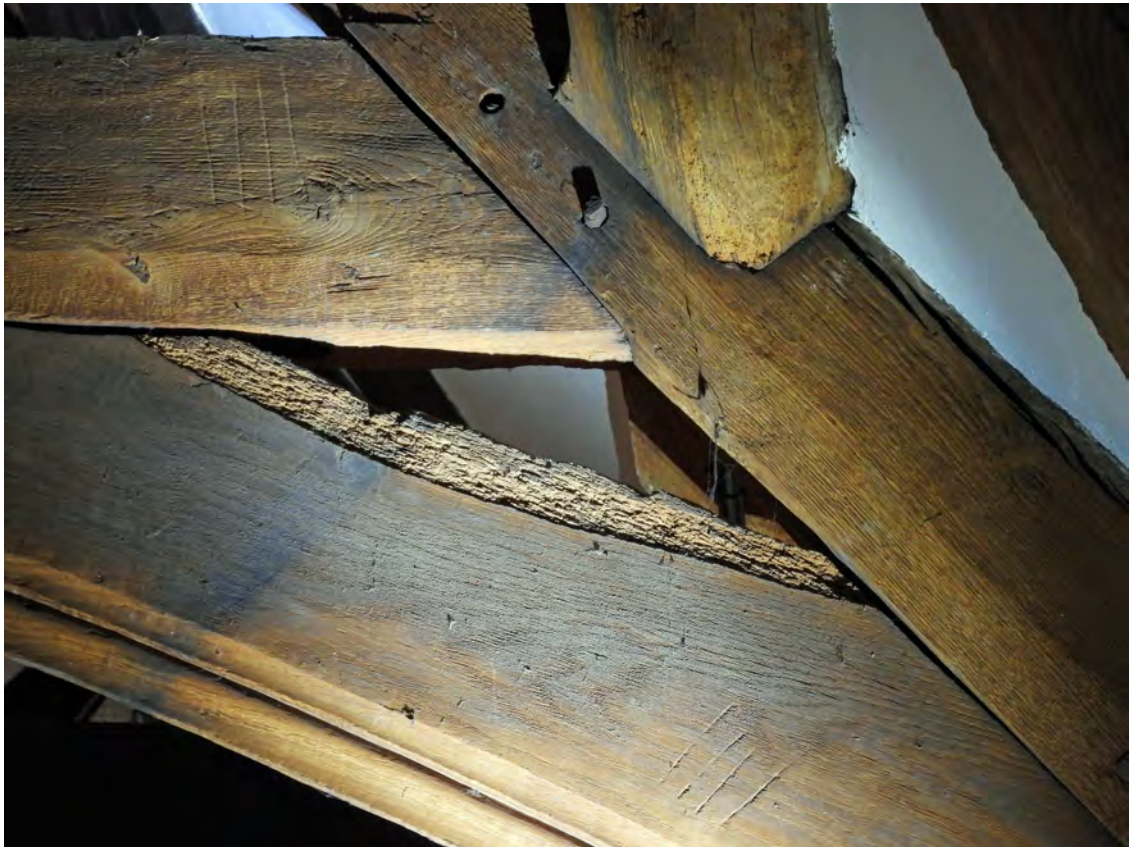
Carpenters' assembly marks: Truss 4, west face, north and south with differencing.

Carpenters' assembly marks are also likely to shed light on the construction process of the almshouse. Those noted so far indicate that the roof was manufactured (and probably erected) from east to west, and it is reasonable to assume that the roof of the western parts of the building followed the same pattern. However, discontinuities in the numbering are usually indicators of hiatuses in the building process, At Yeovil St John in the period just before 1400 the erection of the west tower caused the western roof trusses to be erected out of sequence, and it is possible that the same could have occurred at Wells if the Guildhall formed a separate episode in the building process. At Wells also, in building the Bishops Barn in the mid-fifteenth century, two sequences of roof-truss numbers suggest two phases of construction. Again, it might be profitable to ask residents about numbers on the roof trusses.

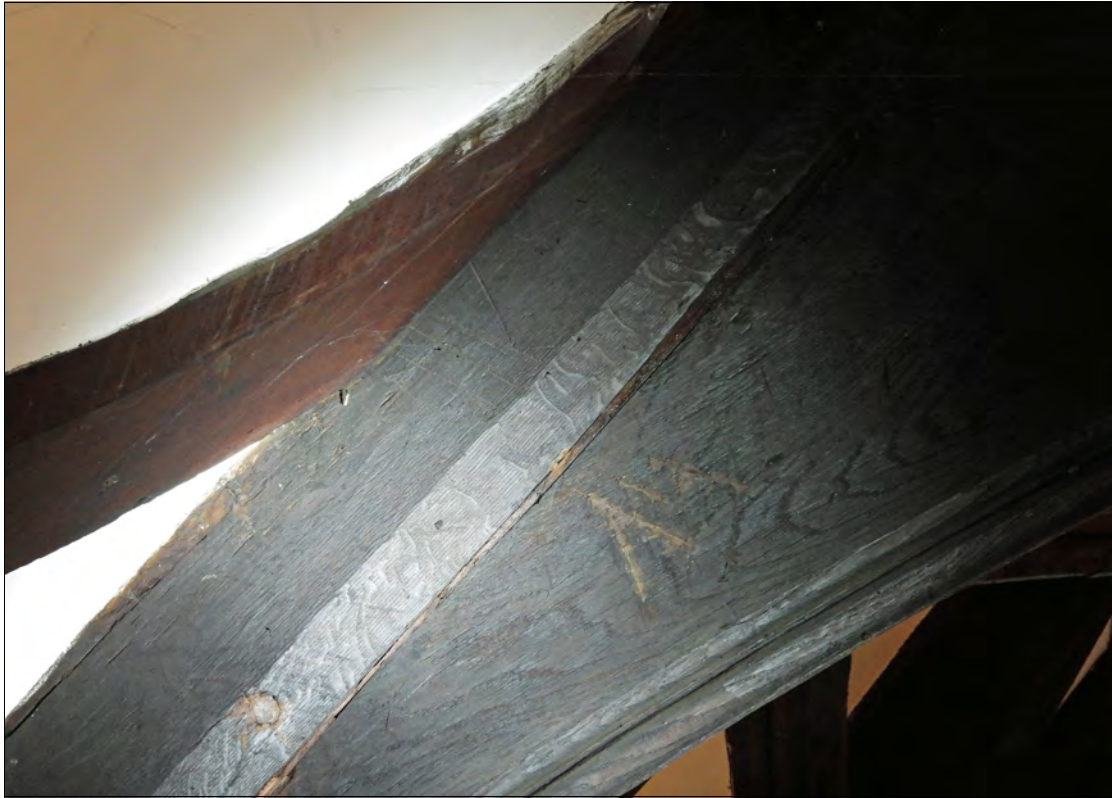
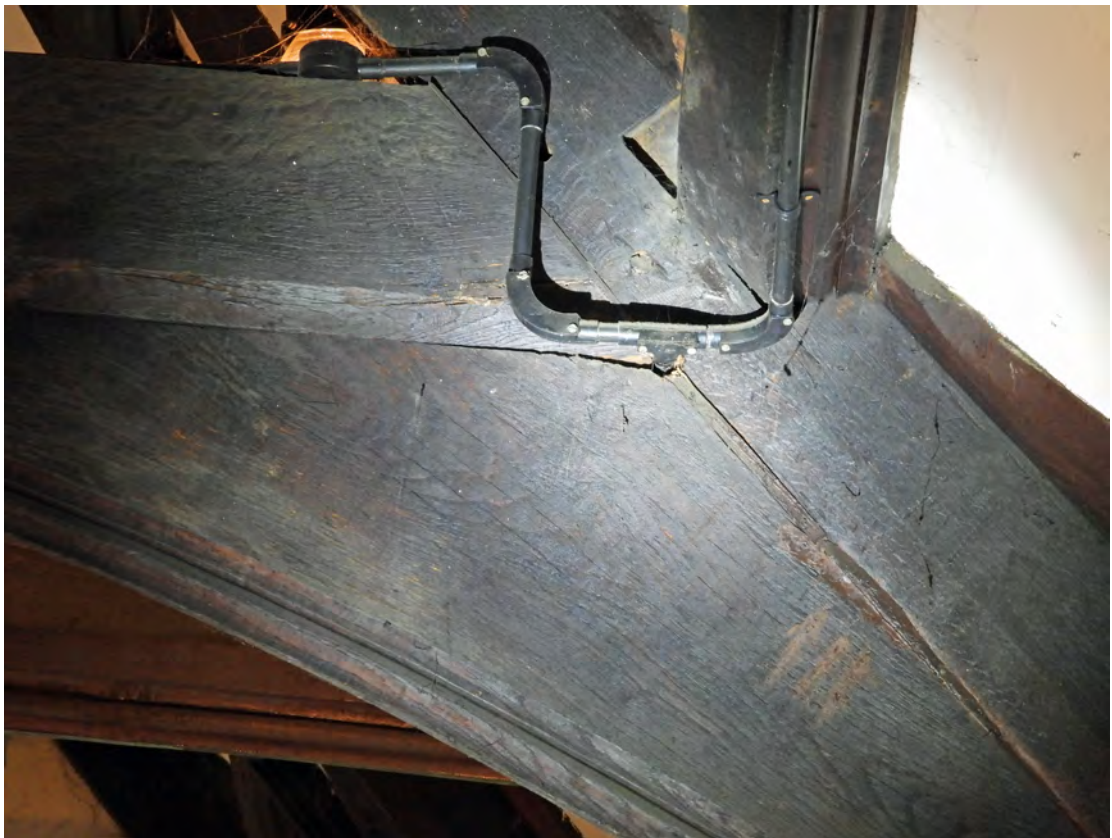
Carpenters' assembly marks, Truss 3 - north and south sides with differencing.

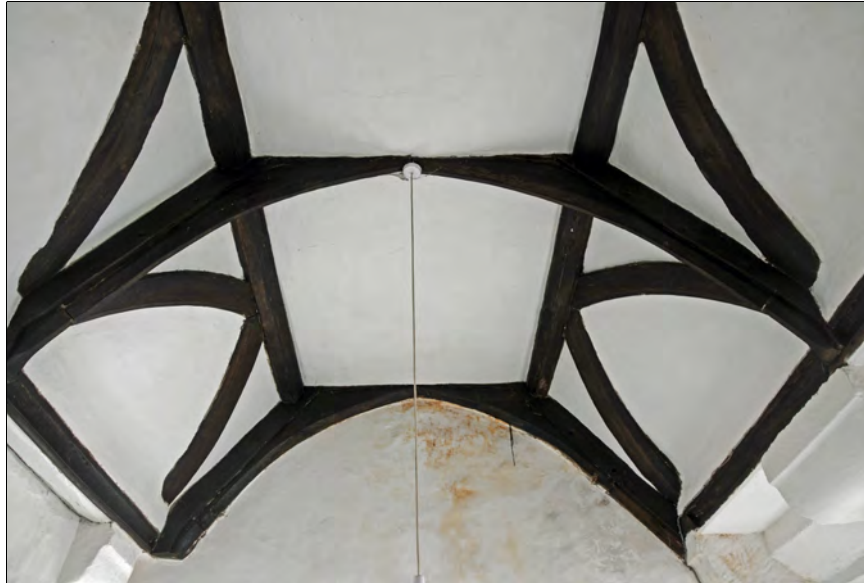
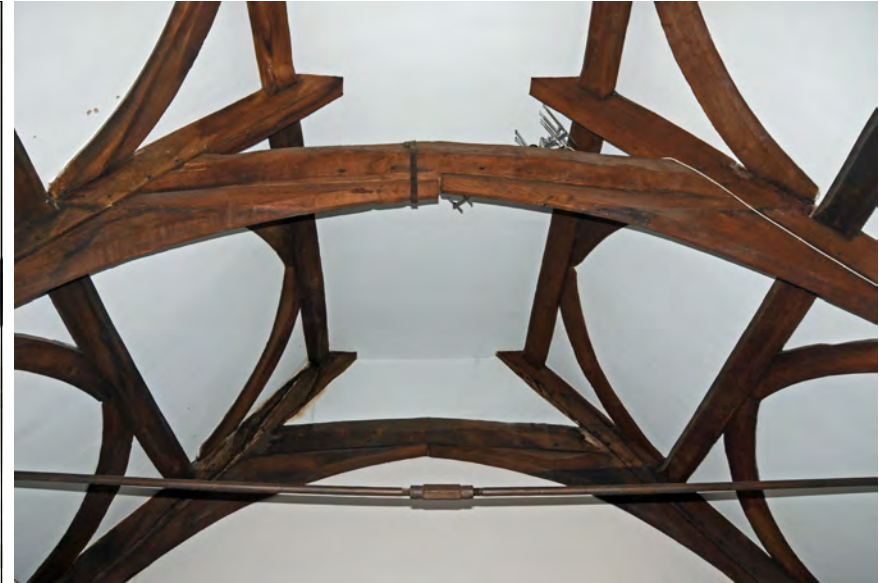
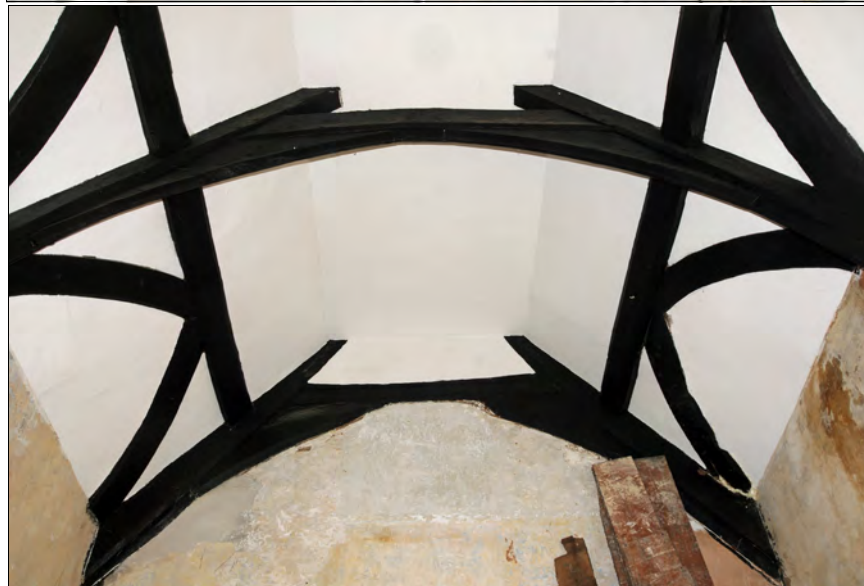
Wells: the roof of Penniless Porch (c.1451) (top left); No.9 Market Place (the Nova Opera c.1450) (top right) and No.9 Vicars' Close (left).

The general similarities of the design: with arch-braced cranked collars, and the lower purlins supporting windbraces, suggests that the roof of the house in the Close belongs to the campaign of rebuilding under Bishop Bekynton and his executors - the timbers of No.20 having been dated by dendrochronology to 1466.

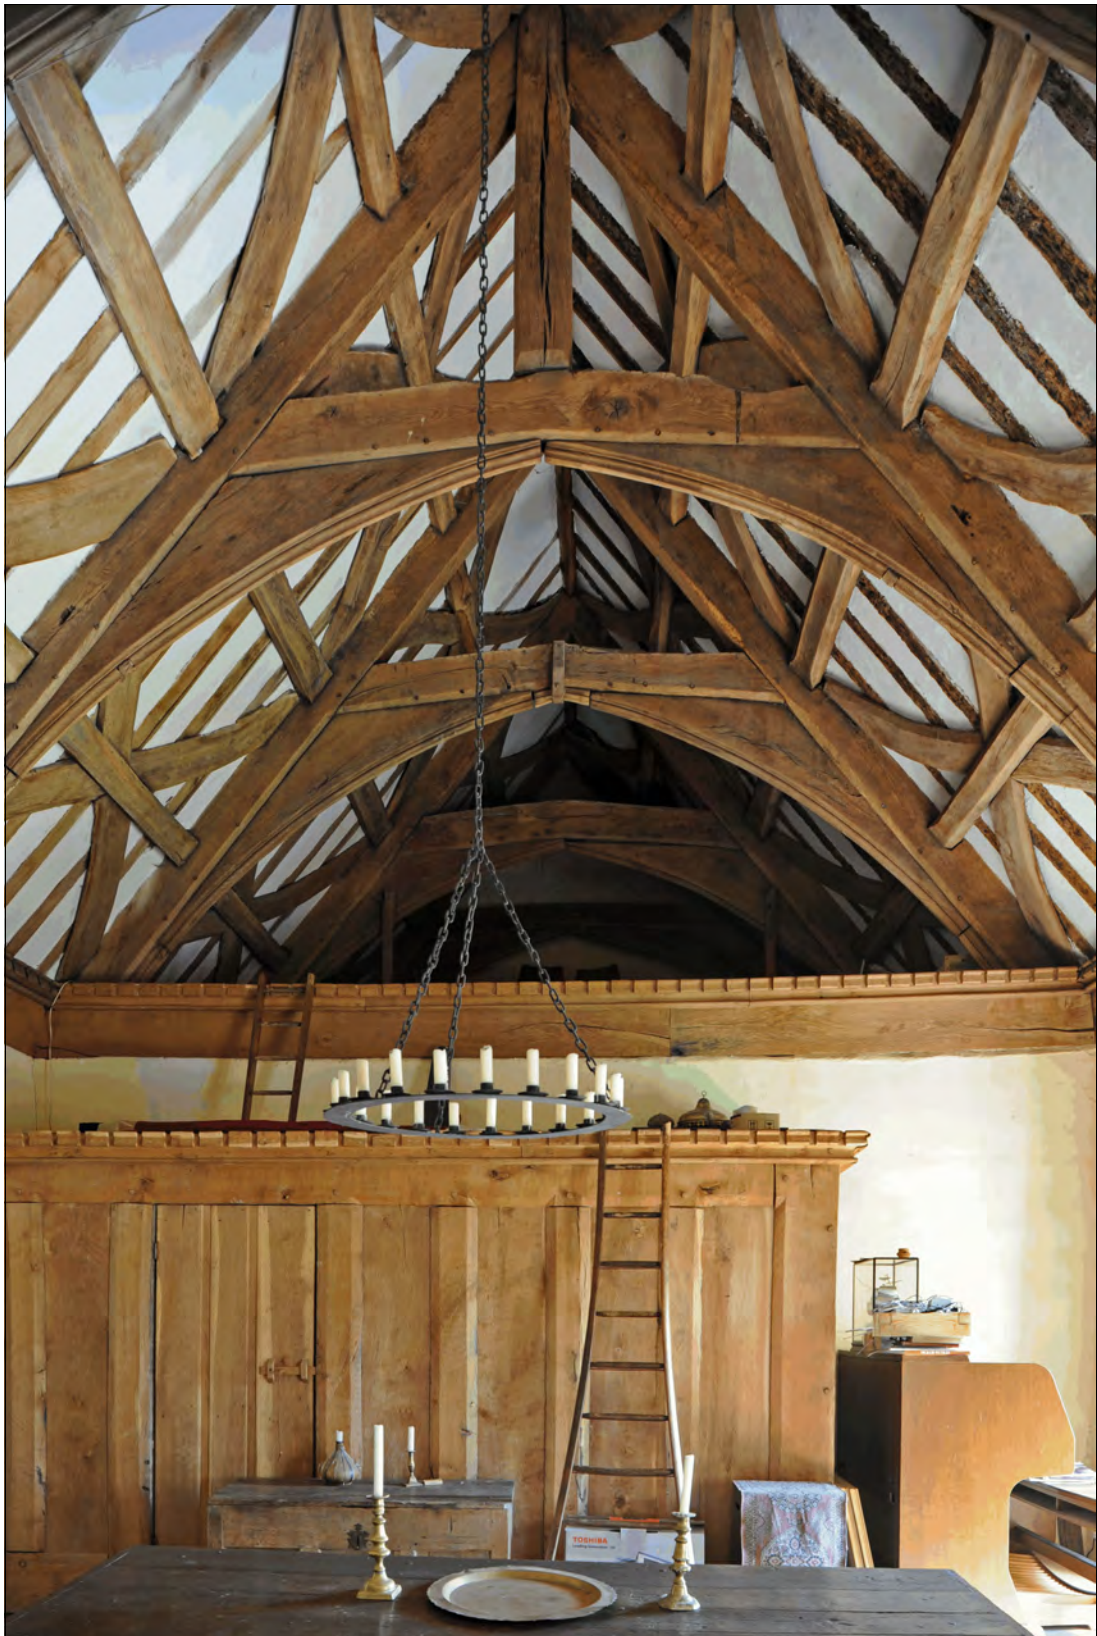
Interior of the divided fifteenth century hall, looking east

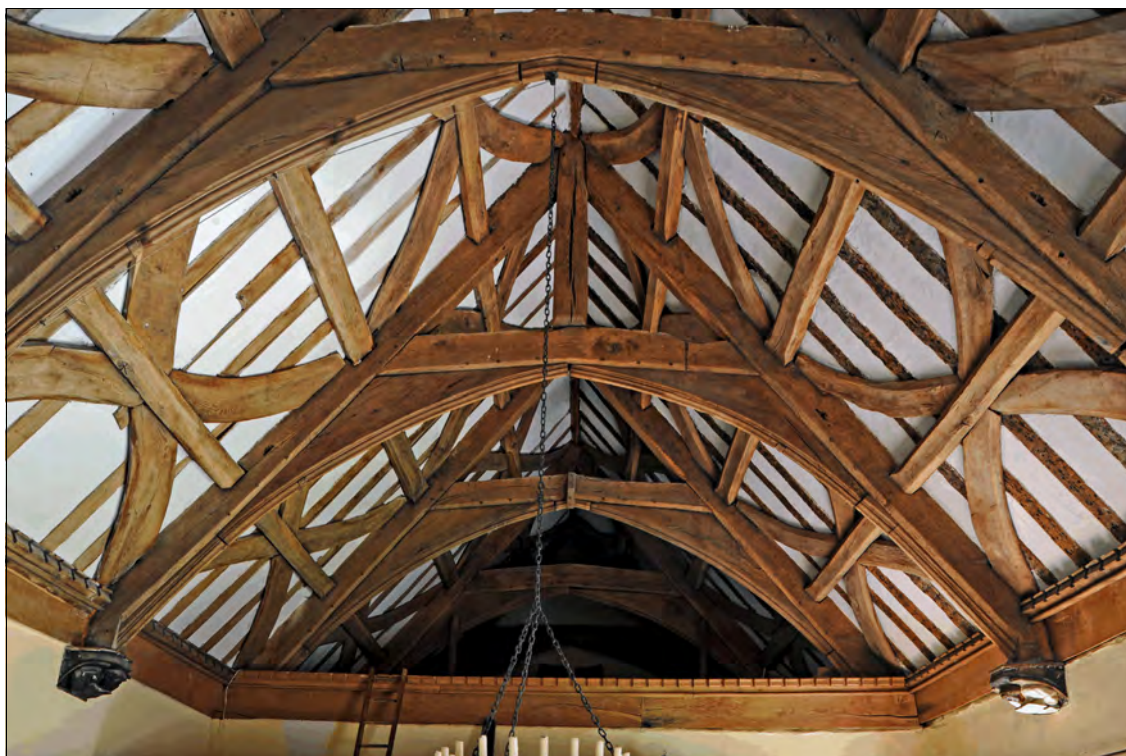
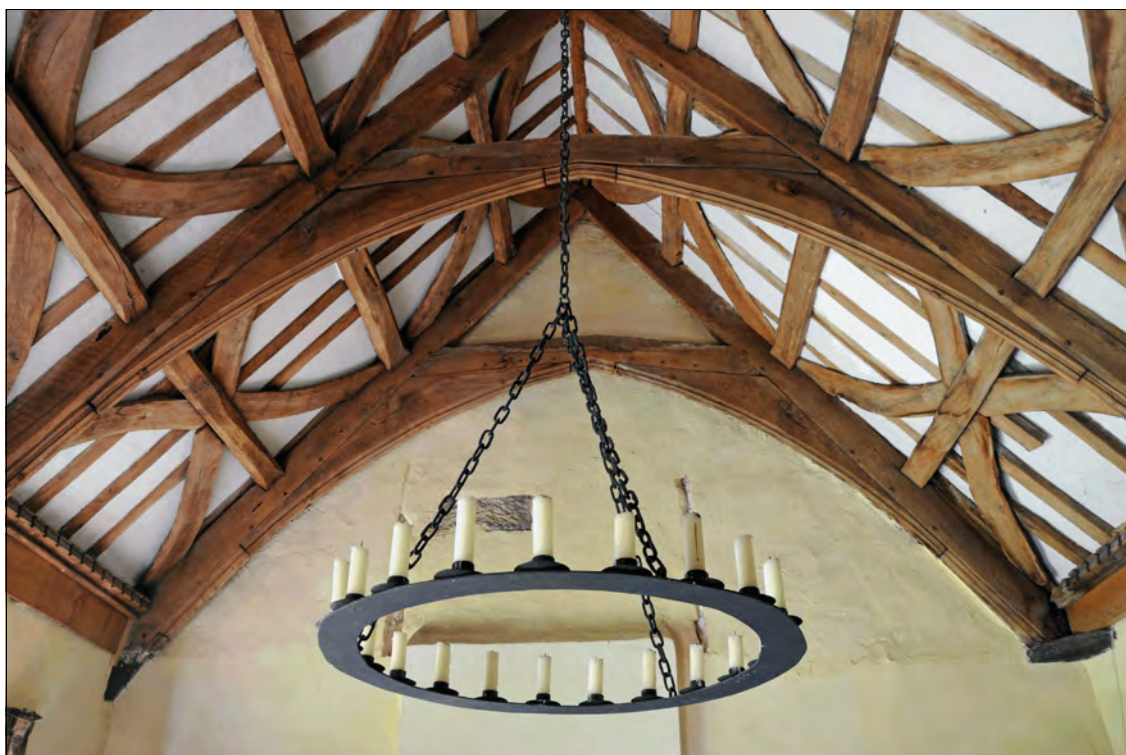
The fifteenth century hall roof looking east (top) and west (below)

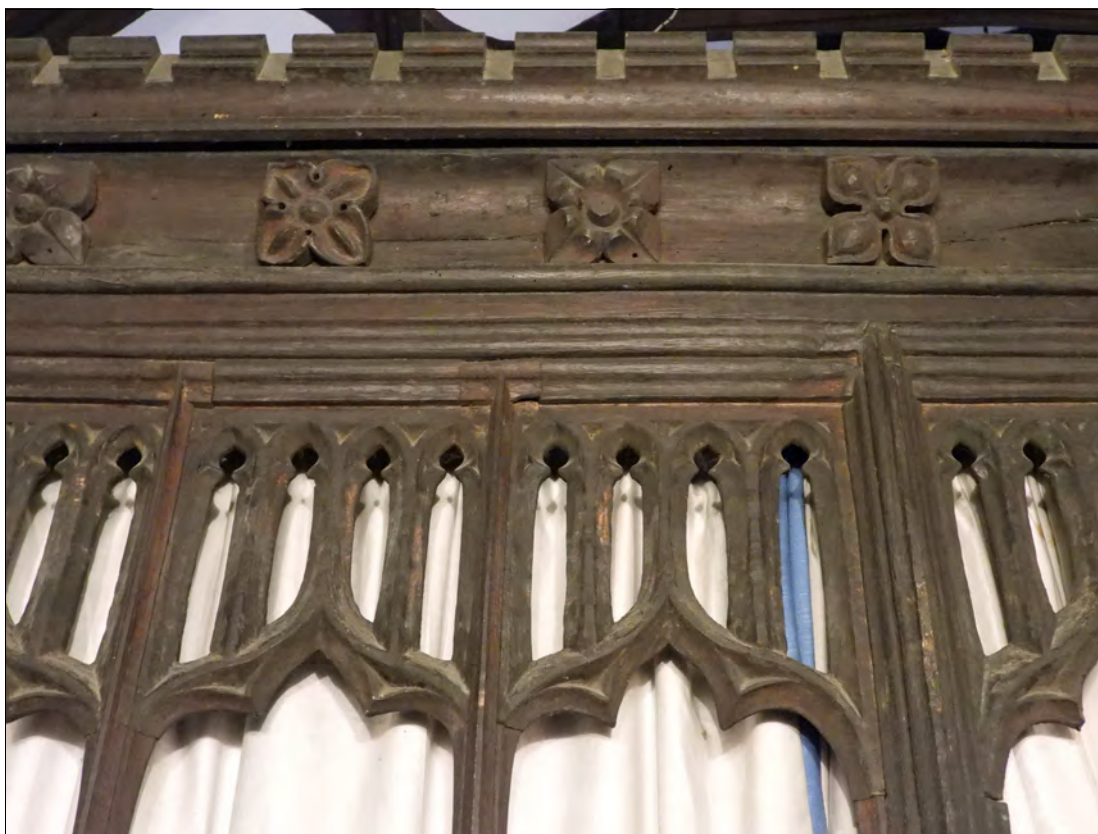
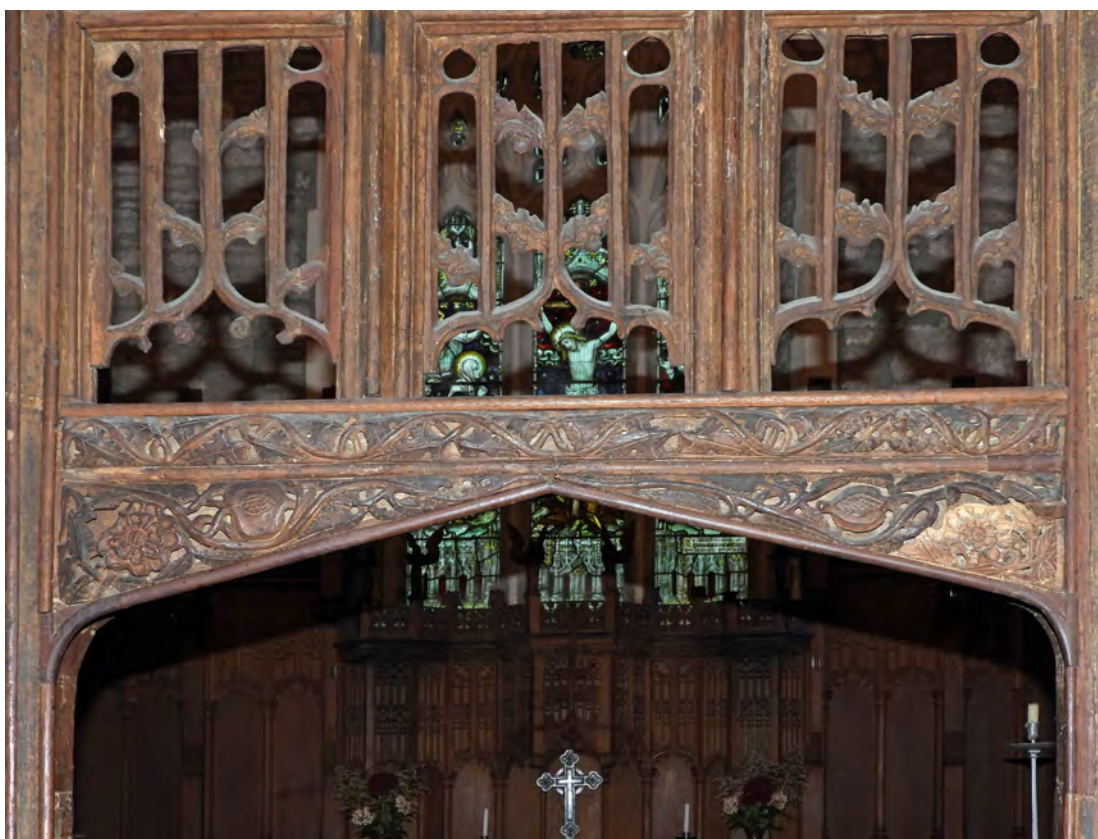
Tracery heads in the screen at Wells and at Loxton (below)

The standard work on west country screens, Bond and Camm (1911), does not mention the Almshouse chapel screen, but it would appear to belong to their 'North Somerset Group', although in a very simple form. The developed designs of the North Somerset Group (**) have simple square tracery heads which consist of four parallel openings defined by a central vertical canopy head, usually with foliate crockets and a five-cusped arch head, with parallel rising mullions. At Wells, however, the canopy head is only three-cusped, and lacks crockets: this suggests Loxton as the closest parallel, although here the canopy is five cusped with crockets. The screen at Loxton bears pomegranates and Tudor roses, suggesting a date after 1508, while it seems likely that the simplicity of the Wells screen may be the result of an early date in the 1430s.

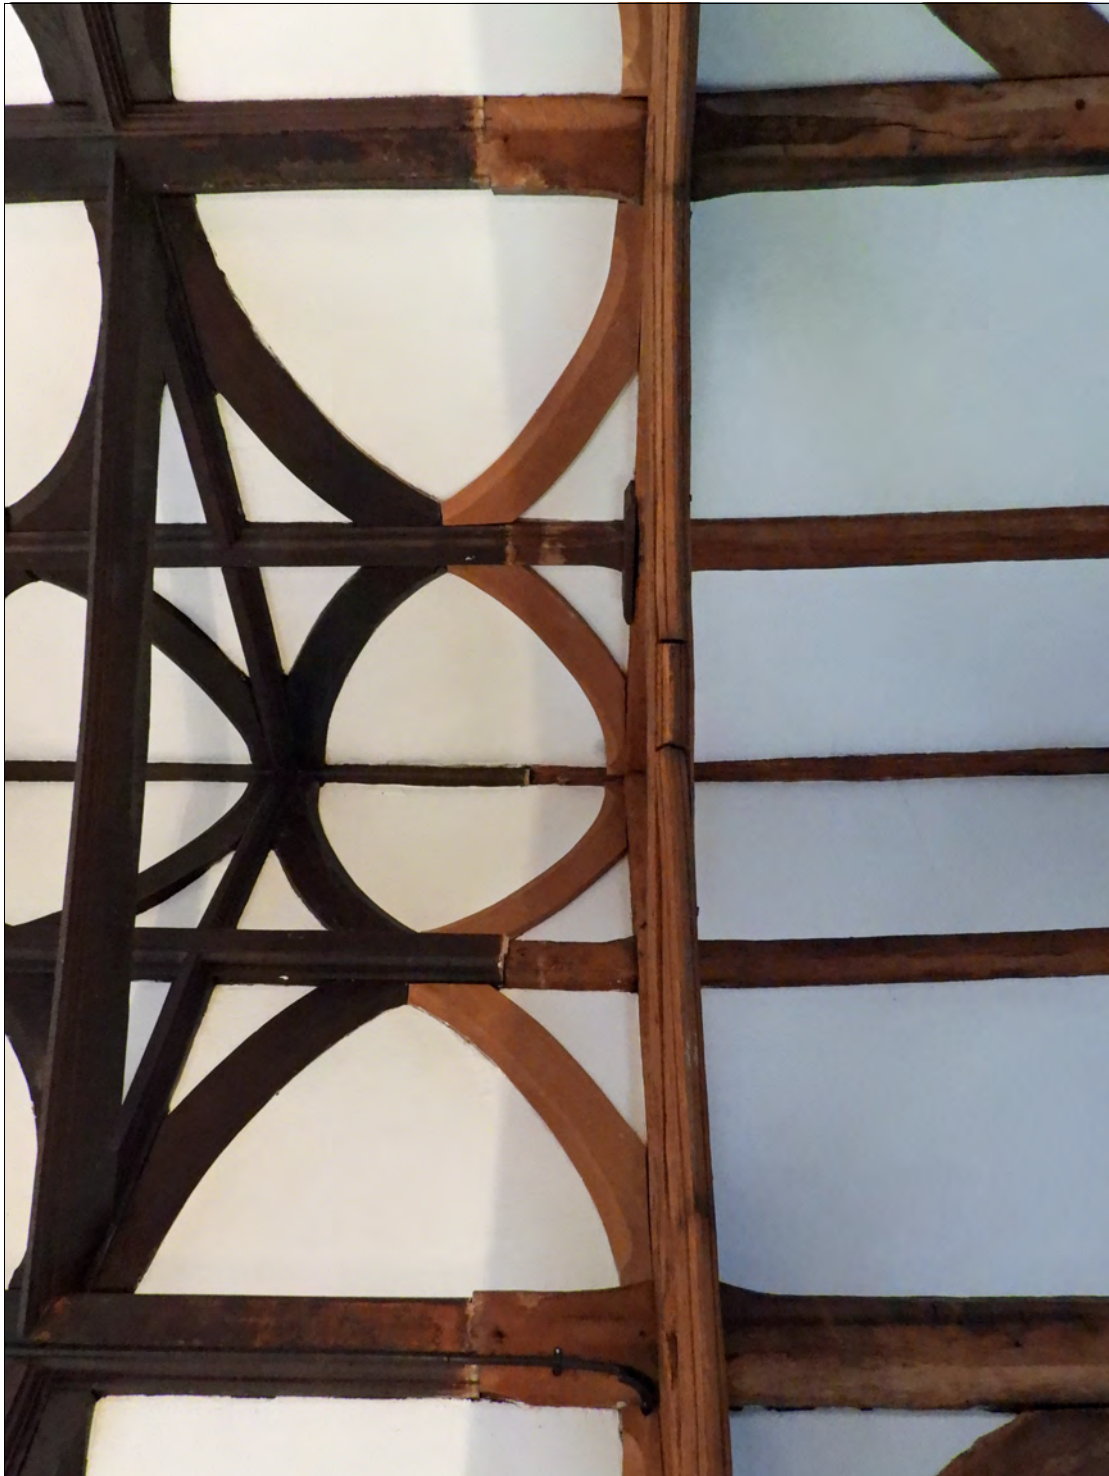
Repairs following the removal of the 1850 cross wall dividing the chapel from the accommodation to the west, showing as paler timber.
