## **PROPOSED NORTH ELEVATION**

## **PROPOSED SOUTH ELEVATION**

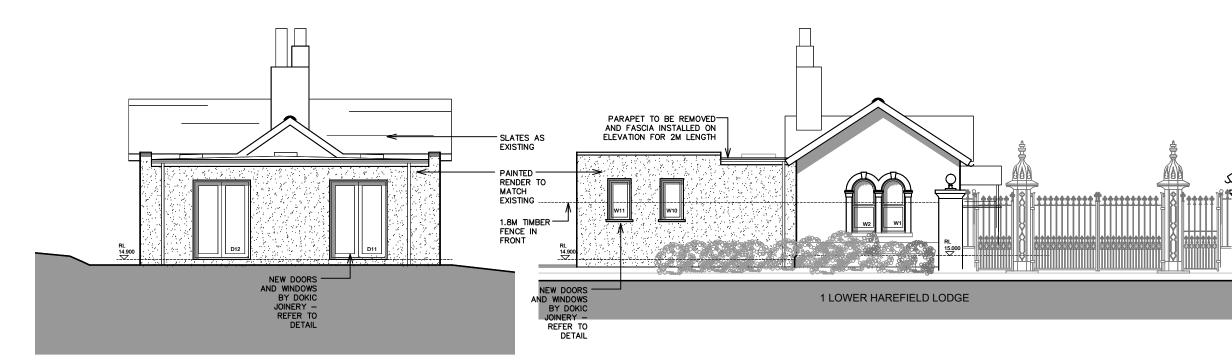
## **PROPOSED WEST ELEVATION**

DURING THE WORKS MANY OF THE TIMBERS IN THE ORIGINAL HOUSE HAVE BEEN FOUND TO BE ROTTEN. THESE TIMBERS ARE TO BE REPLACED WITH MATCHING TIMBERS AS REQUIRED. EXISTING SLATES ARE TO BE REPLACED WITH CORDAL PLYENDALE SLATES

## CHIMNEY B REPLACED WITH ONE TO MATCH A CEDRAL RIVENDALE SLATES SLATES AS EXISTING JUBILEE GROVE FIELD PAINTED RENDER-AS EXISTING \*\*\*\*\*\* RL 15.000 15.000 **Dec**cos NEW PAINTED METAL GATE TO MATCH STYLE OF EXISTING FENCE **PROPOSED EAST ELEVATION**

- THIS CHIMNEY POT IS TO BE EITHER REPLACED WITH ORIGINAL ONE FOUND ON SITE IF IT CAN BE REPARED OR

NEW/RECLAIMED TO MATCH EXISTING
