**SITE B,
GLASGOW BUSINESS PARK,
GLASGOW**

**PHASE I
COAL MINING
RISK ASSESSMENT**

Phase I Coal Mining Risk Assessment

Project Reference: PI7/478

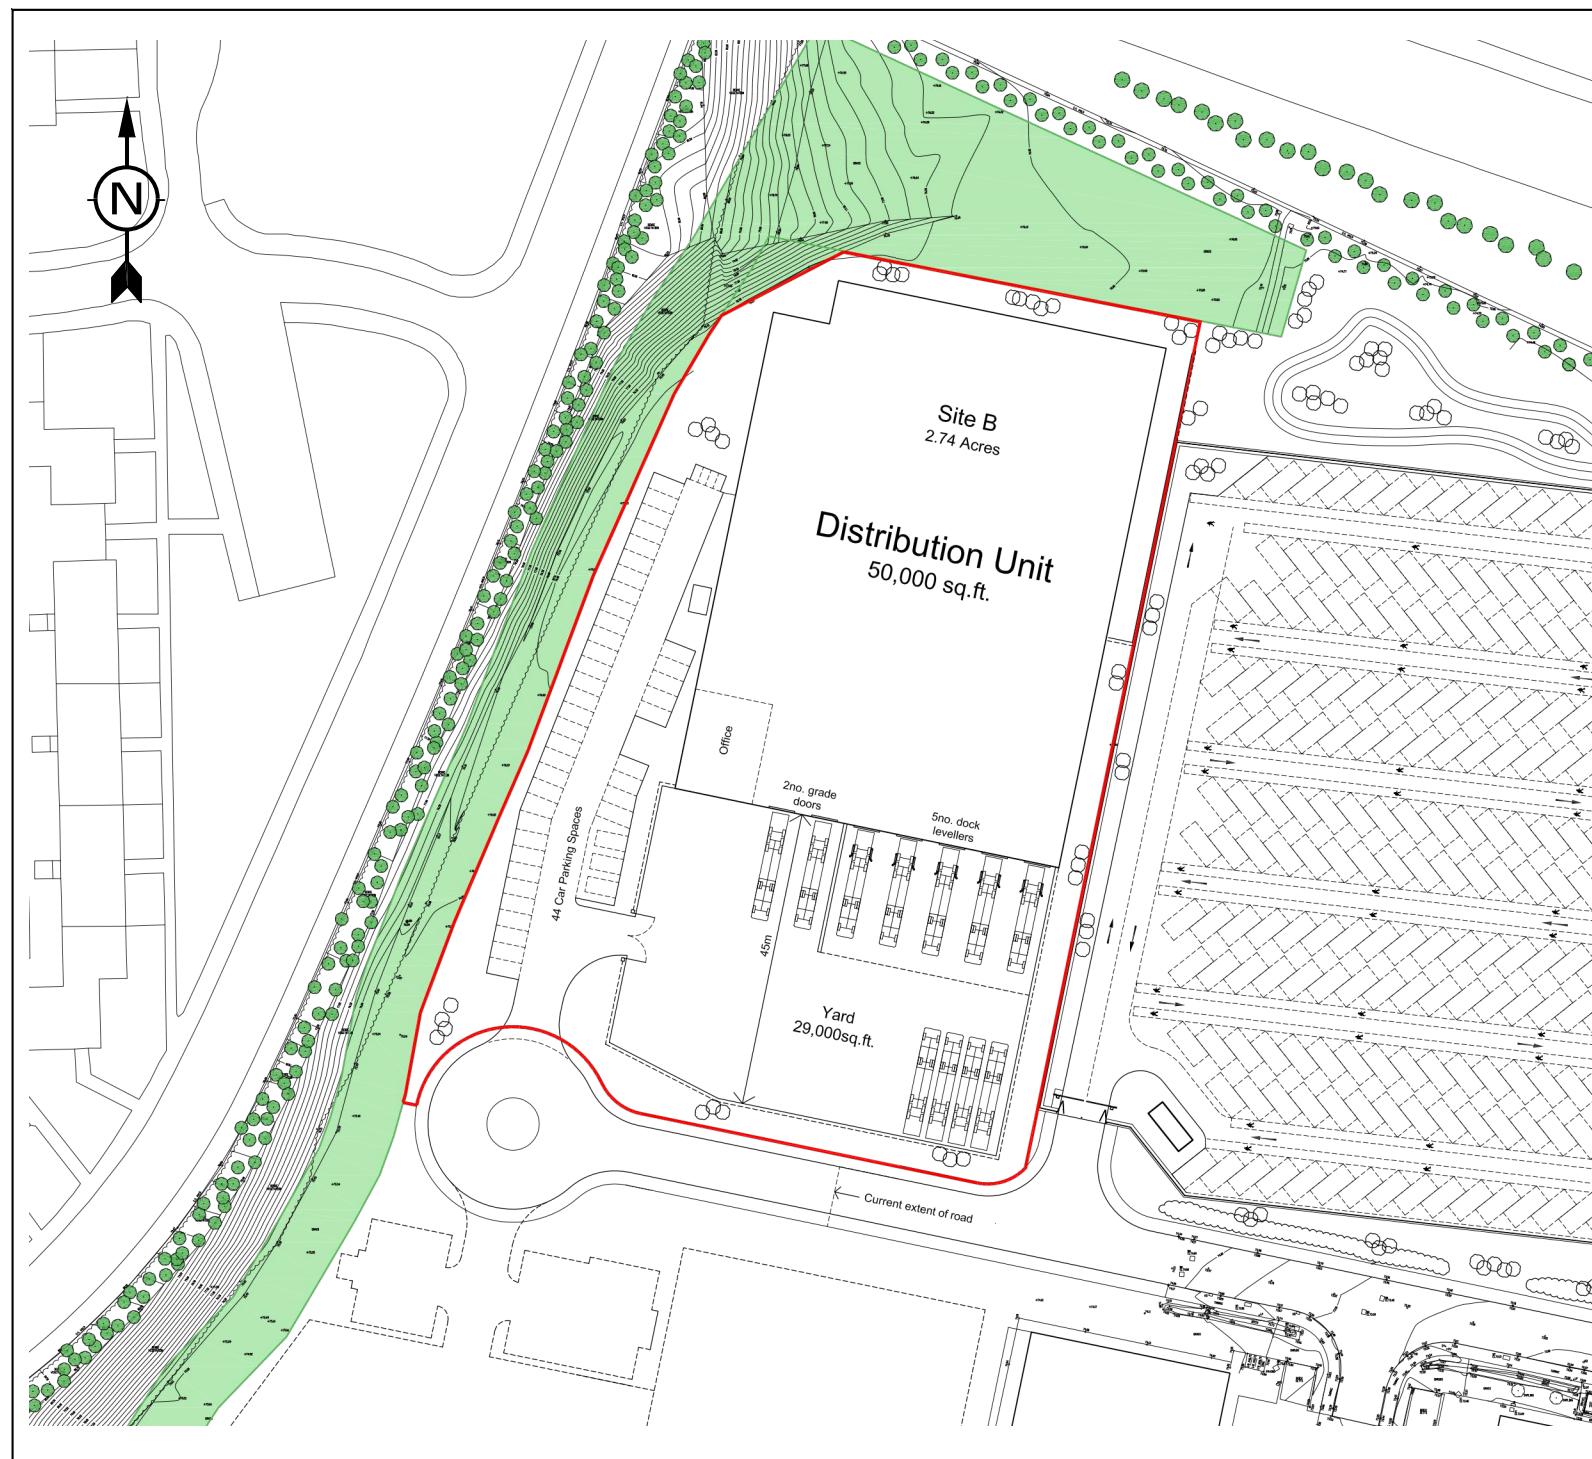
DRAWN BY RC	CHK'D BY SA	APP'D BY PB	DATE 12.04.21	SCALE Not to Scale
PROJECT No. P17/478	DRAWING No.	P17/478/(CMRA/R/F/02)		
		REVISION

PROPOSED DEVELOPMENT LAYOUT PLAN

- 1.1.1 We understand that Hermiston Securities (the Client) are proposing the development of a new commercial/industrial unit with associated areas of parking and road infrastructure at a site titled 'Site B, Glasgow Business Park, Glasgow' (refer to Drawing Nos. P17/478/CMRA/F/01 and 02). In relation to the proposed development, the Client has requested a Coal Mining Risk Assessment be undertaken in support of the development. As a specialist geo-environmental consultancy firm with experience of impacts related to shallow mine workings, we were subsequently requested to advise accordingly.

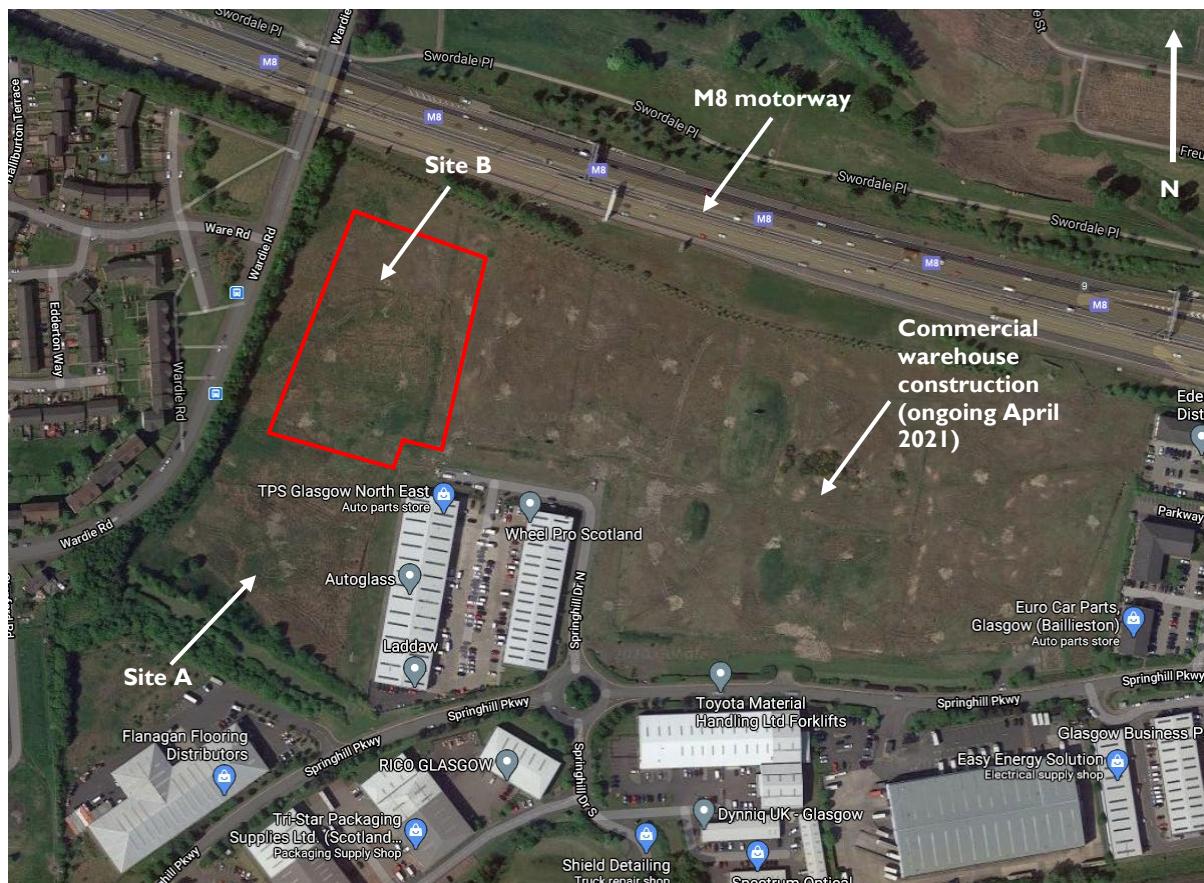
Plate 01 – Aerial Photograph of the Site (courtesy of Google Maps, approximately dated 2019)

2.2.1 The context of the site is indicated on Plate 01, which showed it to be bound by the M8 motorway to the north and commercial units to the south-east. Our recent walkover survey showed that the construction of a commercial warehouse was ongoing within the land to the immediate east. The main access route into the site was from Springhill Drive North located to the south, as shown below.
