**ALTERATIONS TO THE GARAGE AT  
THE OLD COACH HOUSE,  
EAST TISTED, HAMPSHIRE  
GU34 3QJ**

**Heritage Statement**

April 2021

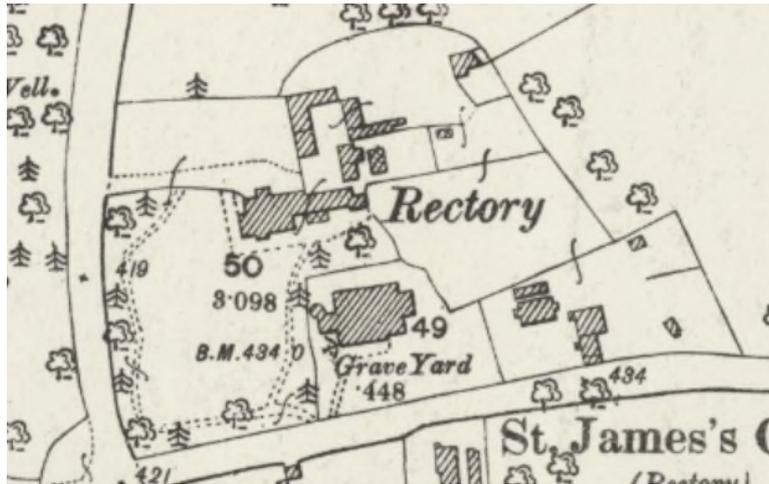
Figure 1  
Ordnance Survey  
2<sup>nd</sup> edition 25"  
map, 1872.

- 2.2 The earliest map consulted for this assessment was the Ordnance Survey 1<sup>st</sup> edition 25 inch map of 1871. The arrangement of the Rectory and its ancillary buildings shown in 1871 was unchanged on the 2<sup>nd</sup> edition 25 inch map of 1896 (Figure 1). These maps show the Rectory with an attached east range which formed the south side of a courtyard group of buildings including what is now the Old Coach House which then forms part of a L-plan range with a return wing at the north end of the east elevation forming the north side of the courtyard. The main north – south range is shown as divided into two parts with the smaller, south part representing the cottage. To the east side of the yard were two smaller detached buildings. There had been no evident change to this group up to the 1970s (1972-6 1:2500 map).

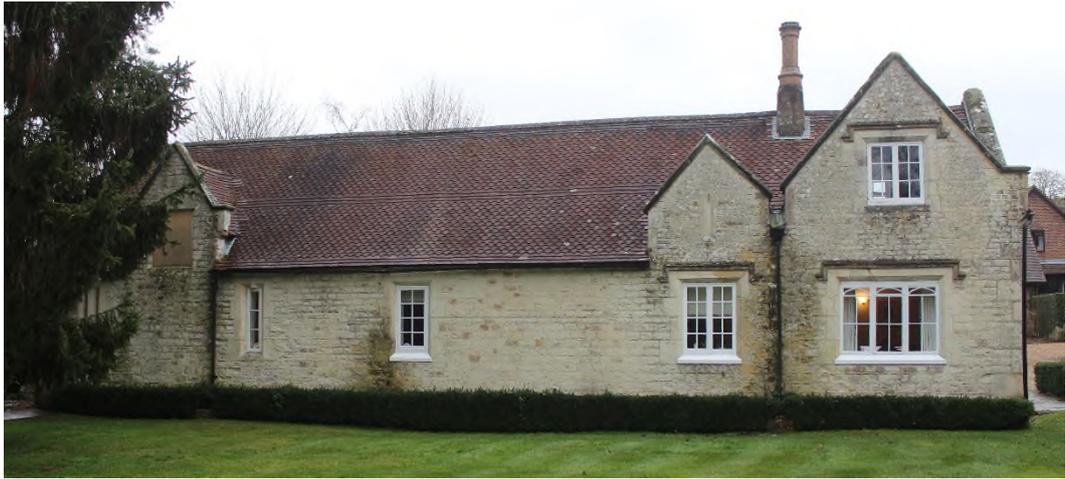
Figure 2 West elevation of the Old Coach House.

5.5 The west elevation of the building, which would have originally been most prominent when approaching the former rectory from the road, has been subject to relatively little change but

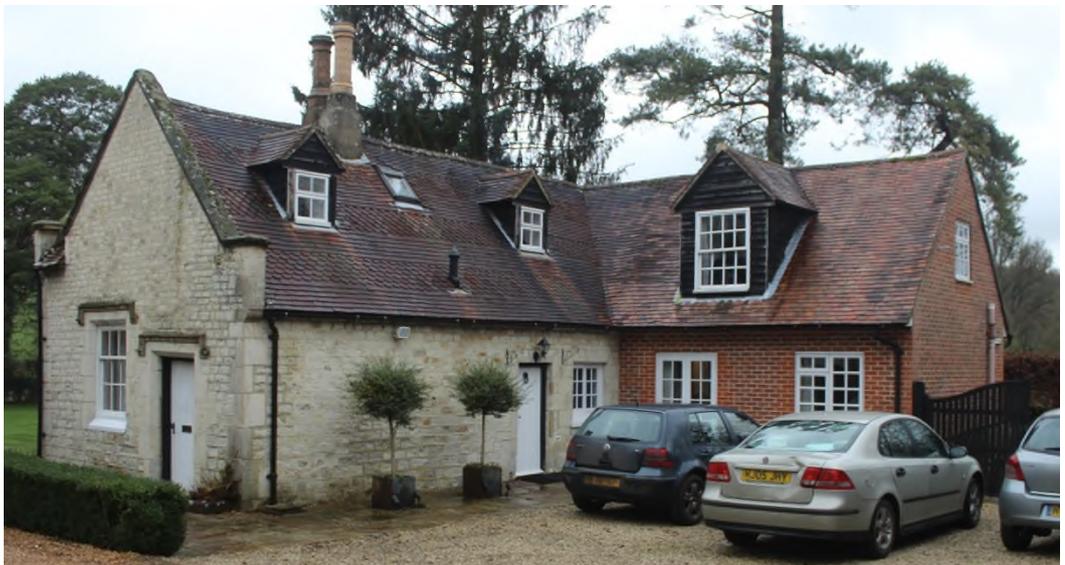
Figure 3 The Old Coach House, south part of the east elevation and the modern brick extension viewed from the south-east.

- 3.2 The east elevation of the original element has a 1½ storey brick addition extending from the centre of the range (Figure 3). To the south of this addition the east elevation has a door and a two-light casement at ground floor level and two small dormer windows to the roof slope. The original entrance to the cottage element is in the south elevation, the door and the adjacent sash window having heard moulds with labels. To the north of the brick extension the earlier element has a wide door and two modern two-light casement windows (Figure 4). There is also a relatively large dormer to the roof slope.

- 3.3 The brick extension is a late 20<sup>th</sup> century addition laid in red stretcher bond brick with a plain clay tile roof, gabled to the east and having the same ridge height as the main range (Figures 3 and 4). There is a large gabled dormer to the south slope of similar form to that on the east slope of the main range to the north of the extension and a lateral stack on the north side of the addition.

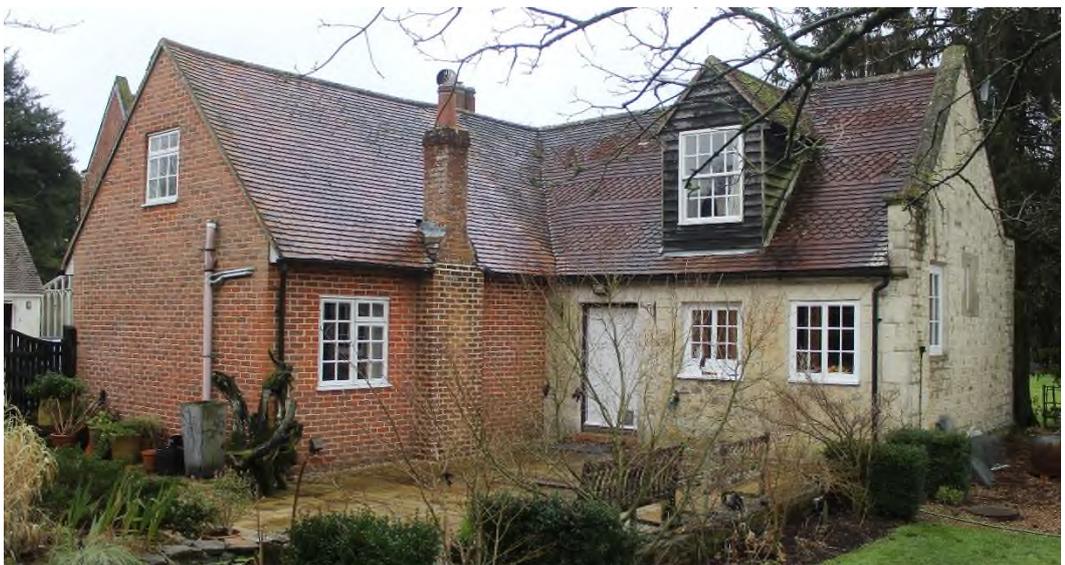
Figure 4 The north part of the east elevation and the north side of the brick extension. The garage

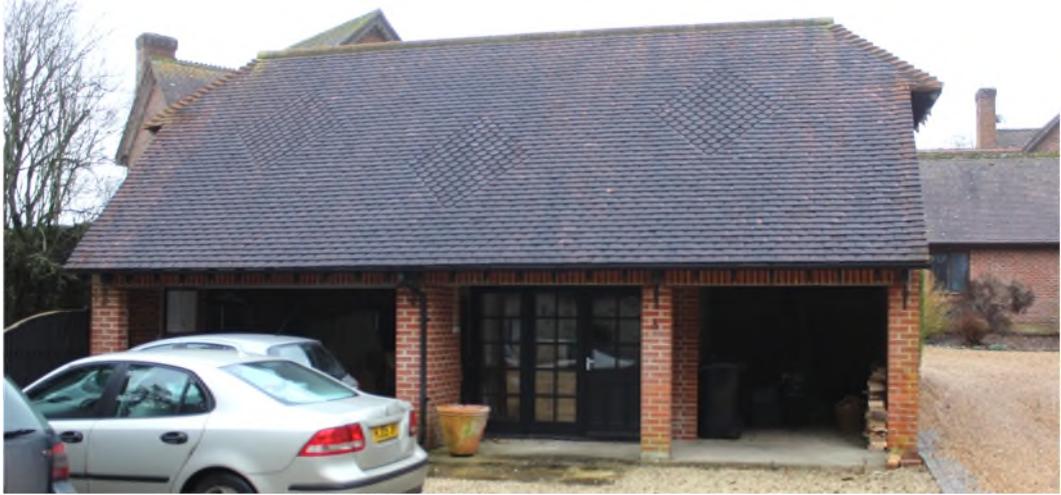
Figure 5 The modern garage associated with the Old Coach House.

- 3.5 Opposite the Old Coach House is a modern garage building constructed in brick with a dark clay tile half-hipped roof (Figure 5). The building has three bays to the ground floor with attic rooms that provide ancillary accommodation.

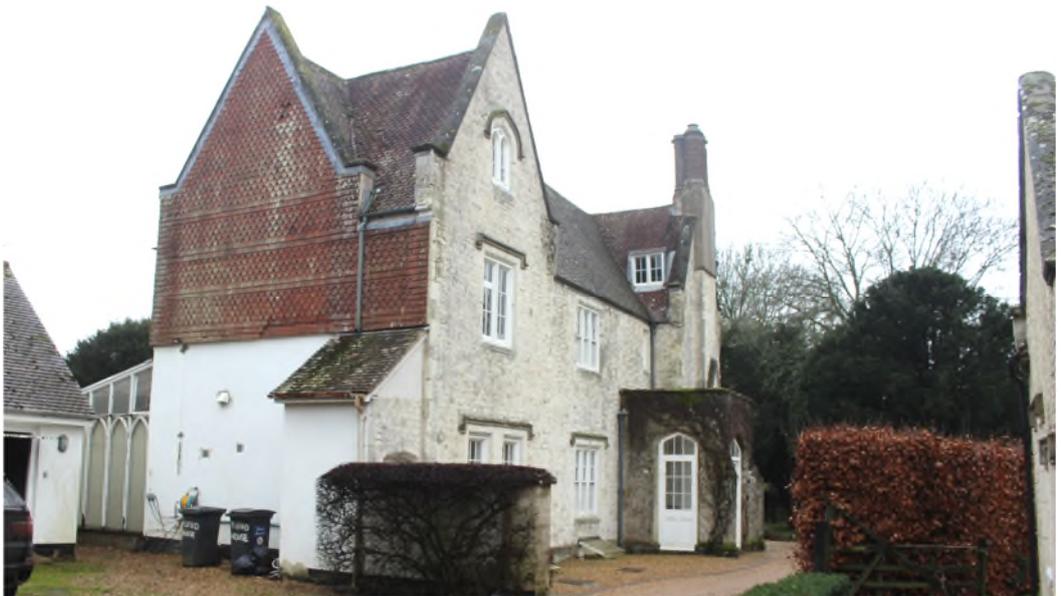
Figure 6 Tisted House with the south gable of the Old Coach House to the right hand edge of the picture.

- 3.6 The most significant aspect of the setting of the Old Coach House is its relationship with Tisted House, the former Rectory which stands across the drive from its former ancillary building (Figure 6). The service courtyard character that appears to have existed until the 1970s at least has been lost. Originally the drive from the A32 to the rectory was open on its north side, this area of lawn has now been planted with a tall hedge to provide the garden to the Old Coach House but which limits the ability to appreciate these two buildings together when entering the property.

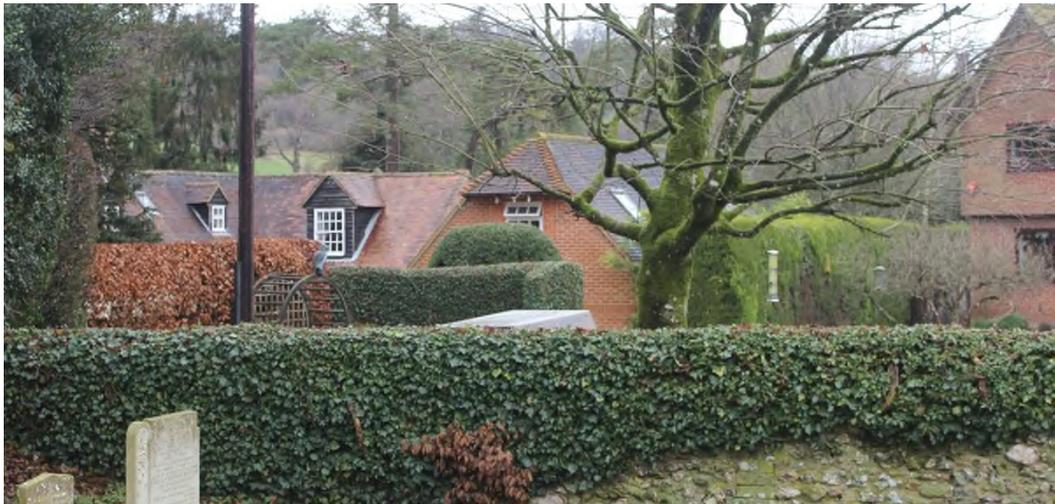
Figure 7 The view towards the Old Coach House from the churchyard. Only the roof of the house is visible with the garage partially obscuring the view to the modern extension.

- 3.7 Tisted House was built adjacent to the church, its grounds wrapping around the northern and western sides of the churchyard. Due to the hedge to the northern boundary in particular, there is little visual connection between the church and its former rectory and the Old Coach House can only be partly seen from the eastern part of the churchyard (Figure 7).
- 3.8 From the main road, A32, to the north of the village, there are limited views towards Tisted House and the Old Coach House (Figure 11). One of the modern red brick houses built within the grounds of the former, set on higher ground to the east of the Old Coach House is probably the most dominant element, together with the modern garage and the extension to the Old Coach House.

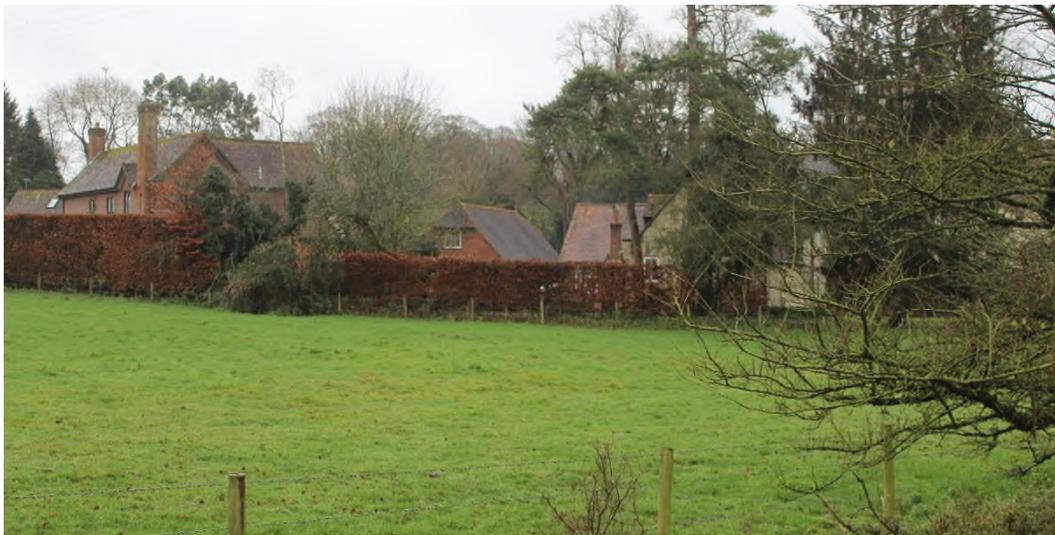
Figure 8 The view from the A32 to the north of the property. The modern extension and the roof of the garage are the main elements that are visible and there is limited visibility of Tisted House.
