Property Address	Blackwater	Sarnia	Two Burrows
		Truro	TR4 8HN
National Grid Reference		173633	46700
Client & Client Ref		TM Property	SP1-28185-1
Report Reference & Date		HM/CMS/128128	10 June 2019

# Mining Search: METALLIFEROUS MINERALS

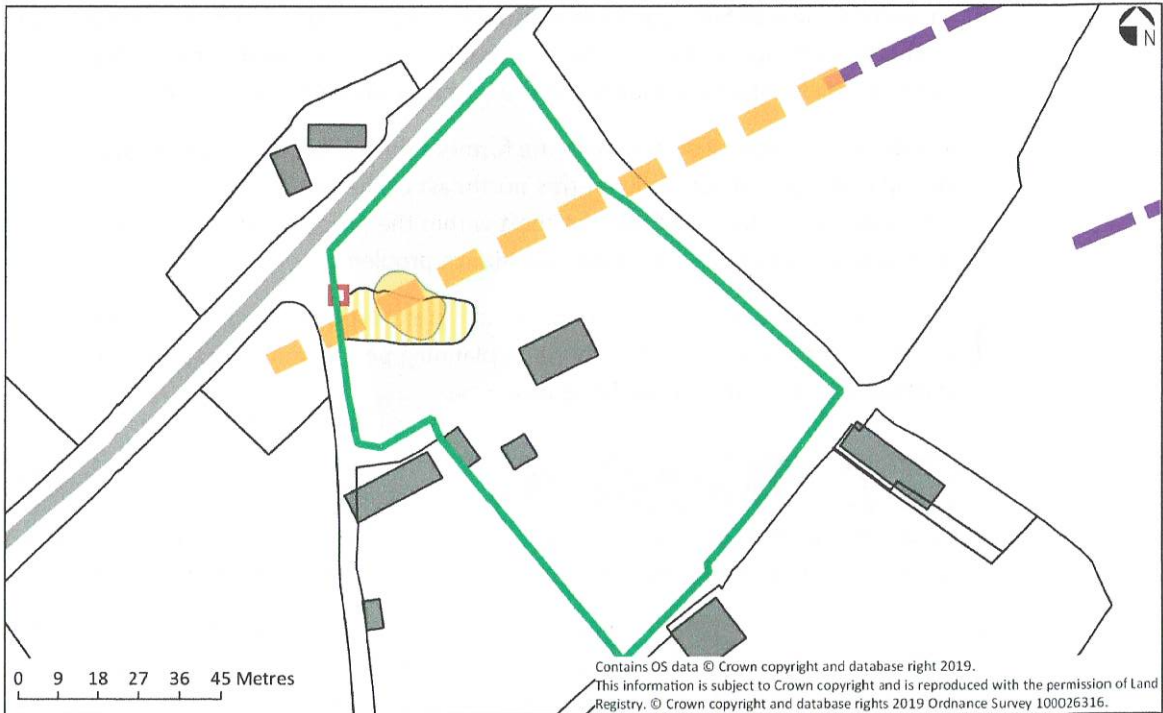
Our records indicate that a possible surface working associated with the former Prince Coburg Mine lies within the property, approximately located 10 metres northwest of the dwelling. This feature is recorded on an old Ordnance Survey map. It is also annotated as a quarry on an old mine plan. However, as this is on the mineral lode (deposit) alignment, we believe it is related to metalliferous mining. The Ordnance Survey map also shows a small enclosure that may indicate a mine shaft.

A mineral lode, also associated with the former Prince Coburg Mine, is recorded on a nineteenth century mining map approximately 50 metres northeast of the property. We believe this extends southwest to the suspected surface working and shaft within the property. Unrecorded mine workings may exist on lode outcrops and these can cause subsidence problems.

In the first instance a walkover survey should be undertaken by a mining consultant in order to provide assurances or recommend any further steps with consideration to the current/proposed site use. A site meeting at this time is advised. Further on-site investigation might be required to fully assess the risk to the garden areas.
