APPENDIX 1 – BOXFORD CEMETERY, STONE STREET ROAD, BOXFORD, CO10 5NP

To fell to ground x3 Sycamores (Trees 1, 2 & 3)

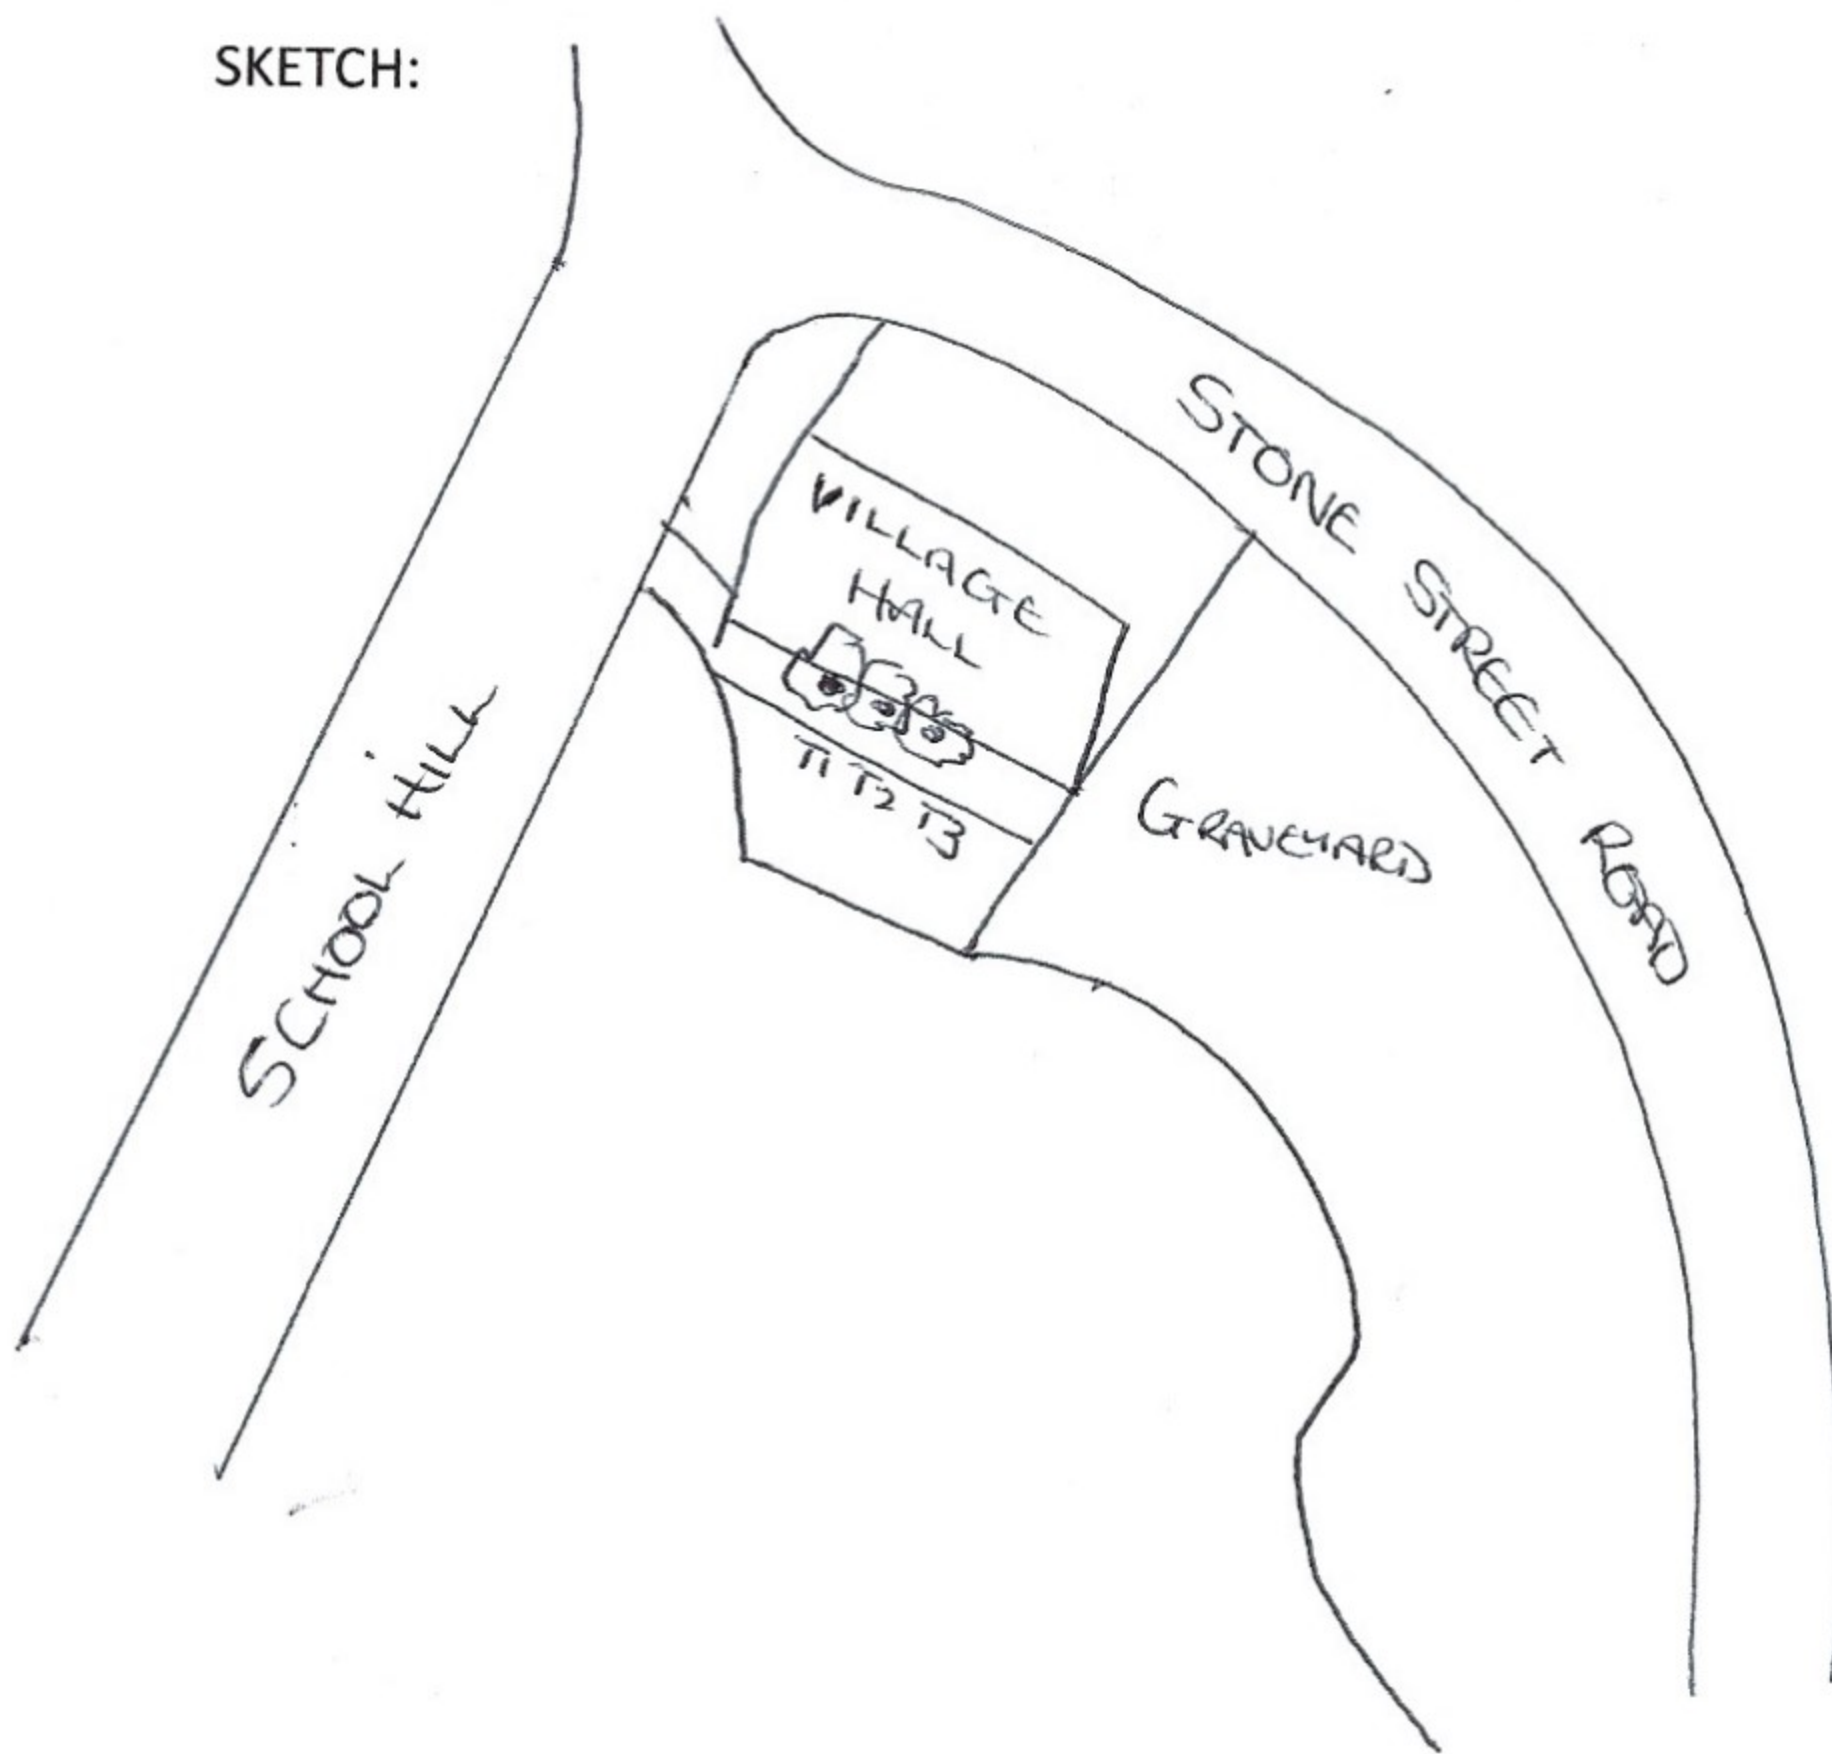
SKETCH:

The trees are growing very close to the rear of the Village Hall and the drains at the rear. They heavily overhang the Village Hall and they are interfering with both the drains and the roof. These trees are semi mature Sycamore trees, likely self seeded. They will if left increase in size three fold and will cause structural damage to the Village Hall. They are growing 1-1.5m from the rear wall of the Village Hall.
