Project **29 Champion Grove**

Drawing No. **2020/P/106**

Drawing **Proposed Rear Elevation** Revision

Purpose **FOR PLANNING**

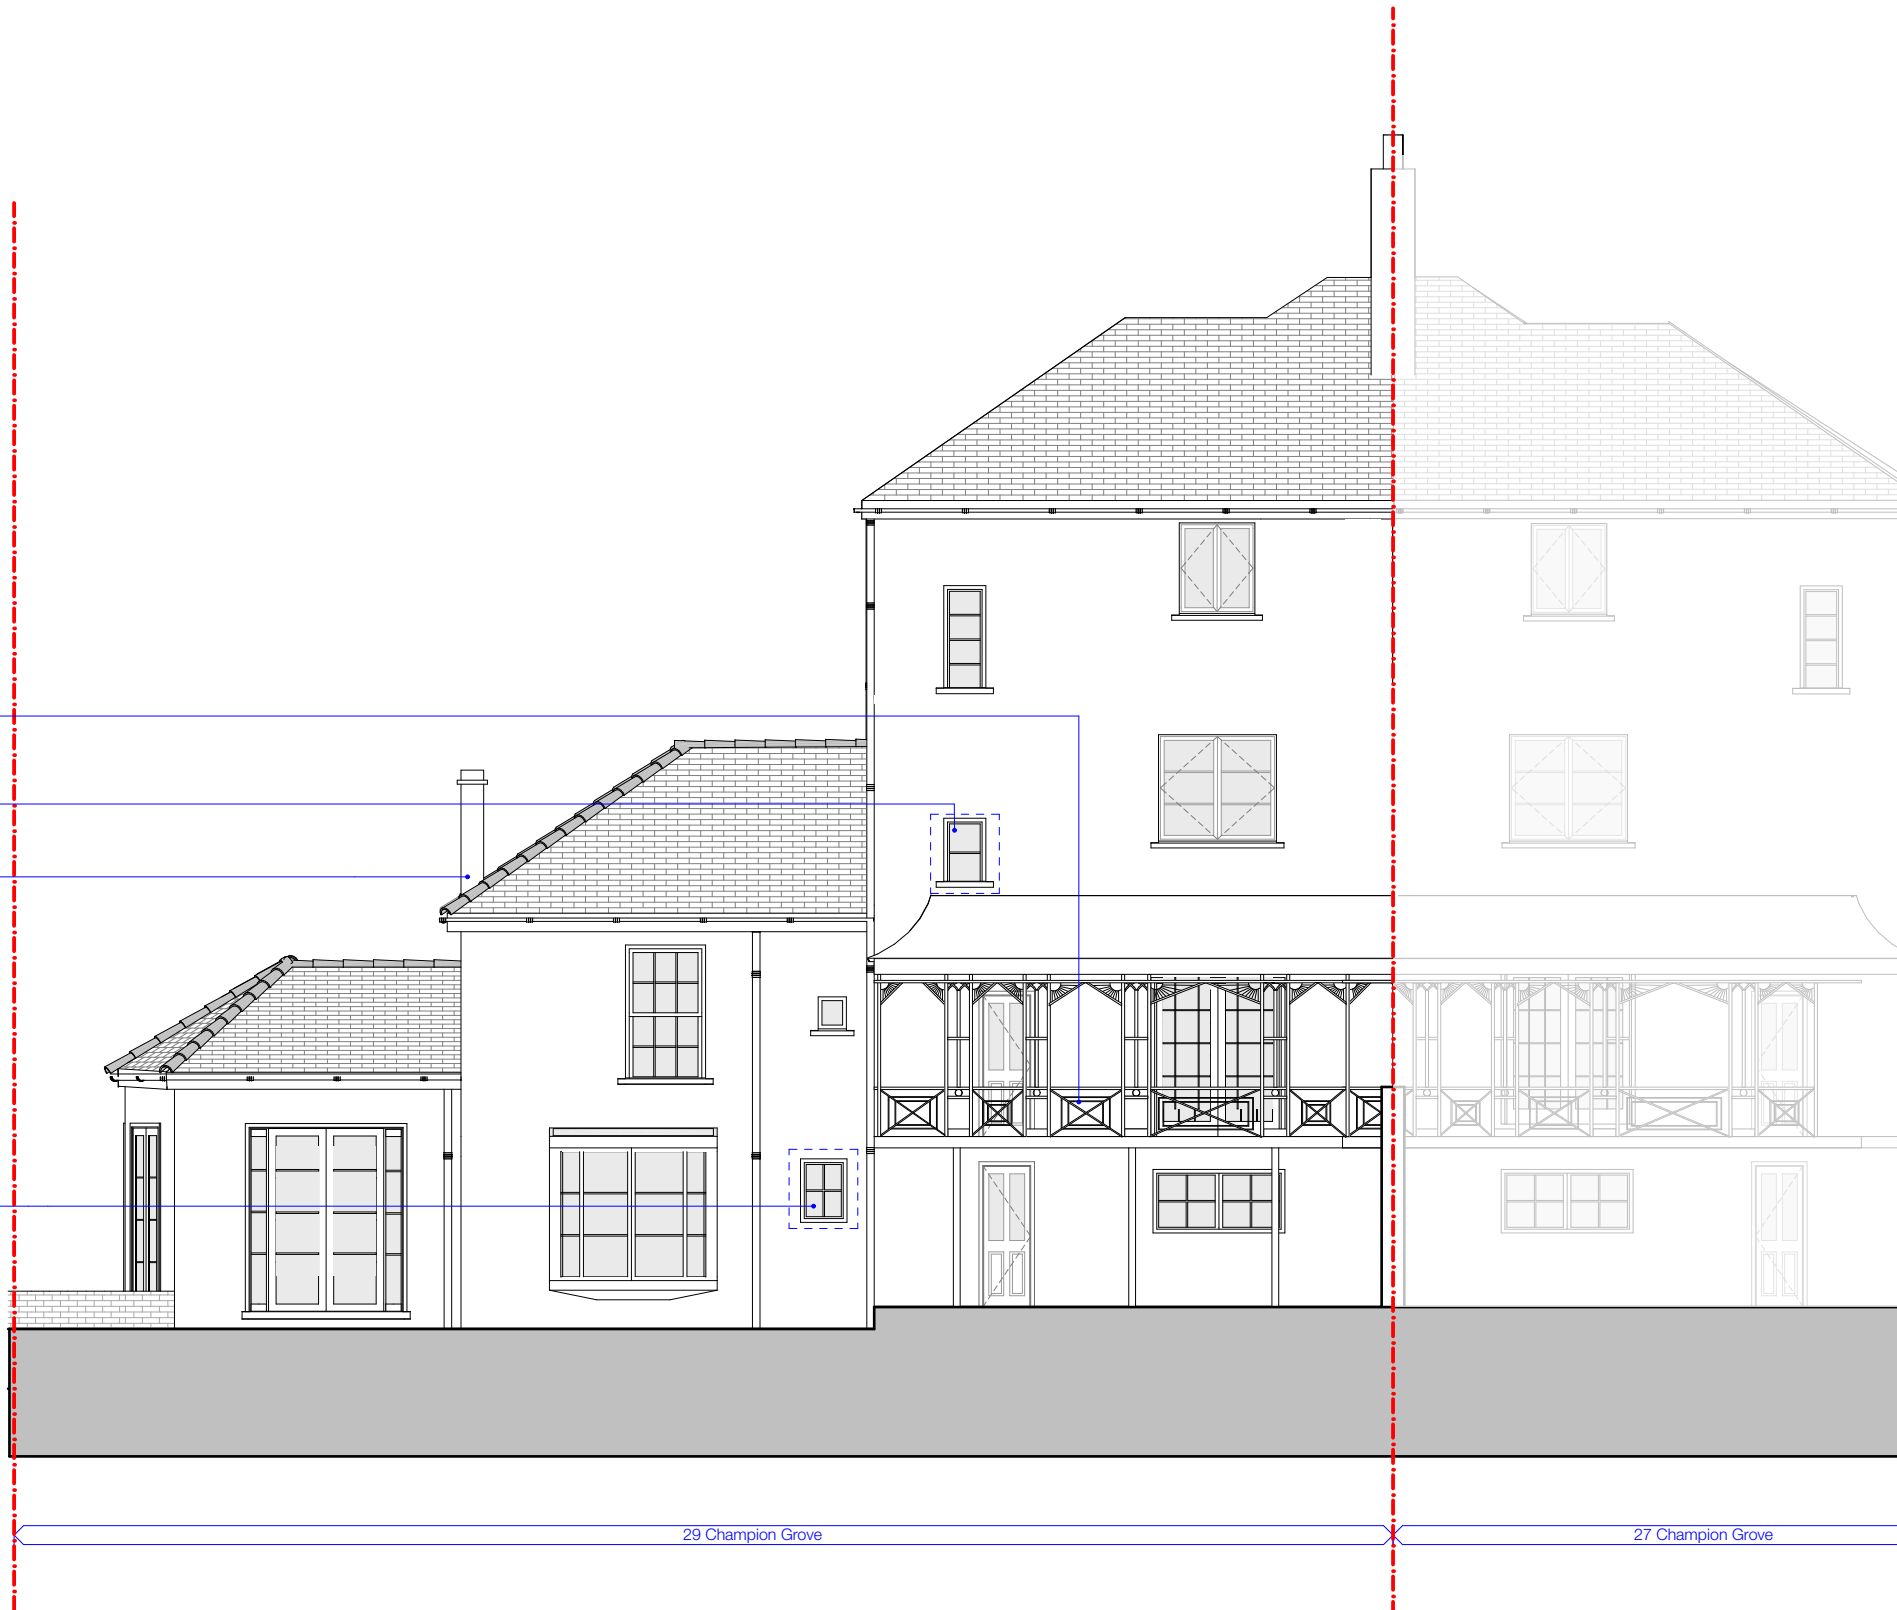
Decorative trellis and filigree detailing to external balcony to be repaired/restored in iron to replicate original detailing and restore period features for public benefit

New high-level window above stair half landing to match style of existing window above.

Existing chimney stack to remain externally

Existing window to be blocked-up internally. No change externally.
