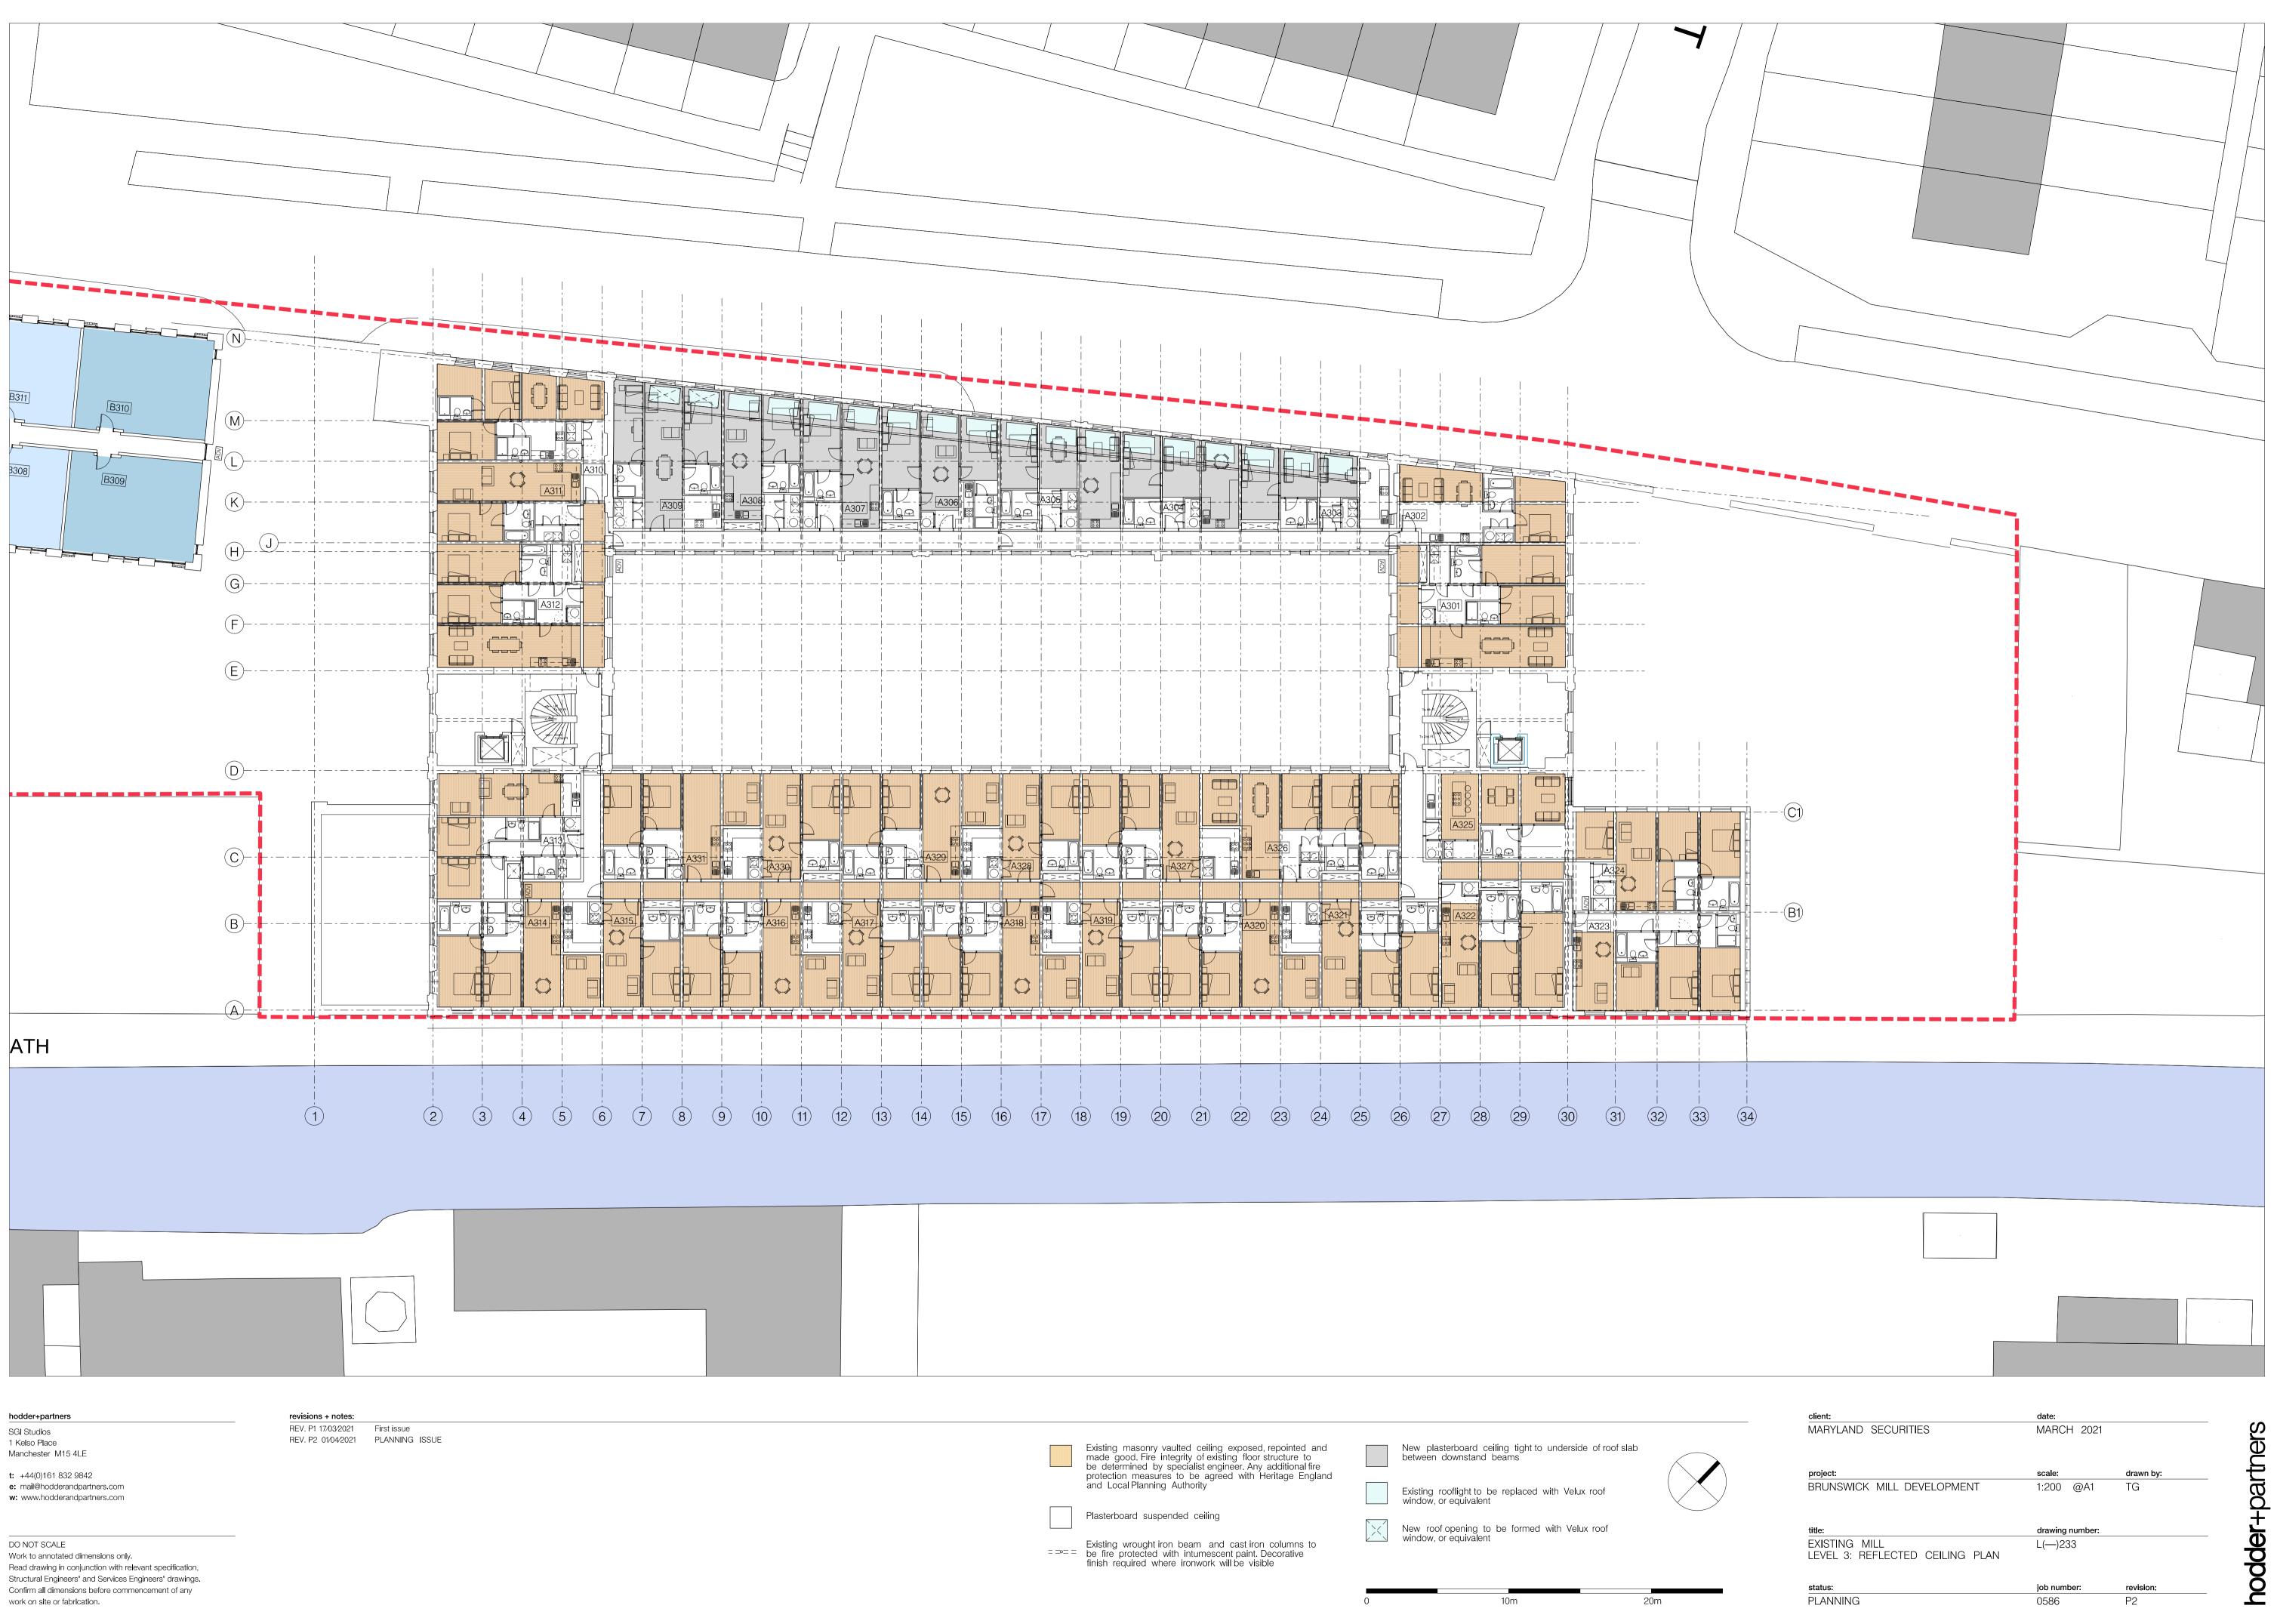
Existing masonry vaulted ceiling exposed, repointed and made good. Fire integrity of existing floor structure to be determined by specialist engineer. Any additional fire protection measures to be agreed with Heritage England and Local Planning Authority	New plasterboard ceiling tight to underside of roof slab between downstand beams Existing rooflight to be replaced with Velux roof	
 Plasterboard suspended ceiling Existing wrought iron beam and cast iron columns to be fire protected with intumescent paint. Decorative finish required where ironwork will be visible	window, or equivalent New roof opening to be formed with Velux roof window, or equivalent
