Status: **FOR COORDINATION**

Client: **SHENTON GROUP**

Project: **CUERDEN HALL**

Orig Title: **TYPICAL REPAIR DETAILS, MASONRY**

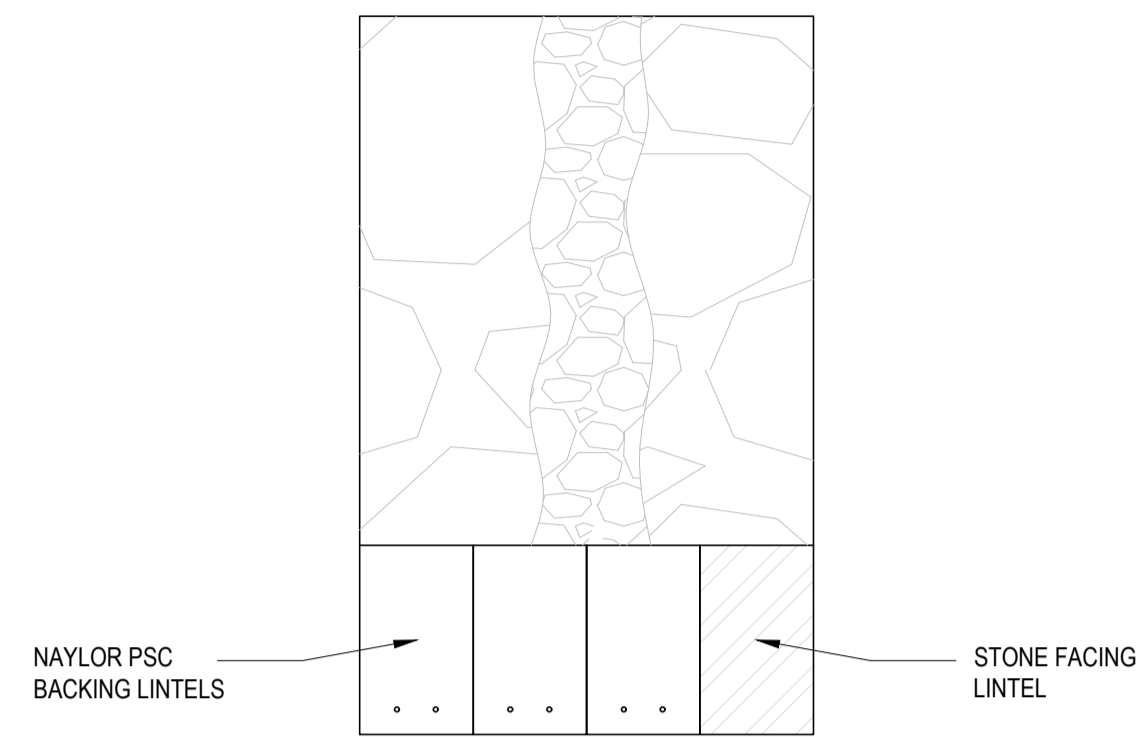
**DETAIL 06:**  
**REINFORCED CONCRETE LINTELS WITH STONE FACING**  
 SCALE 1:10

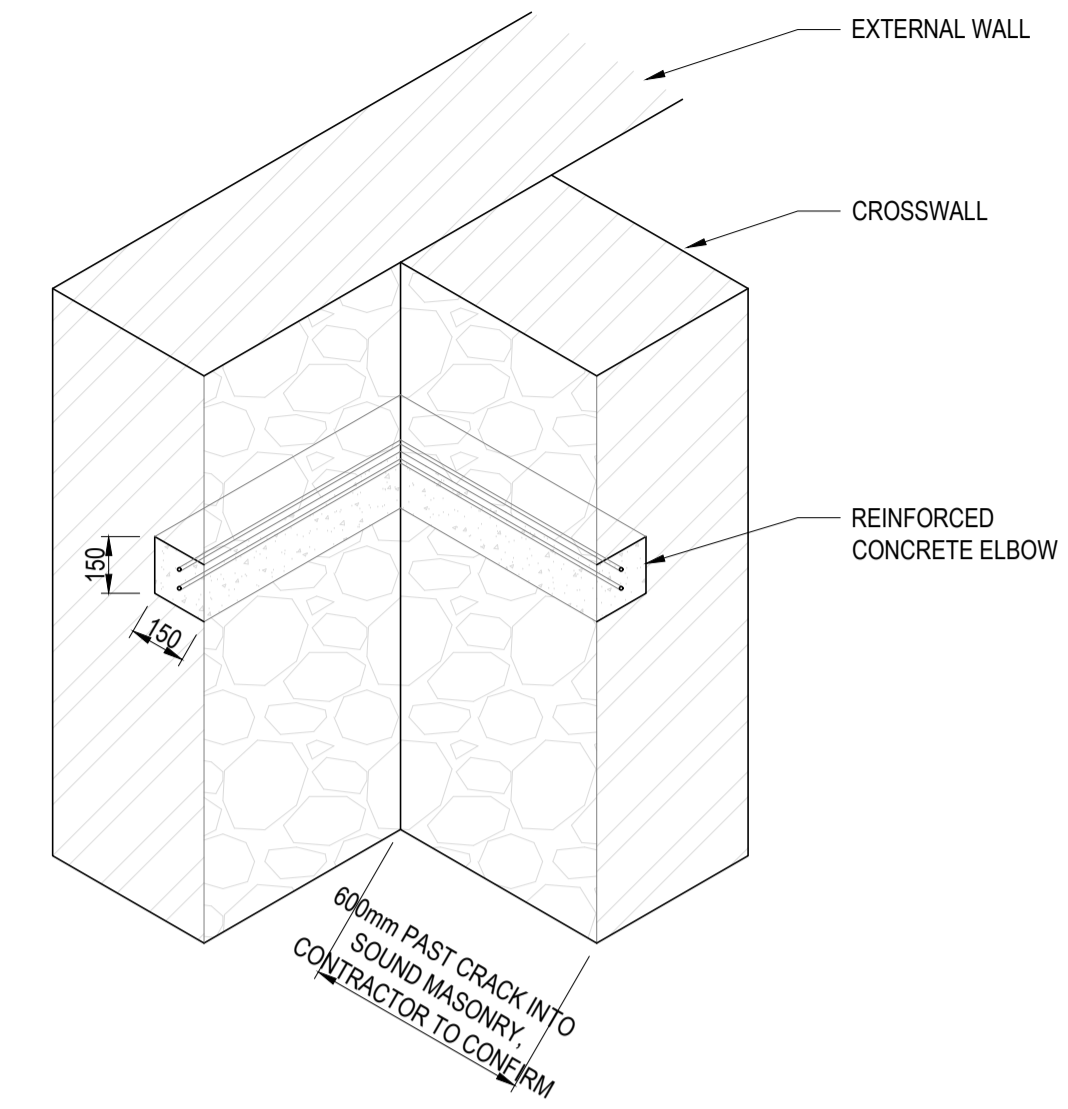
**DETAIL 09:**  
**TYPICAL ELBOW CROSSWALL BOND REPAIR**  
 SCALE 1:20
