PROJECT
 Cuerden Hall, Chorley

TITLE
 Roof Repairs

DRAWING NUMBER
 240729-PUR-00-RF-DR-A-2120

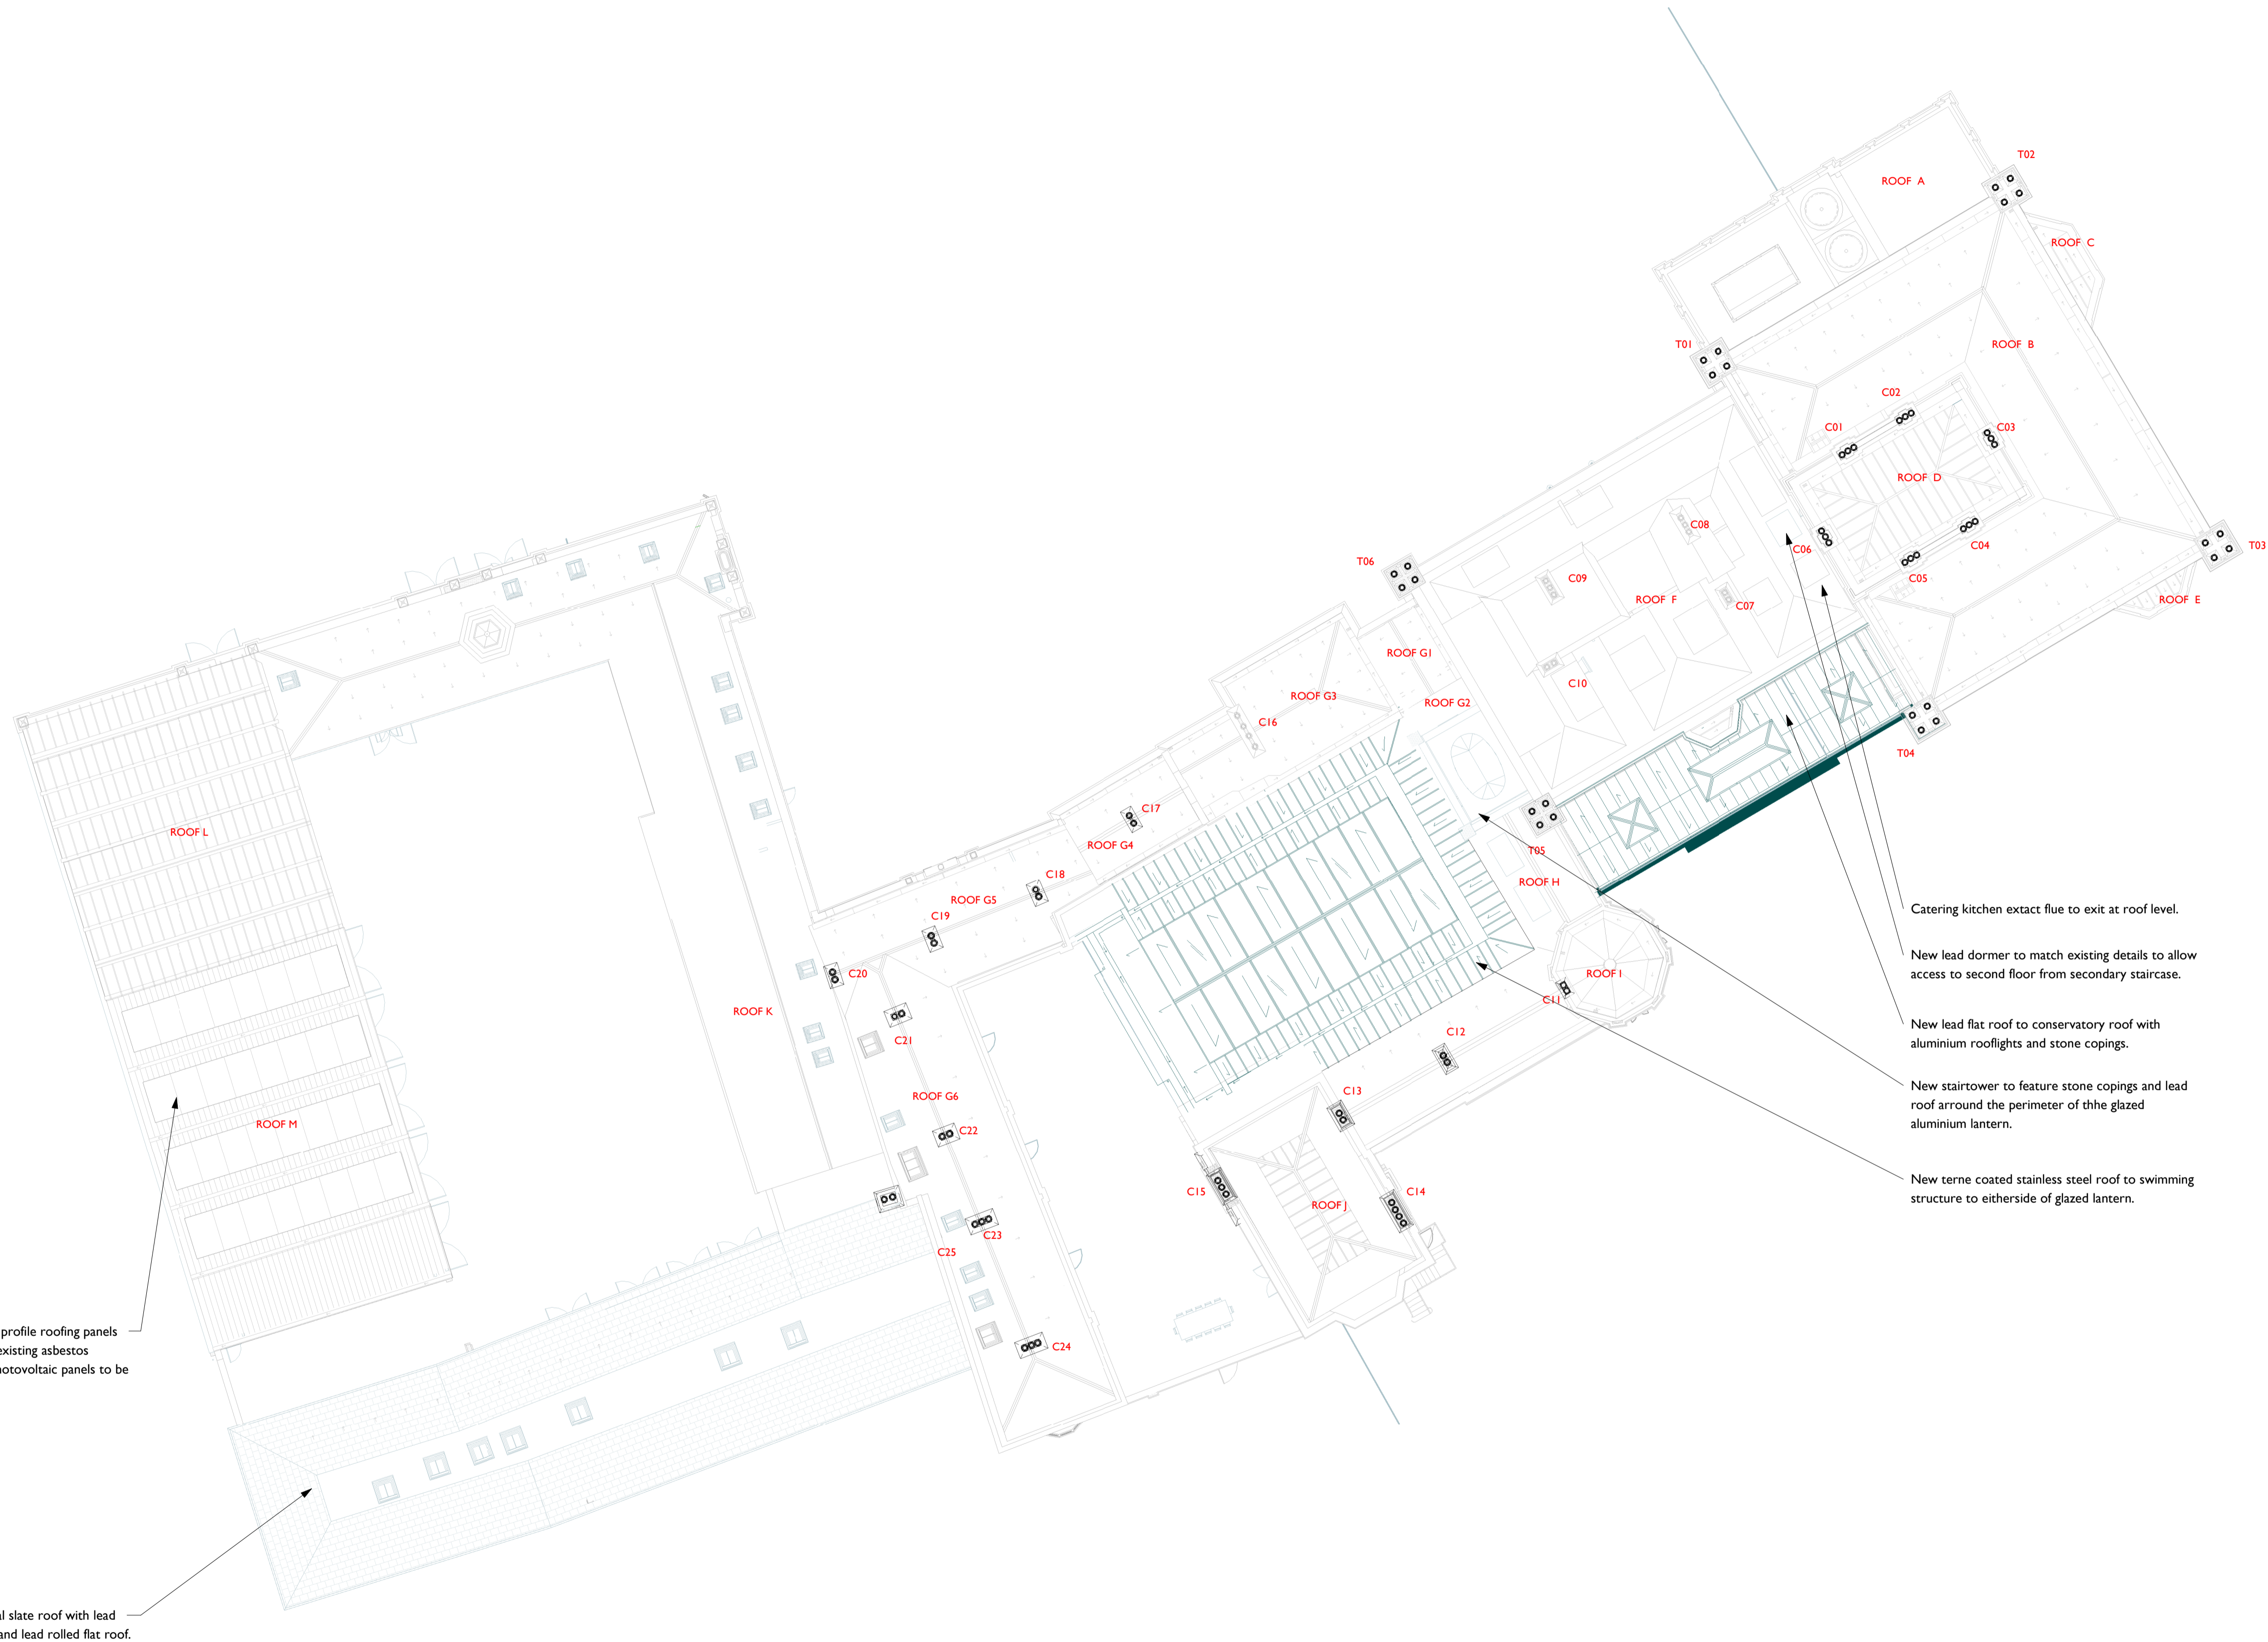
1 Roof Plan as Proposed with Repairs
 2120 1 : 200

New metal profile roofing panels to replace existing asbestos sheeting. Photovoltaic panels to be installed.

New natural slate roof with lead rolled hips and lead rolled flat roof.

- Catering kitchen extract flue to exit at roof level.
- New lead dormer to match existing details to allow access to second floor from secondary staircase.
- New lead flat roof to conservatory roof with aluminium rooflights and stone copings.
- New stairtower to feature stone copings and lead roof around the perimeter of the glazed aluminium lantern.
- New terre coated stainless steel roof to swimming structure to eitherside of glazed lantern.
