Cuerden Hall, Chorley

SUITABILITY/REASON FOR ISSUE P01 S04 - For Planning

240729-PUR-00-XX-DR-A-2003

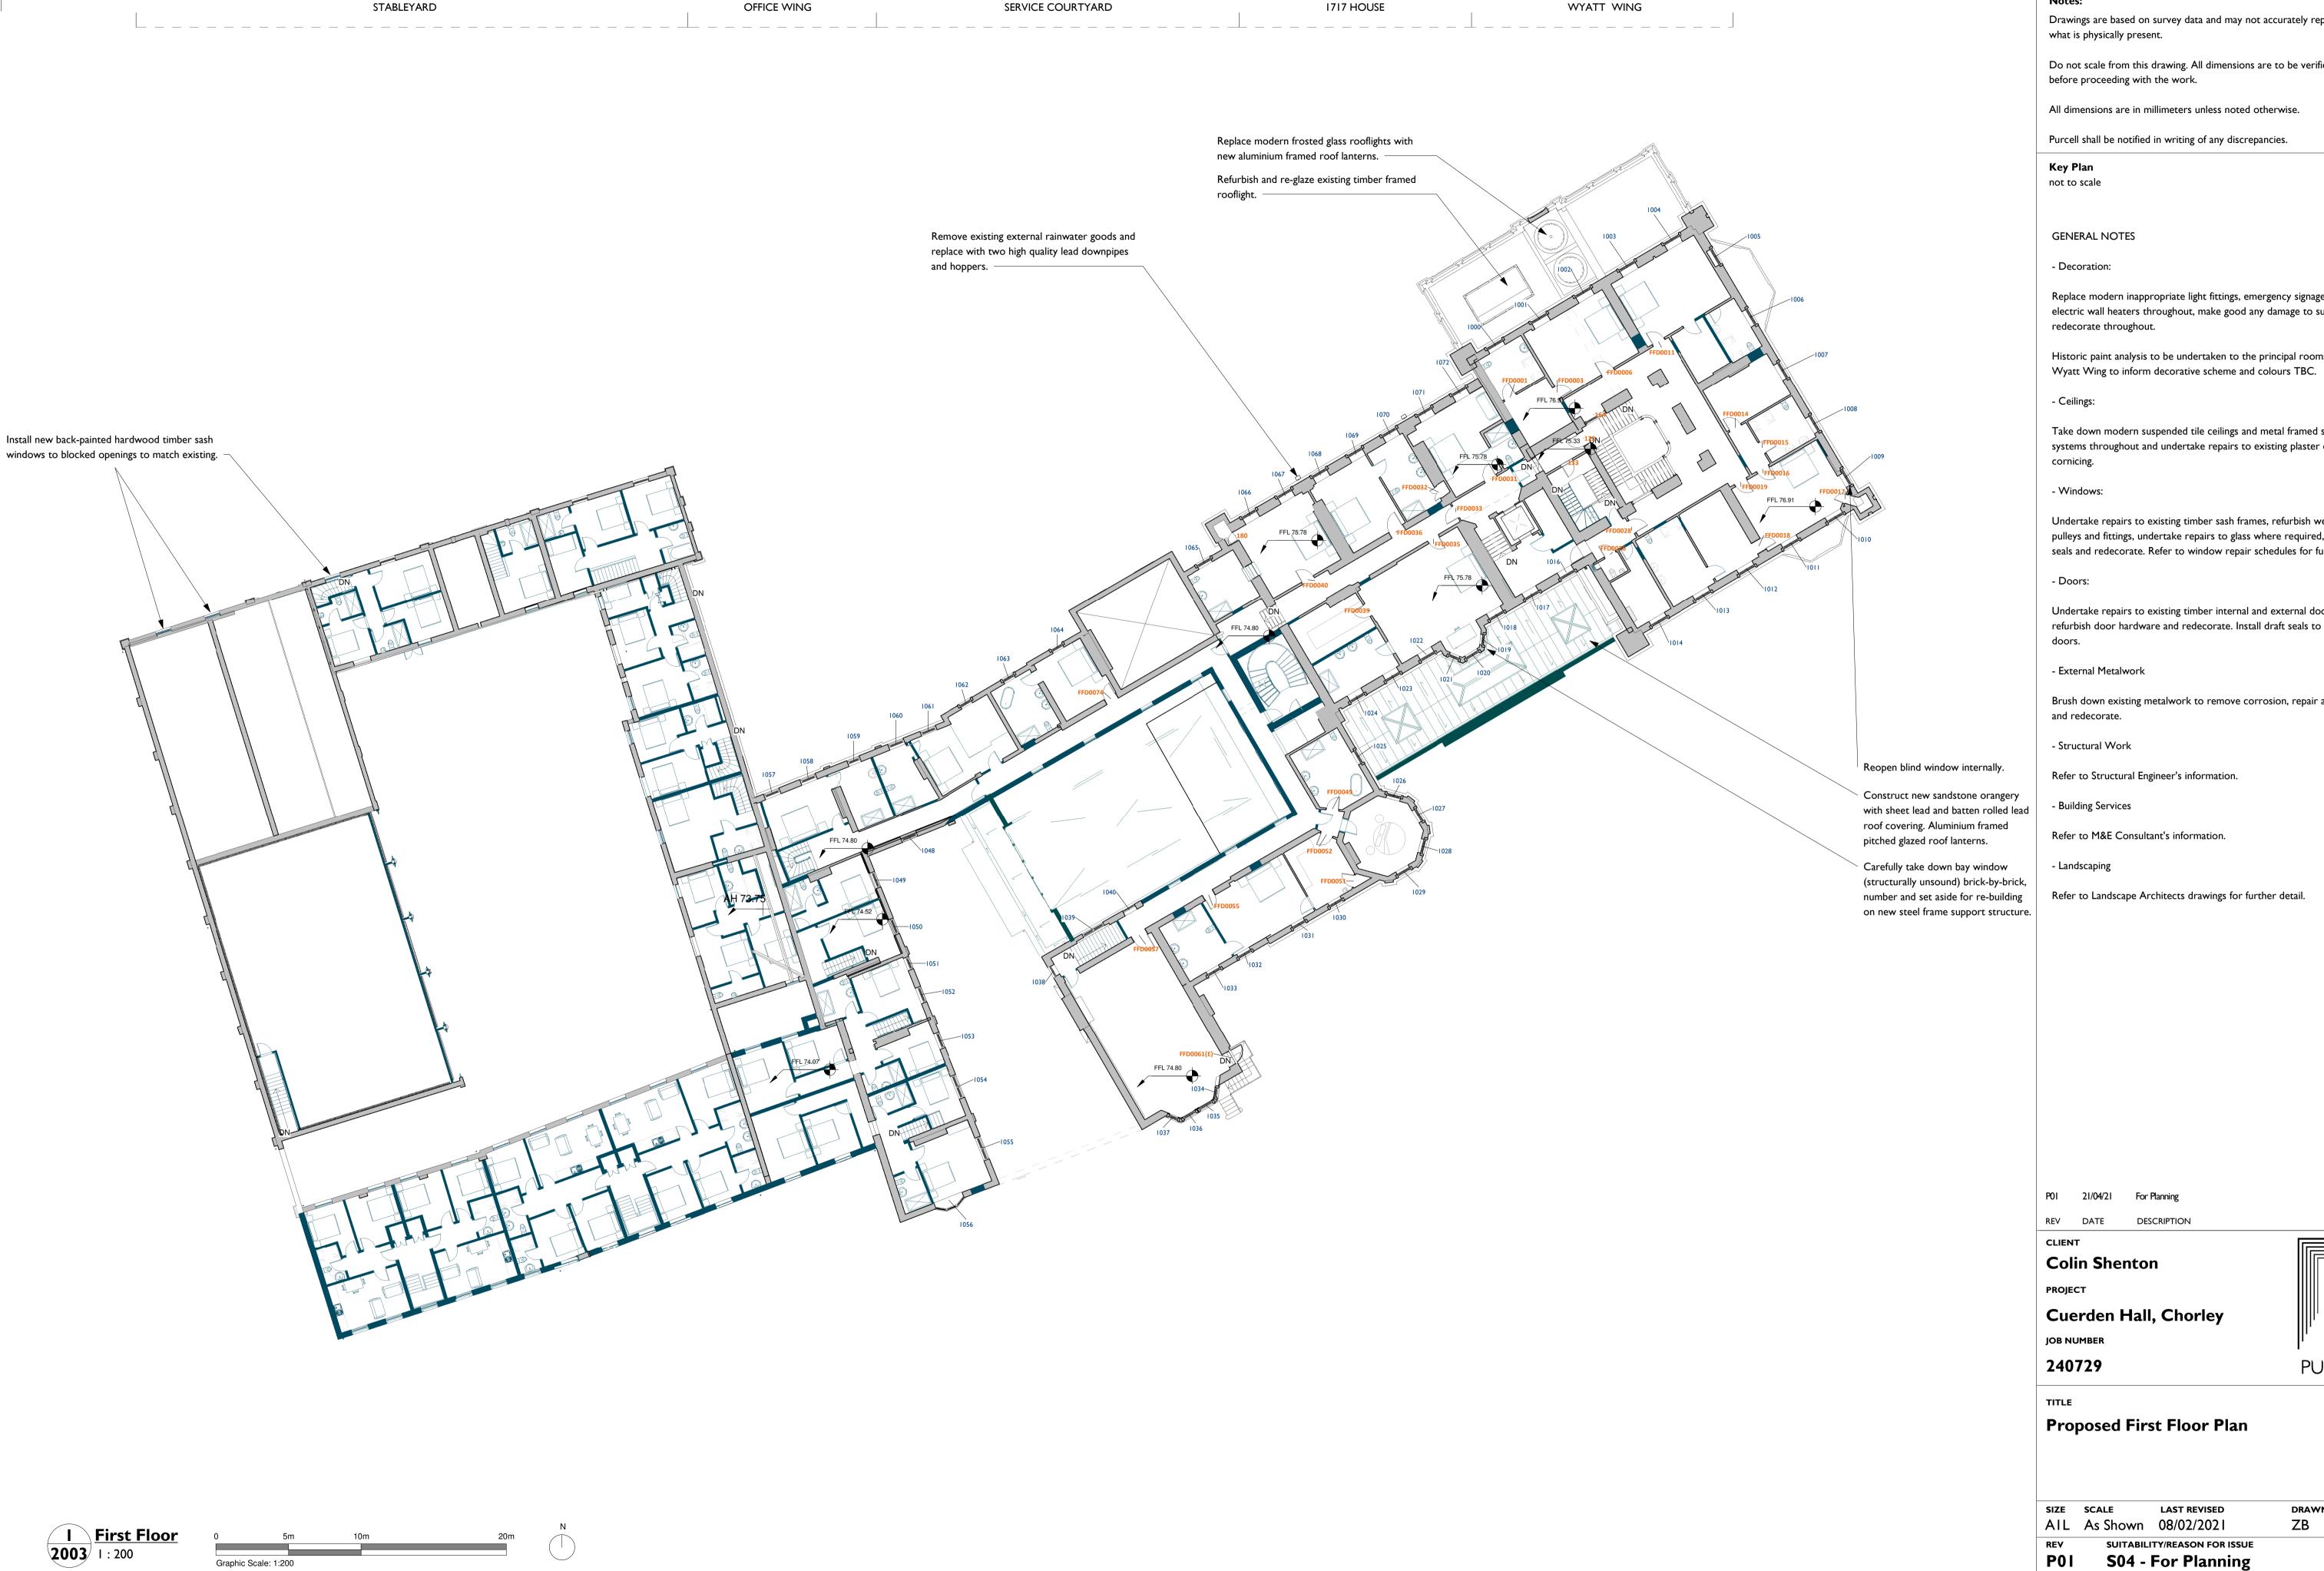
Replace modern inappropriate light fittings, emergency signage and electric wall heaters throughout, make good any damage to surfaces and .

Take down modern suspended tile ceilings and metal framed suspension systems throughout and undertake repairs to existing plaster ceilings and

Undertake repairs to existing timber sash frames, refurbish weights, pulleys and fittings, undertake repairs to glass where required, install draft seals and redecorate. Refer to window repair schedules for further detail.

Undertake repairs to existing timber internal and external doors, refurbish door hardware and redecorate. Install draft seals to external

Brush down existing metalwork to remove corrosion, repair as required
