WOODSELL FARM, HILLSIDE ROAD, STALISFIELD, FAVERSHAM, KENT ME13 0JF
 EXISTING ELEVATIONS of WAGON LODGE
 For ARTYSEA Ltd

DRAWING No
2005/34

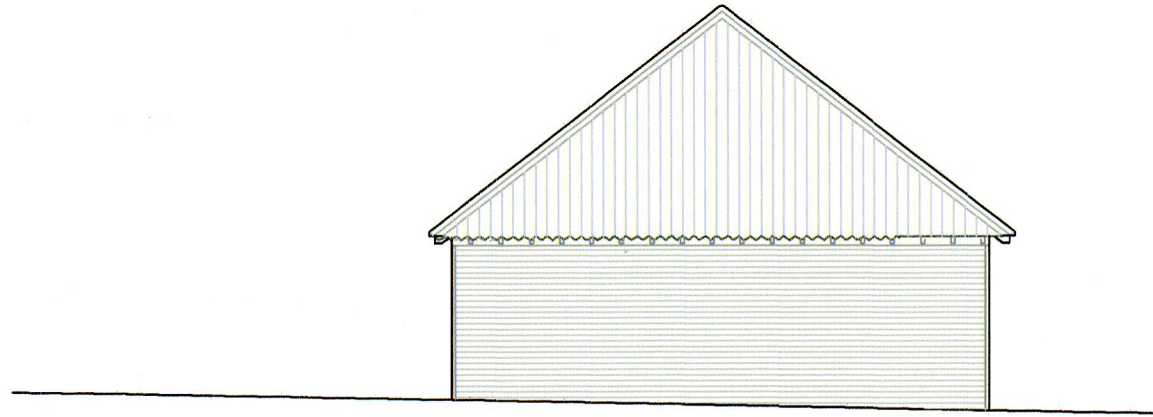
SOUTH-WEST ELEVATION

The Wagon Lodge consists of an oak framed structure with oak posts, head beams and principal roof timbers. Much of it in poor condition. The external walls have been overlaid with corrugated iron sheeting and the roof is corrugated asbestos.

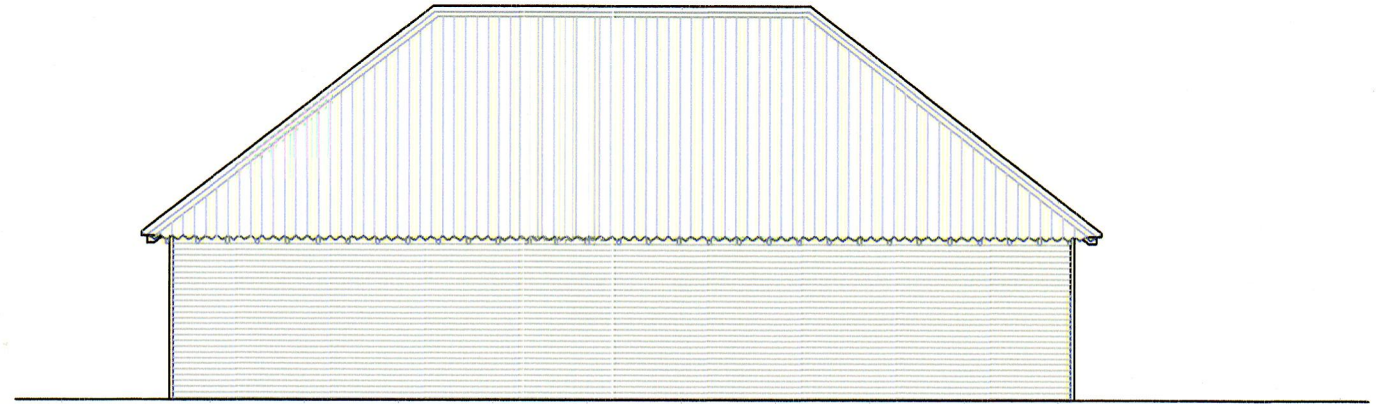
NORTH-WEST ELEVATION

Modern wall plate inserted under original head beam, to be removed and head beam replaced.

Rotten oak corner post to be replaced.

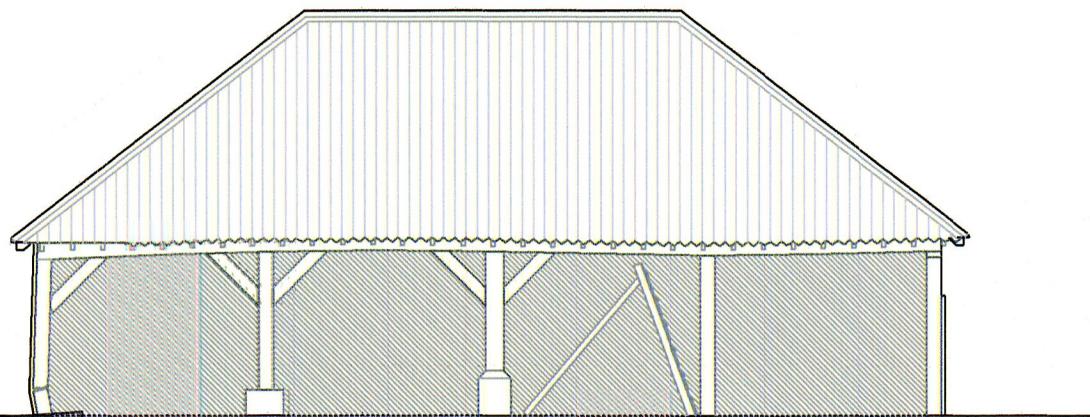
SOUTH-EAST ELEVATION

The Wagon Lodge was originally a 3 bay x 2 bay structure. The eastern end is more modern and it's posts lack braces. Bottoms of posts encased with concrete plinths.

Remnant of original weatherboarded wall panel.
