10 BELGRAVE SQUARE
LONDON

FRONT ELEVATION
GLASS PANES SURVEY

DRNG No	SCALE	DATE
SK-06	1:50 @ A1	JUL 2021

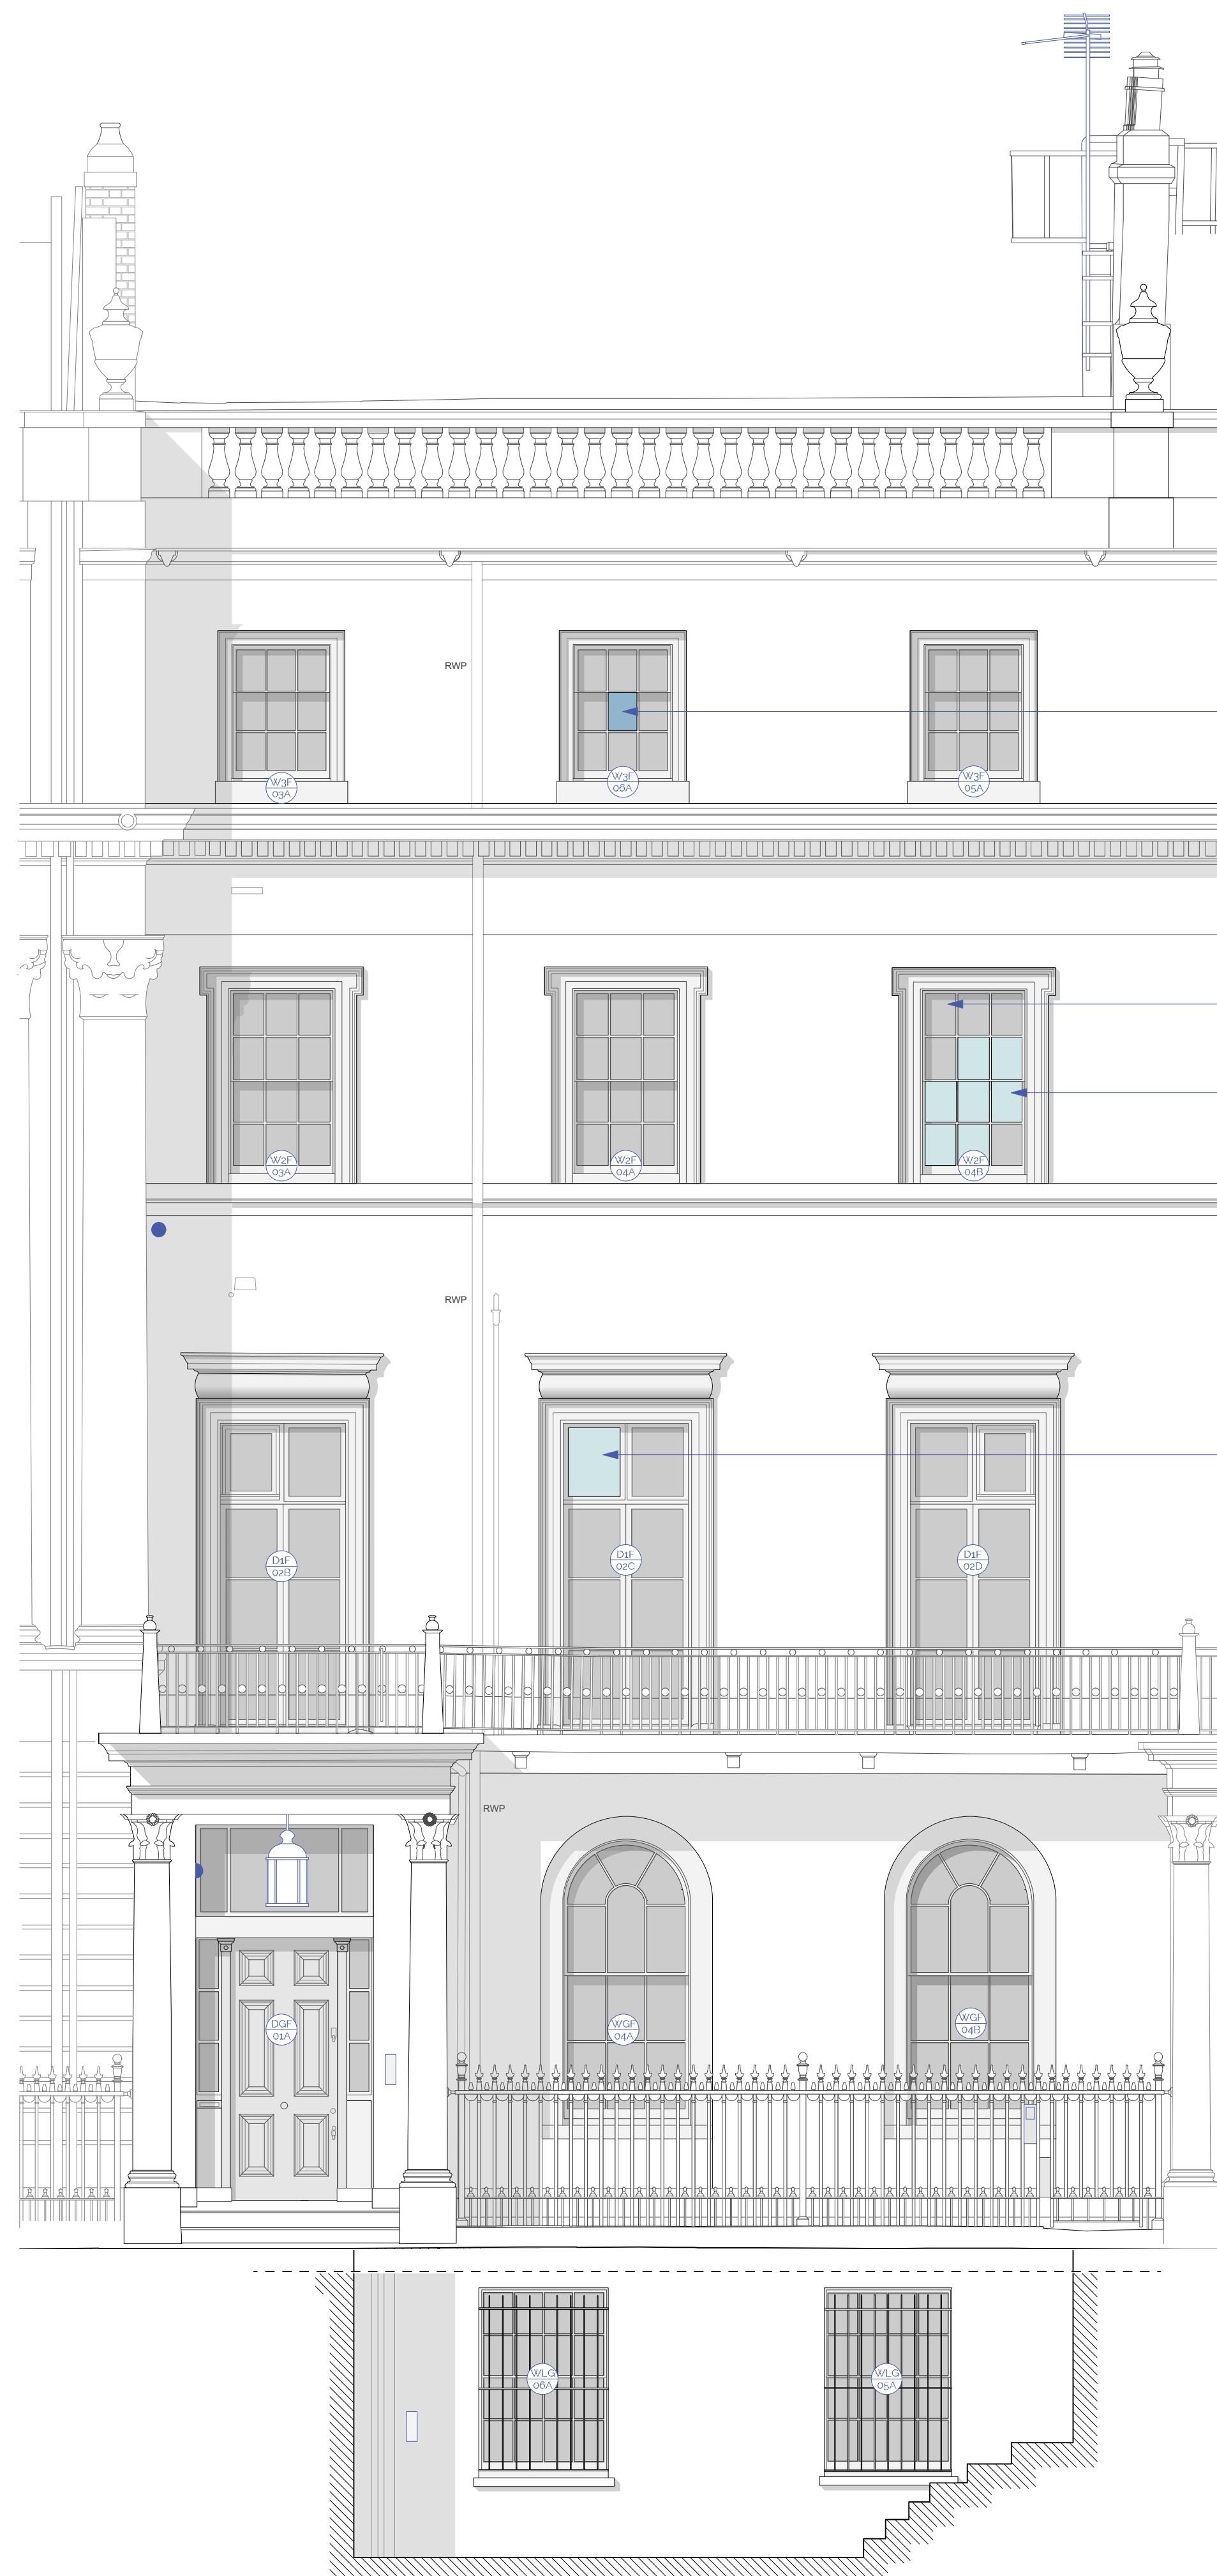
1 Main House front elevation
1:50

ONLY KNOWN LOCATION OF THE CROWN GLASS IN THE PROPERTY.

CRACKED/DAMAGED GLASS PANE

CYLINDER GLASS PANES.

ALL THE REMAINING GLASS PANES ON THE FRONT ELEVATION ARE FLOAT GLASS.
