Heritage Assessment

The Old Vicarage,
High Street,
Sevenoaks

July 2021 | Project Ref 6484

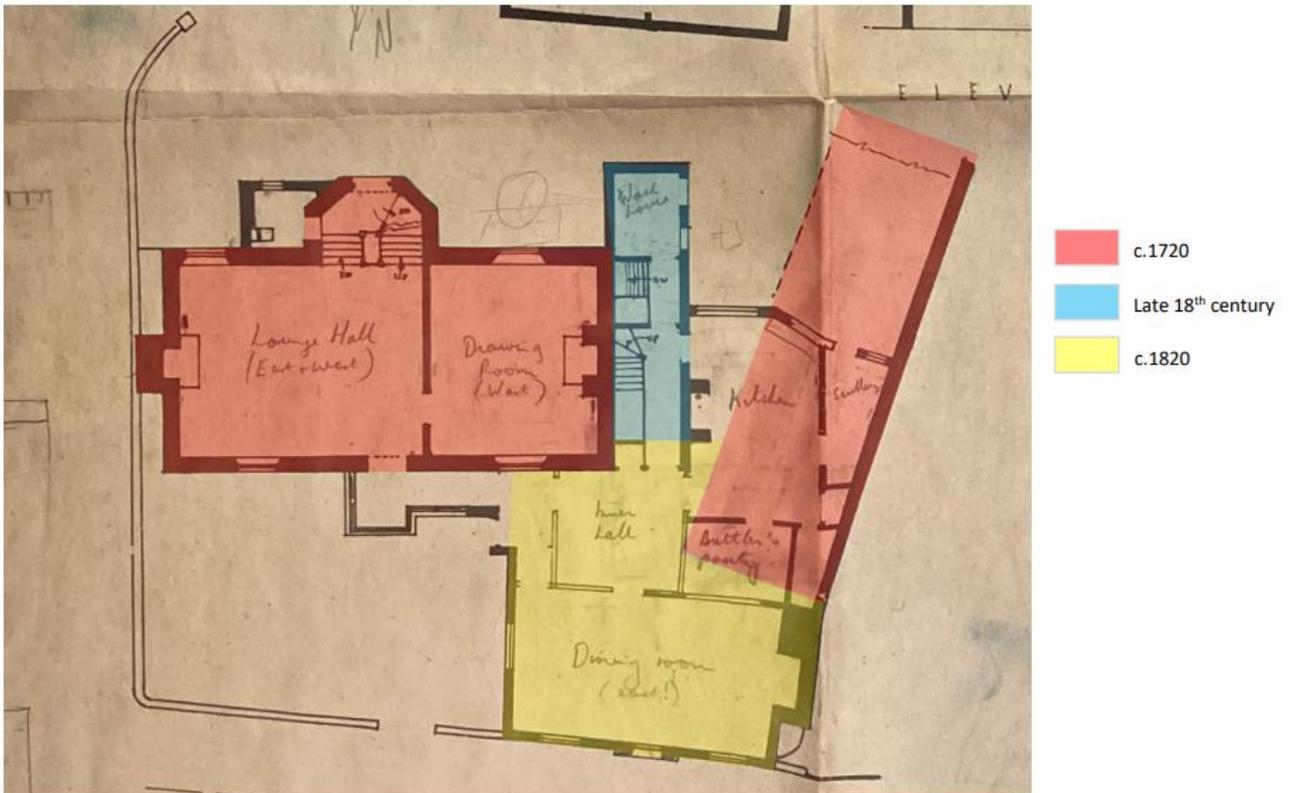
Indicative dating and phasing of the Old Vicarage, Sevenoaks based on site observation, photographs and plans

Figure 1 – Phasing plan, based on a plan of the 1940s, when the front extension (yellow) was still in place. The former coach house is the long building to the right, on an angle.

3.2 Sales particulars dated August 1939 contain a photograph of The Old Vicarage showing a significant two storey extension projecting forward as far as the pavement edge (Figure 3). This extension had clearly been demolished by the date of listing in 1951, but it appears on a plan dating to the 1940s, which has been used as the basis of a phasing plan to indicate how the building may have developed from the early 18th century to the mid-20th century (Figure 1).

3.3 In essence, the core part of the building, including the stair tower at the back (west) seems to date from about 1720 (Figures 1). There was a detached coach house to the north, apparently of a similar date, set at an angle. An extension was added on the north side of the Vicarage, possibly in the late 18th century, and at any rate by the time of the glebe survey of 1816 (Figure 2). This extension may have been single storey; the flat-roofed first floor element over the top was probably a 20th century addition. It is thought that the large extension at the front, demolished c.1950, was added around 1820. This extension probably joined the Vicarage to the coach house, and (although the extension itself was later removed)

3.8 Archaeologically, the building has a relatively simple phasing sequence (Figure 1). The most interesting part of the building, in terms of fabric, is the butt-purlin roof, albeit not wholly visible in its presently ceiled form (Figure 11).

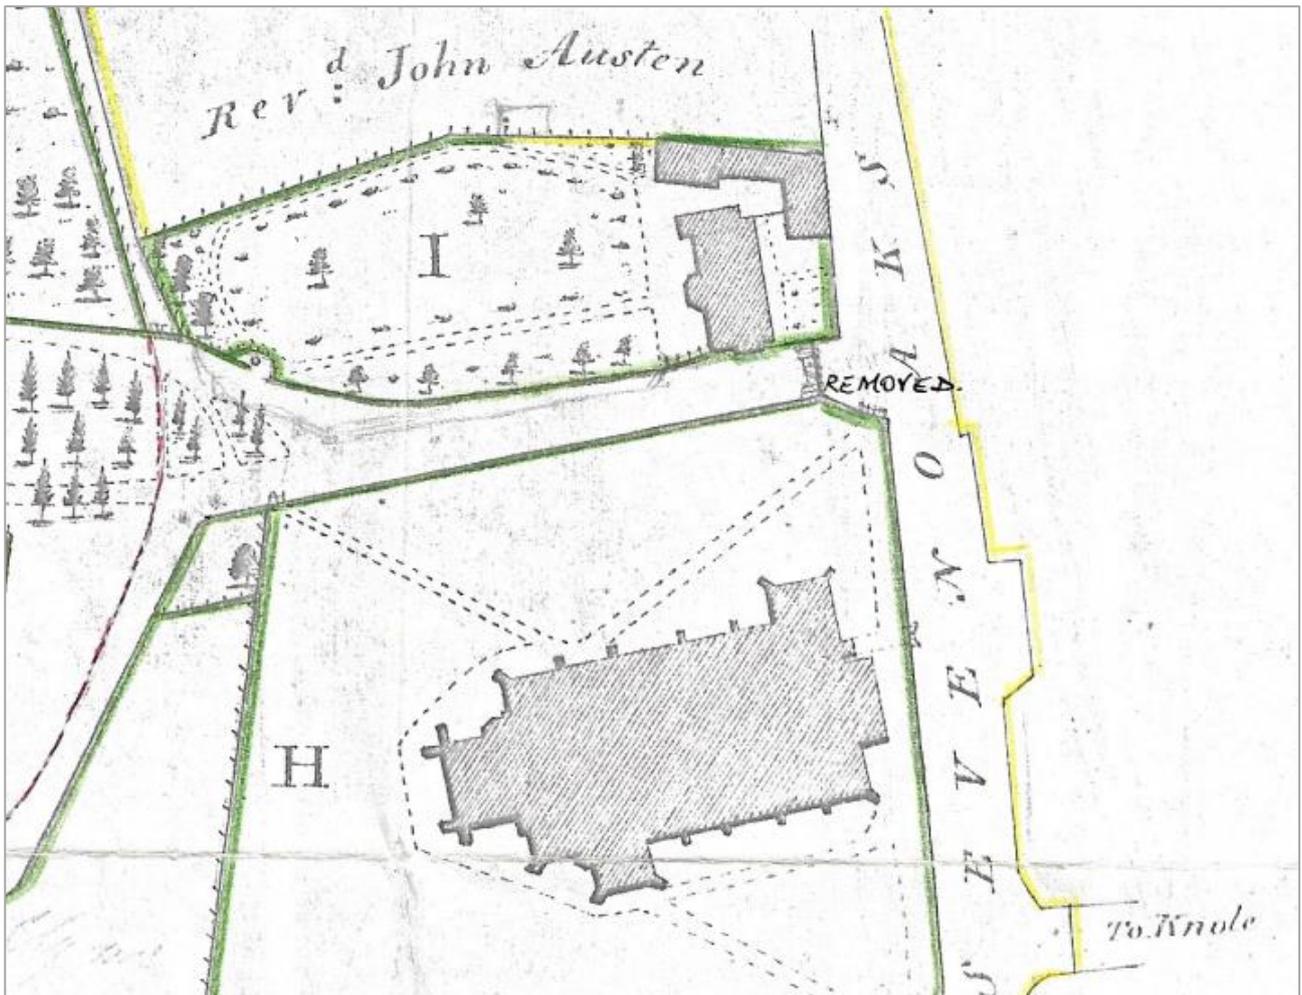
Figure 2 - Extract from a plan of glebe land by Abraham Barham dated 1816, showing the Vicarage to the north of the Church of Saint Nicholas.

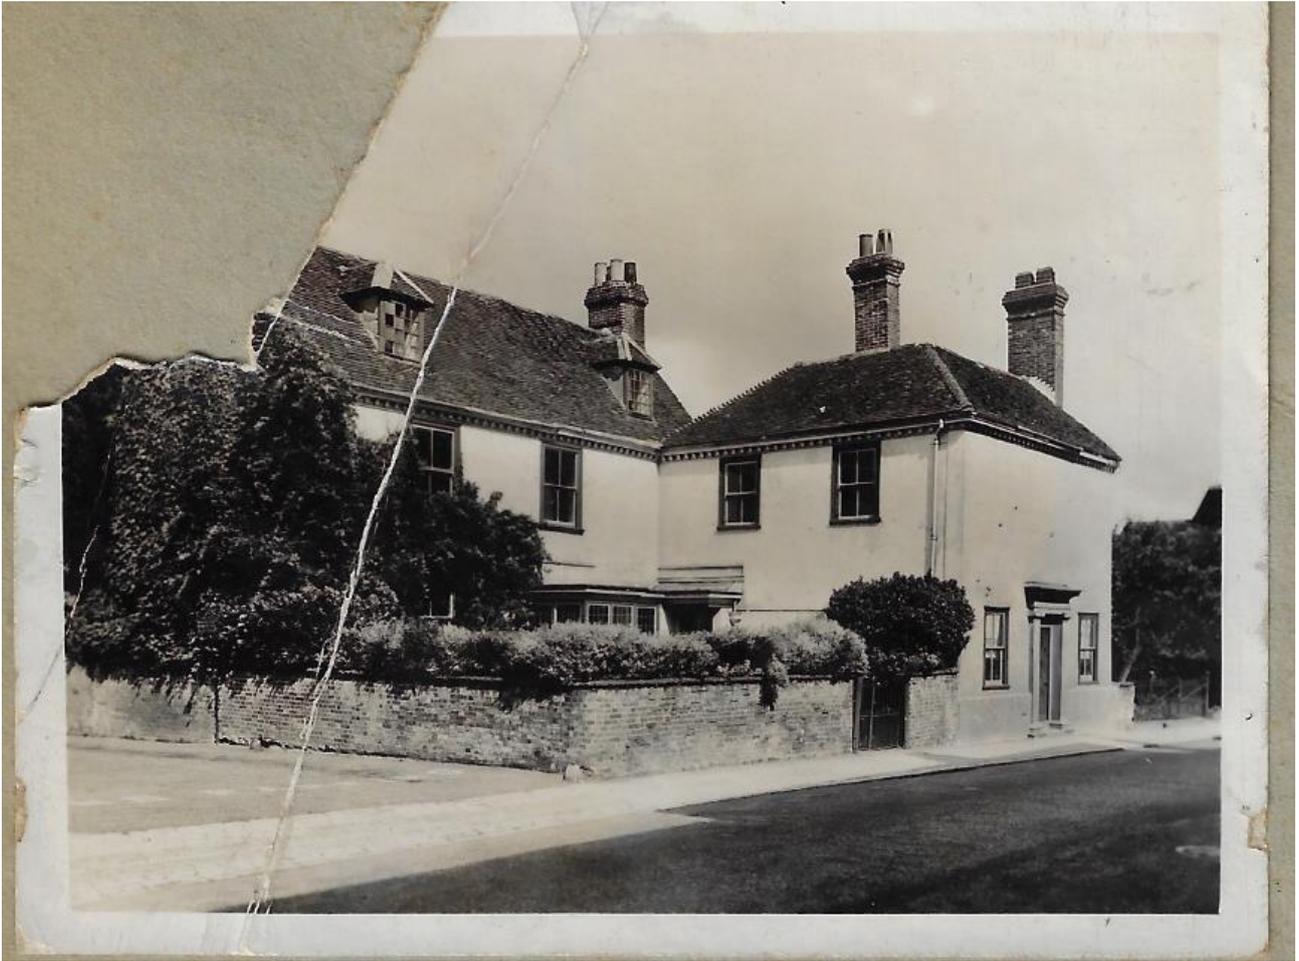
Figure 3 - Sales Particulars, August 1939, showing the front extension of c.1820, thought to have been demolished c.1950.

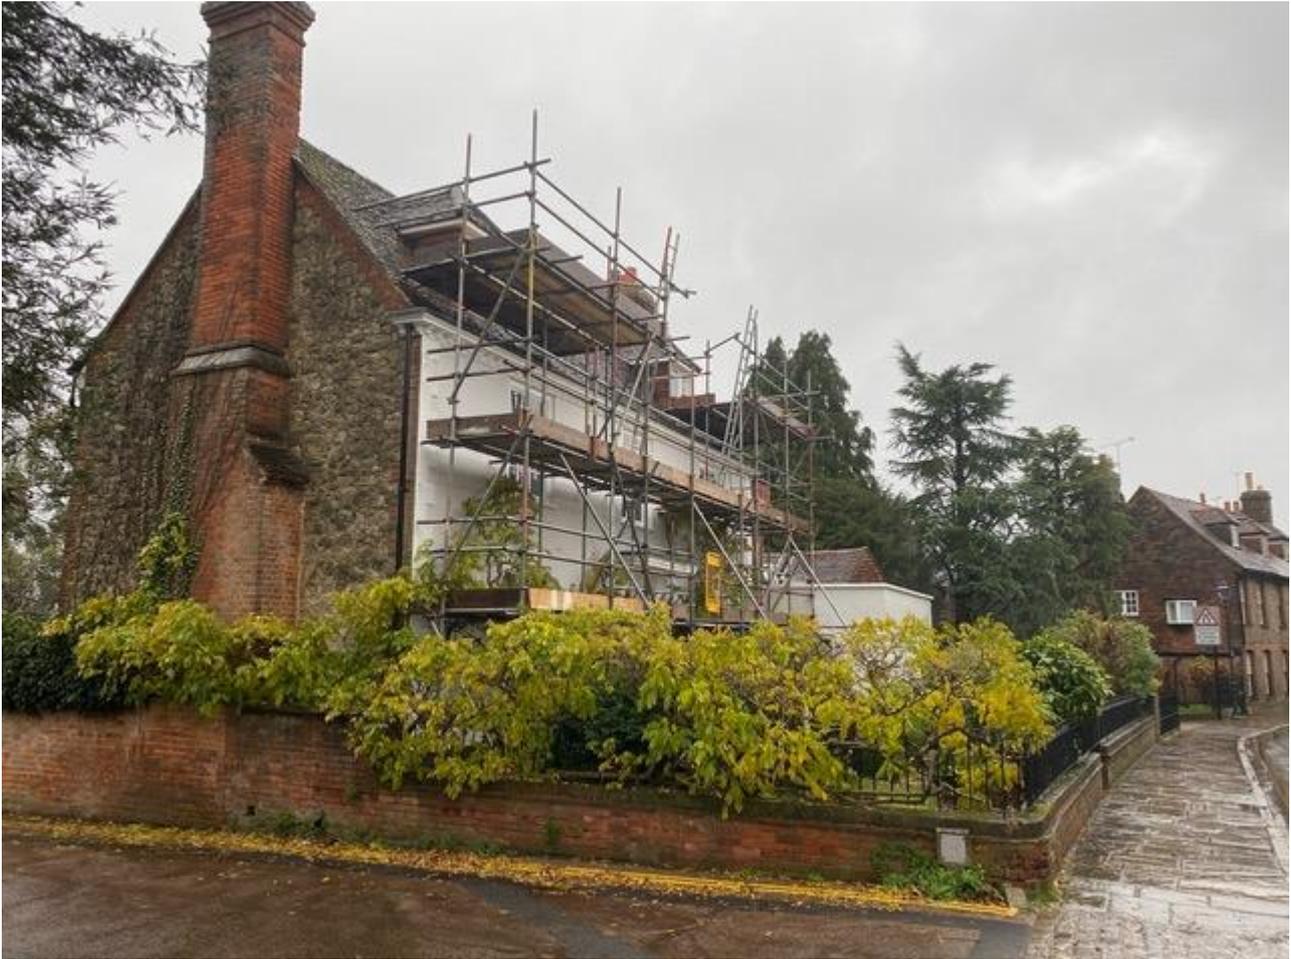
Figure 4 - Front and gable elevation, looking north.

3.4 Photographs of the main elevations appear in Figures 4 to 9.

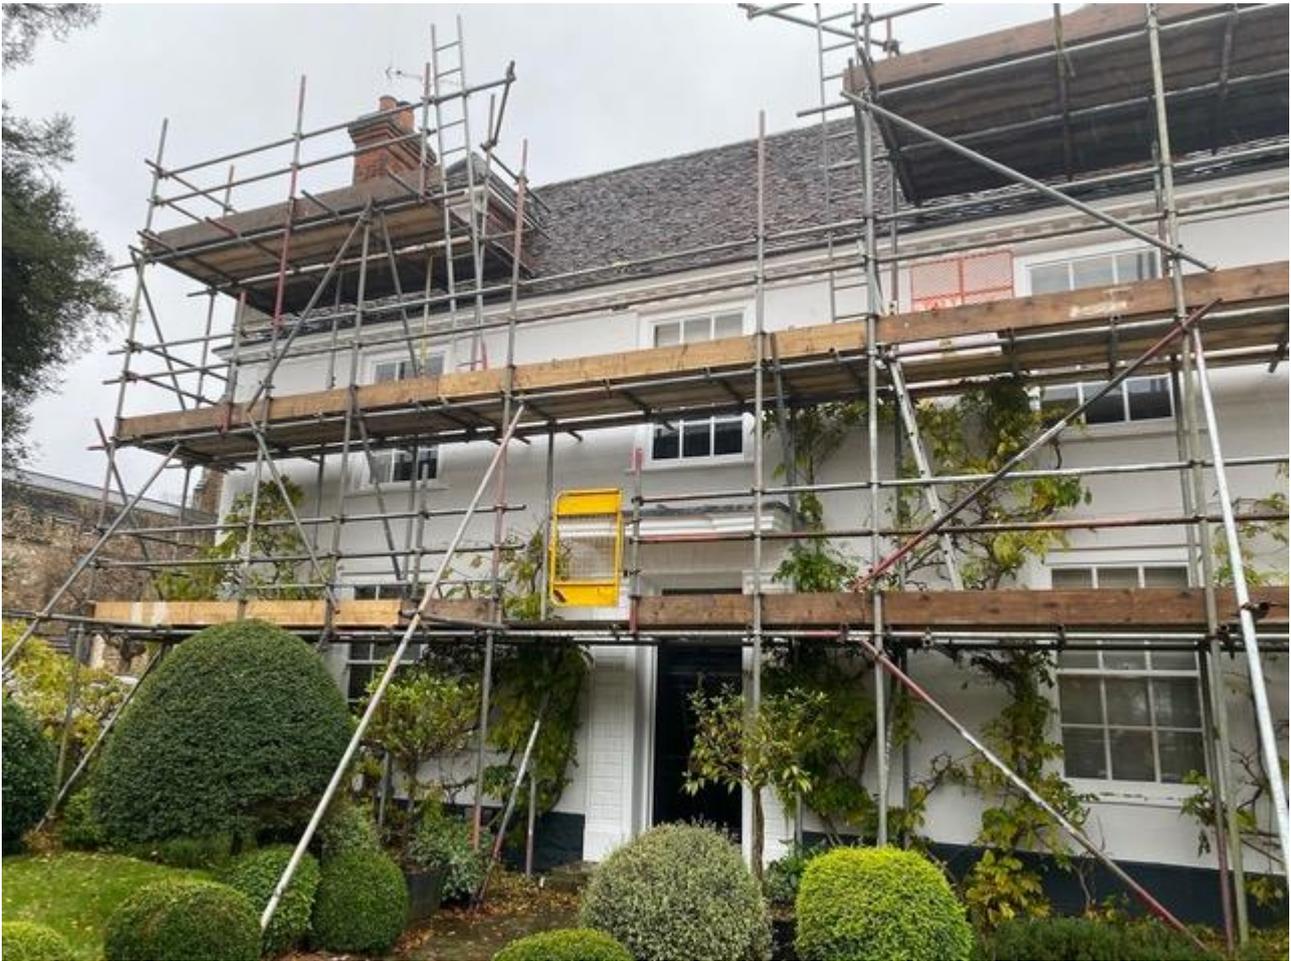
Figure 5 - Front (east) elevation.

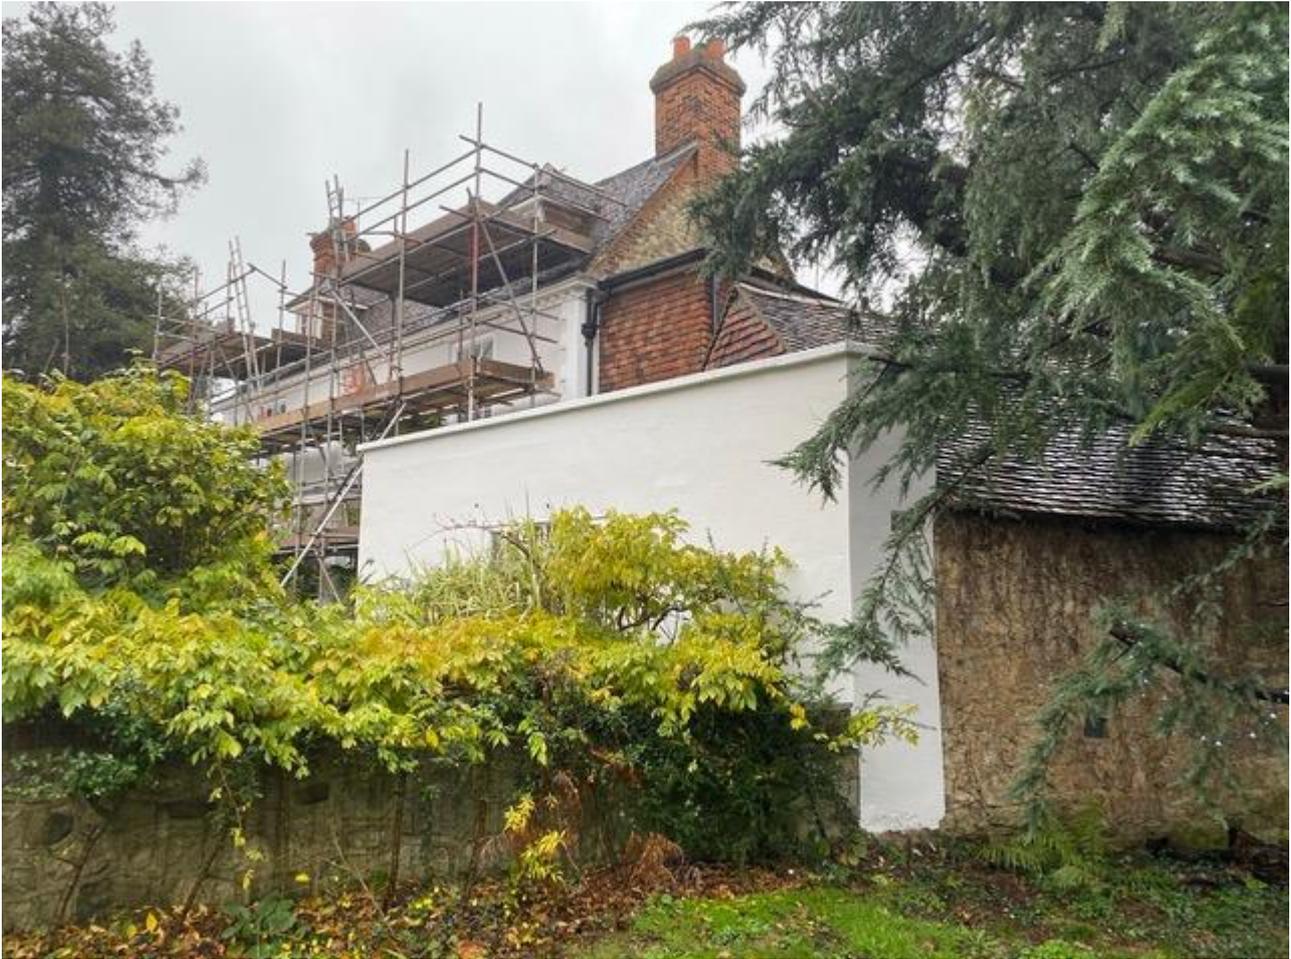
Figure 6 - Front elevation, looking south-west. The rendered projection dates from the mid-20th century, after the demolition of the forward-projecting extension of c.1820.

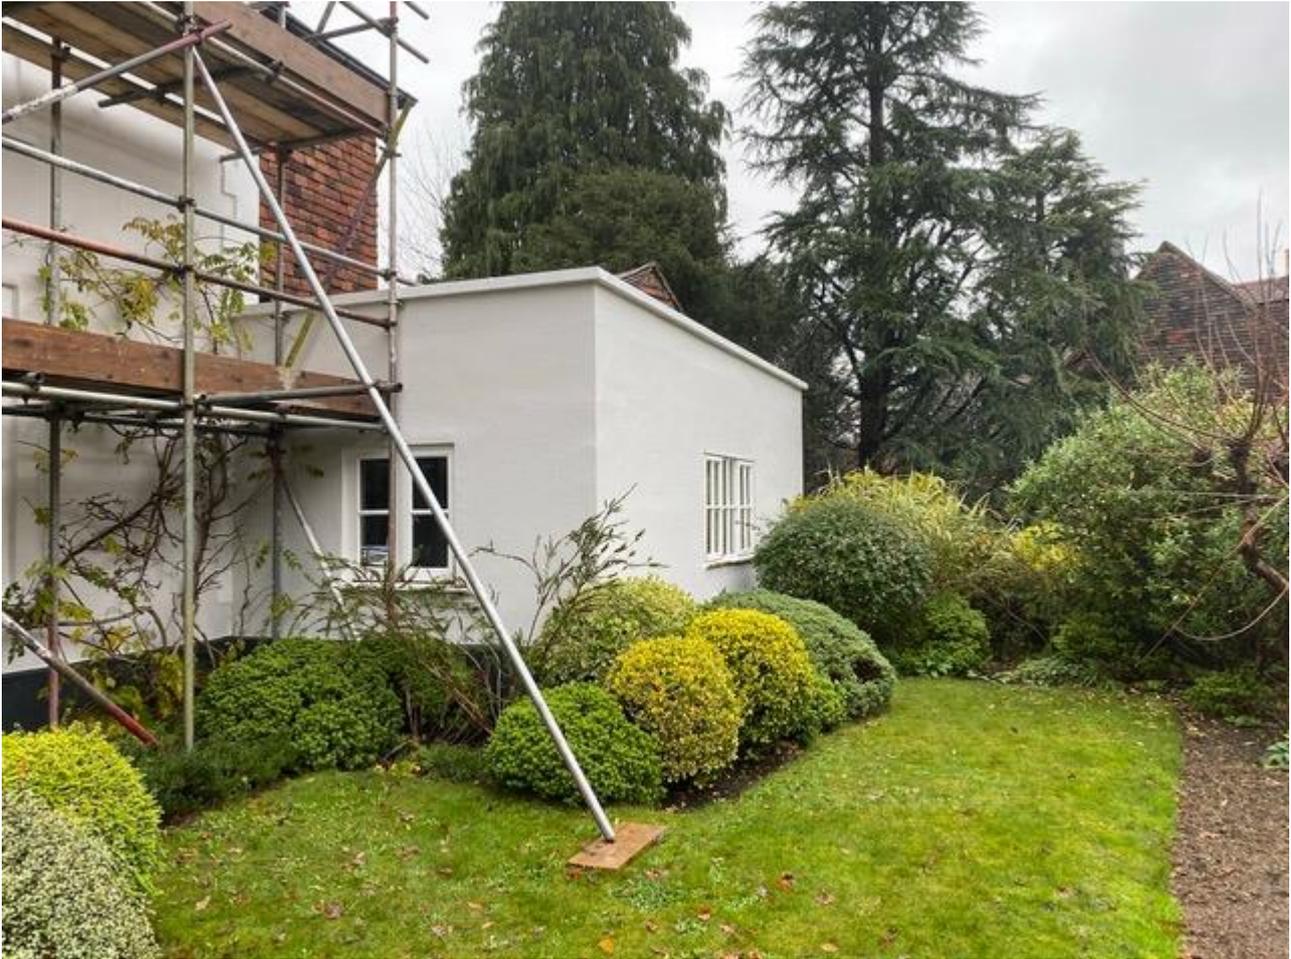
Figure 7 - Front elevation, showing the mid-20th projecting extension that replaced the earlier extension of c.1820 that can be seen in Figure 3.

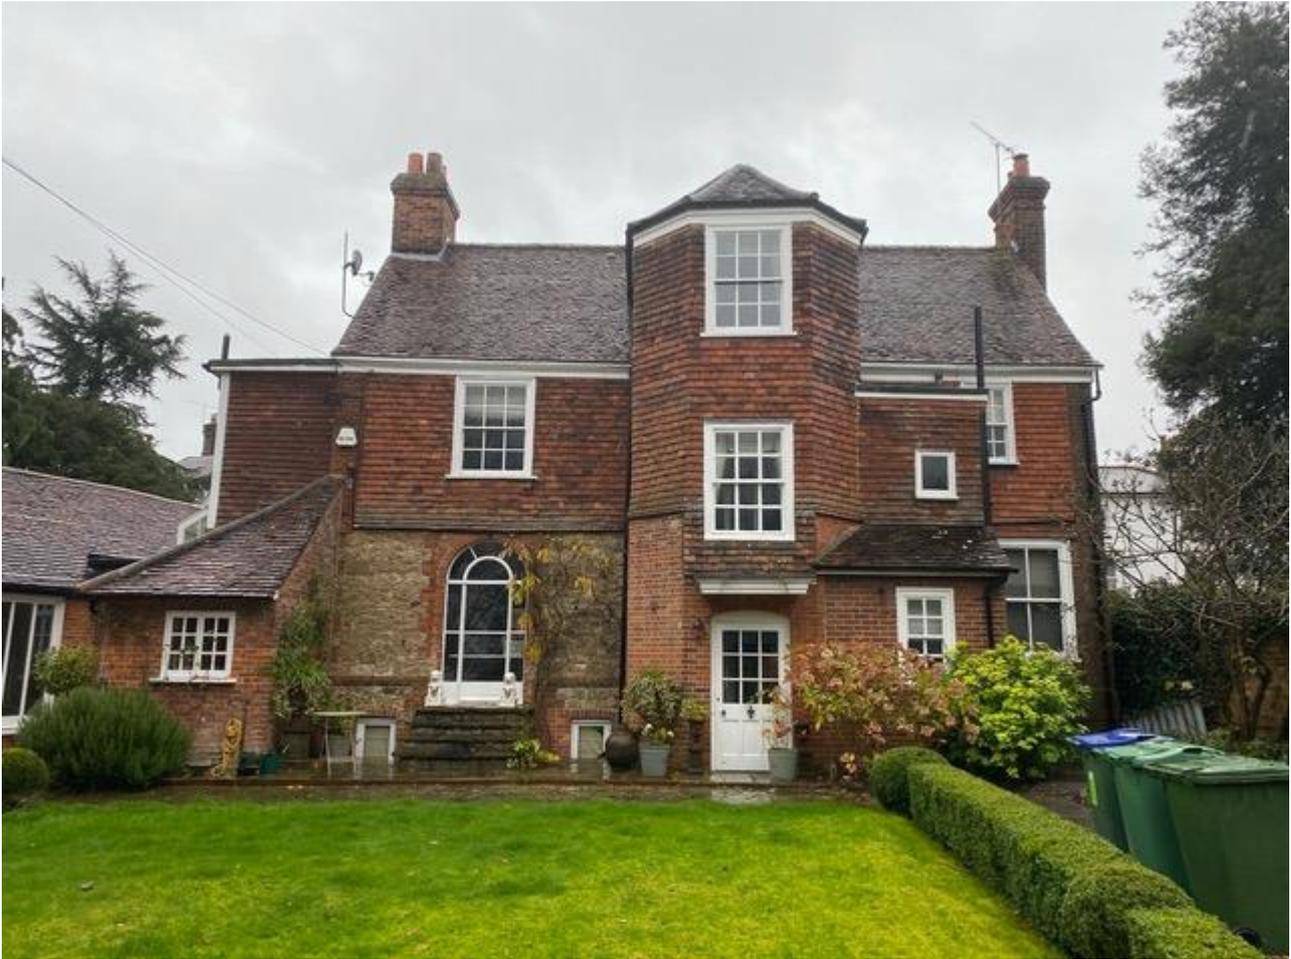
Figure 8 - Rear (west) elevation. Note the stair turret.

3.11 The Old Vicarage is an important building, central to the functioning of the parish church, and at the heart of communal life in Sevenoaks for centuries. It is aesthetically pleasing to look at, and it has a full-height stair turret on the rear elevation, which is relatively rare (Figure 8). The staircase itself is of a fine quality (Figure 10). Much of the interior is plain, and has been altered in detail, but parts of the original floor plan remain and there is a well preserved roof structure of staggered butt-purlin type (Figure 11). The Old Vicarage is essentially a vernacular building with an early Georgian Classical-style frontage, and it is evidently of special architectural and historic interest. The building makes an important contribution to the character and appearance of Sevenoaks High Street Conservation Area.

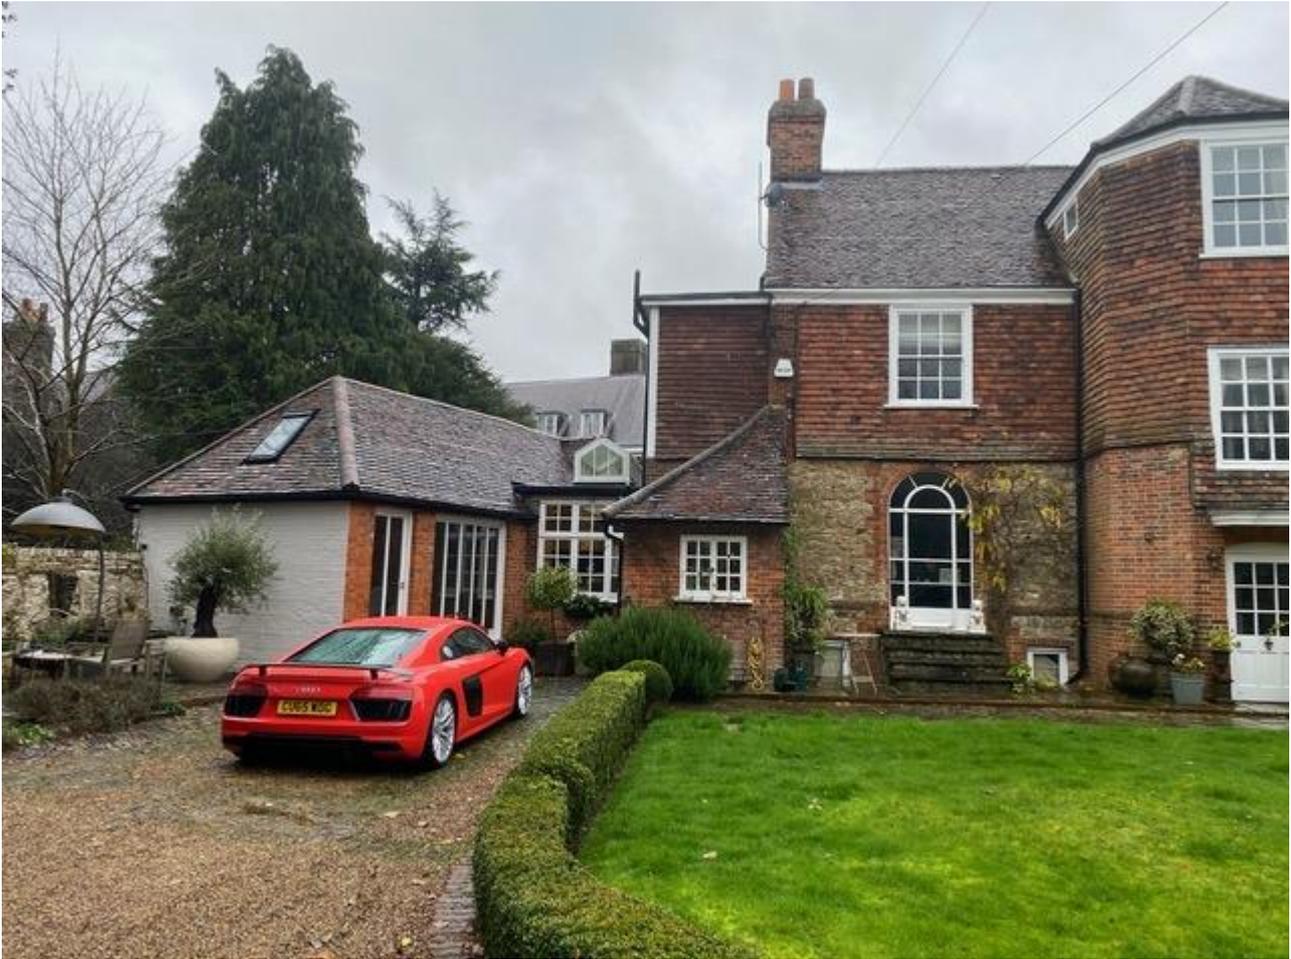
Figure 9 - Rear (west) elevation. The hipped structure on the left is the former coach house, albeit the roof structure is now the only substantively original element.

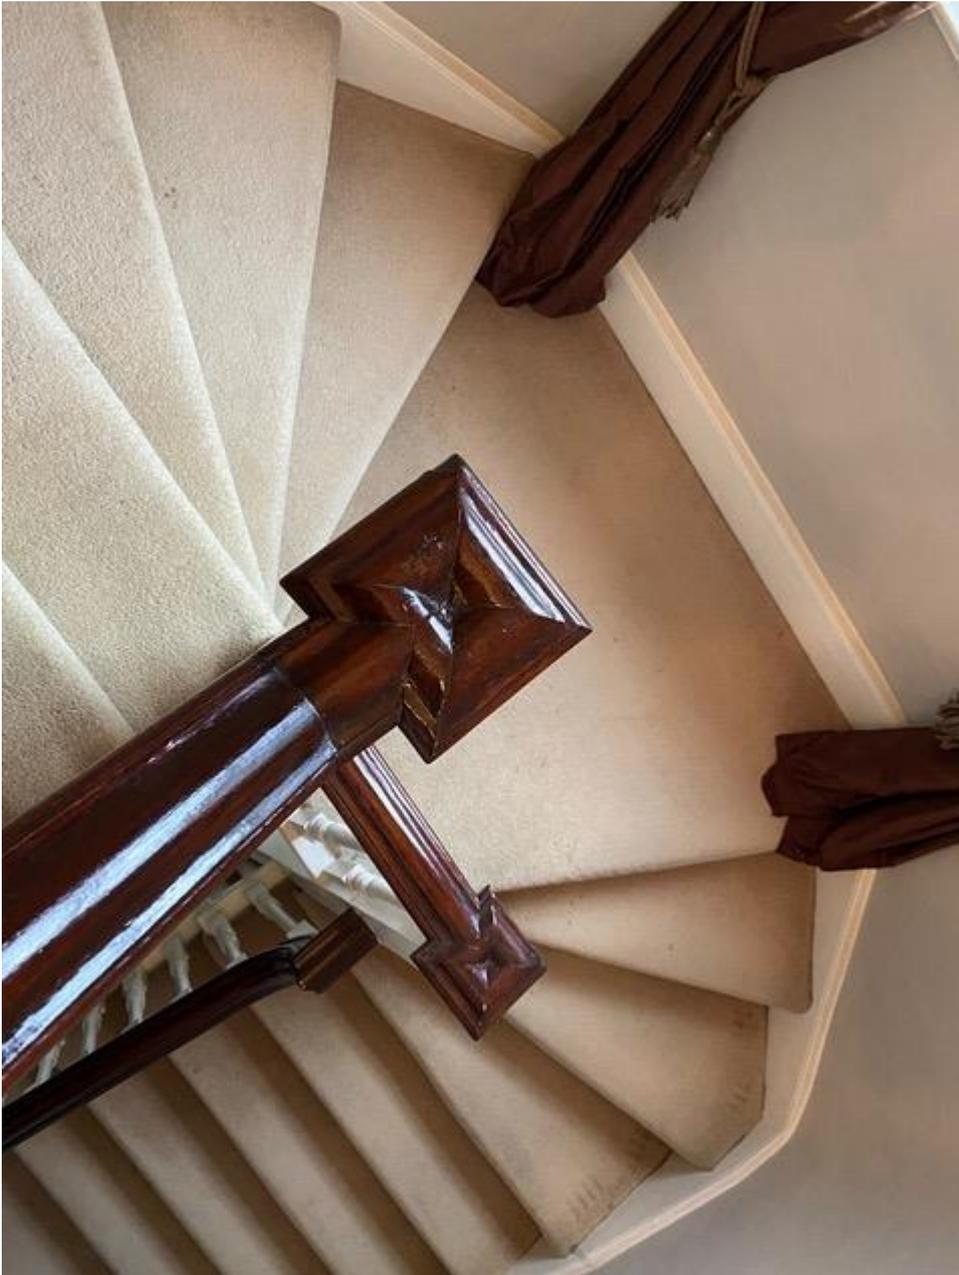
Figure 10 - The 18th century staircase.

3.9 There is an inherent degree of artistic interest in the architecture of the building as a whole, but the principal feature of note is the carefully crafted staircase in the tower at the rear, which has a particularly fine (yet plain) handrail (Figure 10).

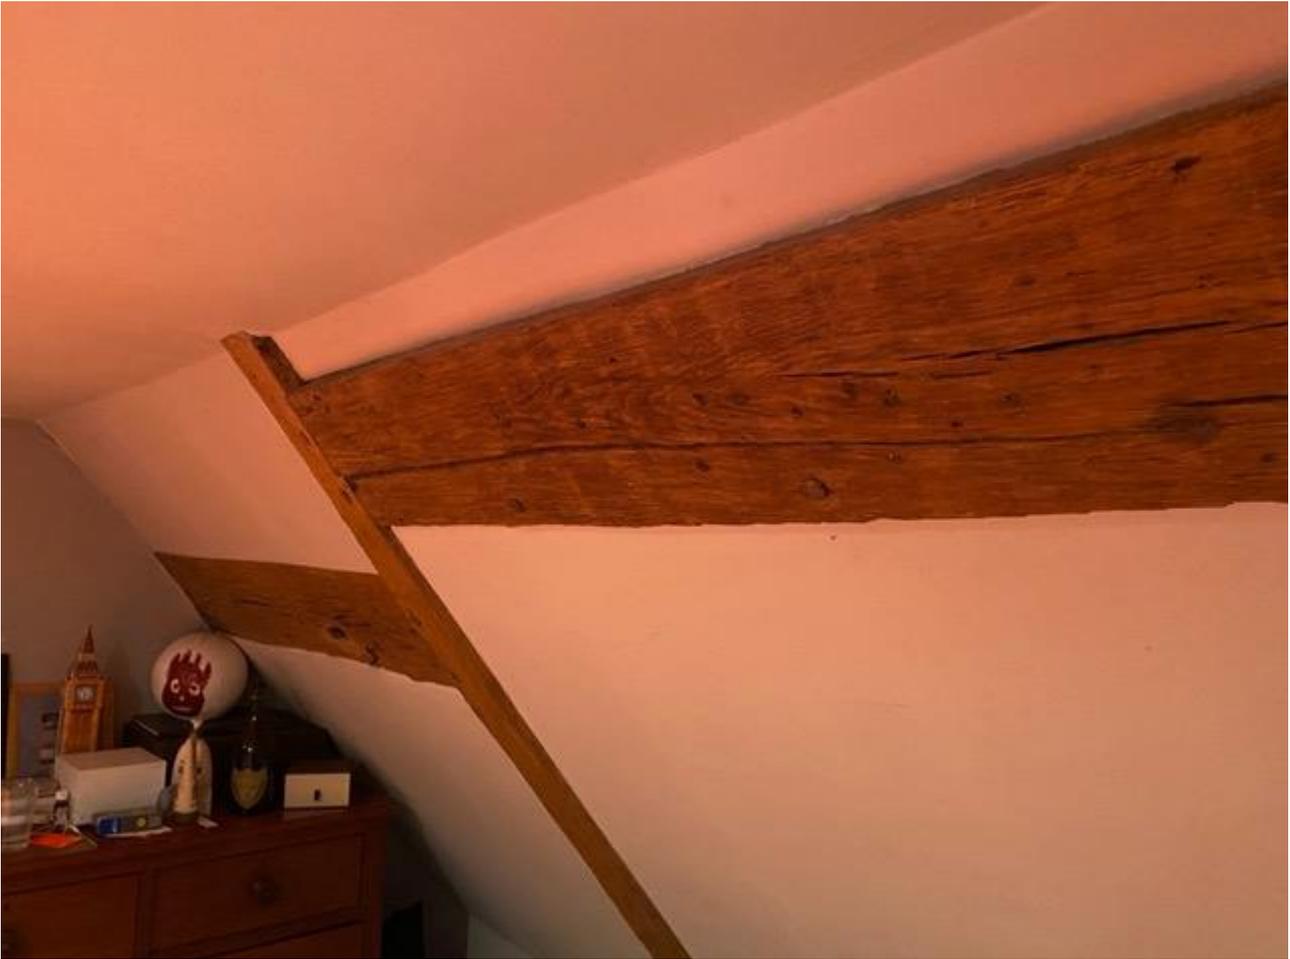
Figure 11 - Roof of The Old Vicarage. This is a staggered butt-purlin roof of early 18th century type.

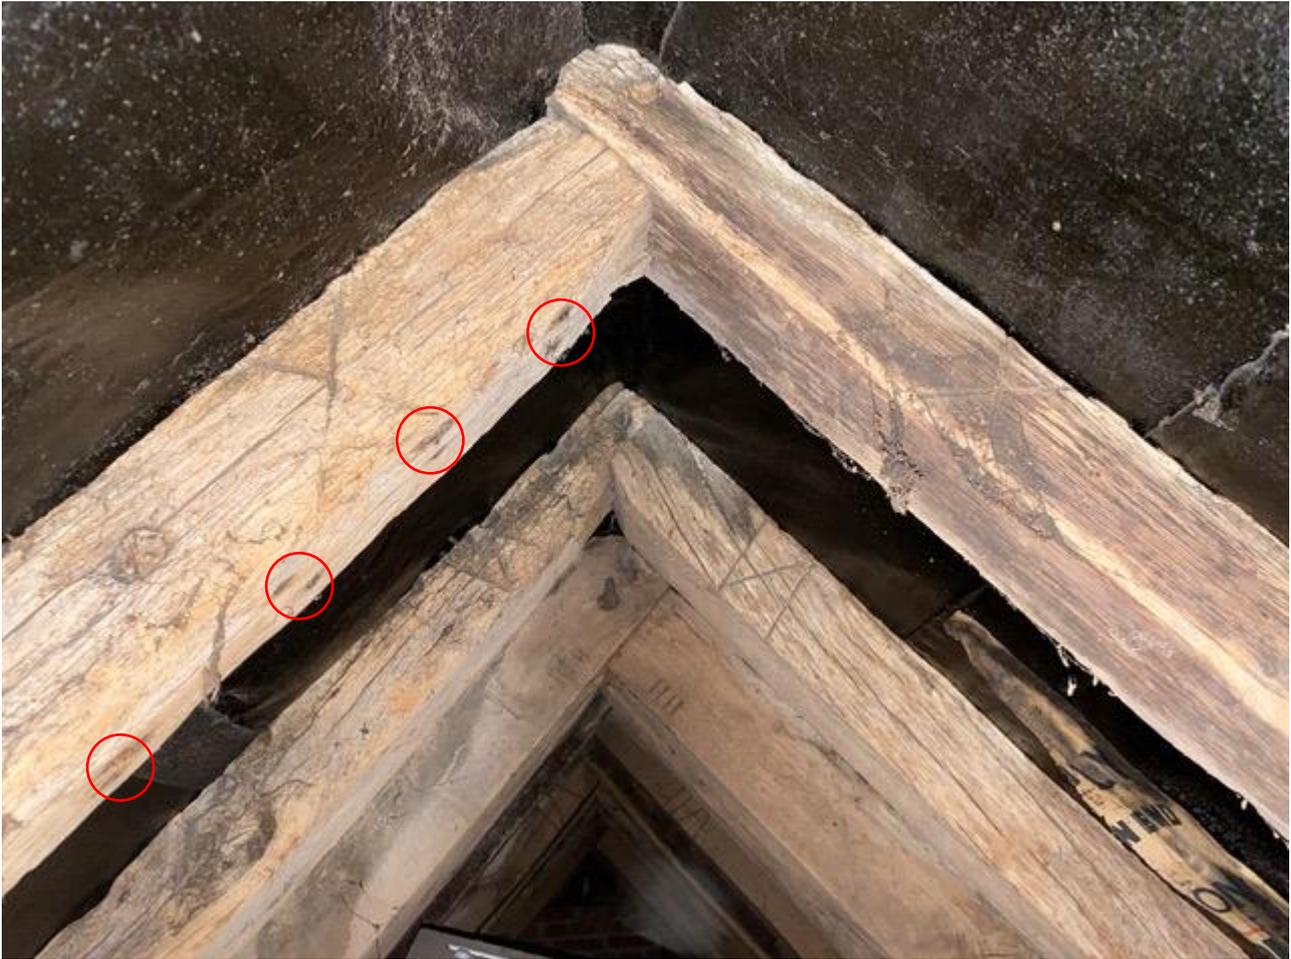
Figure 12 - Roof of The Old Vicarage, above the modern ceiling. Note the carpenters' marks, and the absence of a ridge plate. The common rafters are lapped at the top, and are numbered, so they are in their primary positions. Where there are traces of nails those nails are on the soffits or undersides of the rafters (circled). This is clear evidence that a lath and plaster ceiling was once fixed to the rafters, and that the space was originally open to the apex of the roof. Therefore, the horizontal ceiling at the lower "collar" level is a modern insertion.

4.2 It is proposed to remove modern plaster ceilings on the second floor so that the roof structure can be exposed to the apex of the ridge, as was originally the case in the 18th century. There is clear evidence that the present ceilings are later additions (Figure 12). It is also proposed to create a shower room will be created within the landing area at second floor level. Pre-application advice from the Council was as follows:

- 4.4** Regarding the evidence of the original plaster ceiling to the apex of the roof, Figure 12 shows traces of nails for the laths on the soffits of the common rafters. There is no proposal to alter the historic roof structure, which will be left in place. The fabric to be removed is a later alteration.

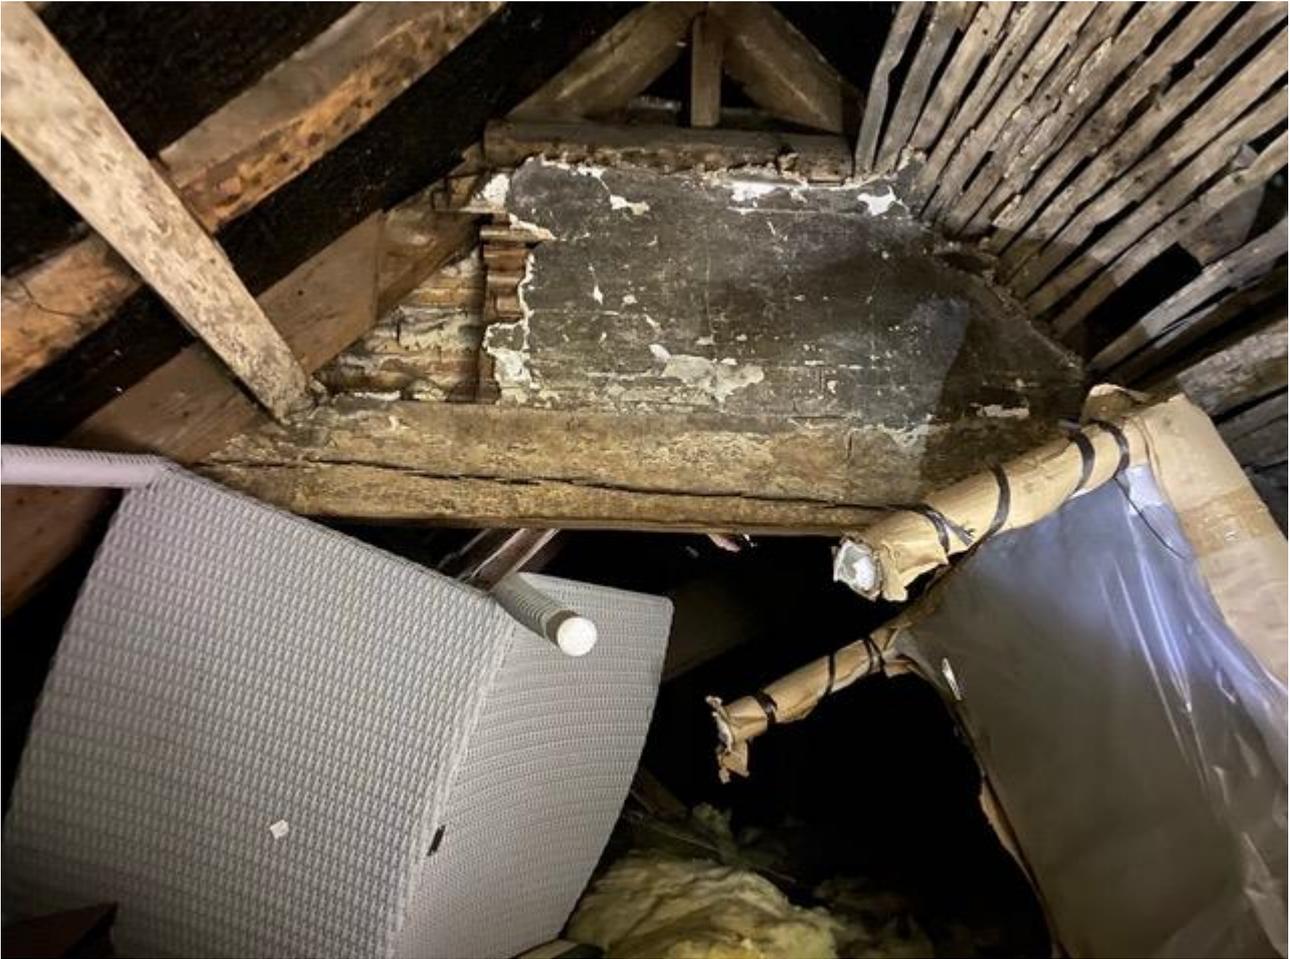
Figure 13 - Roof of the coach house, with evidence of lath and plaster, suggesting that it may have been habitable in the 18th century, perhaps for a groom.

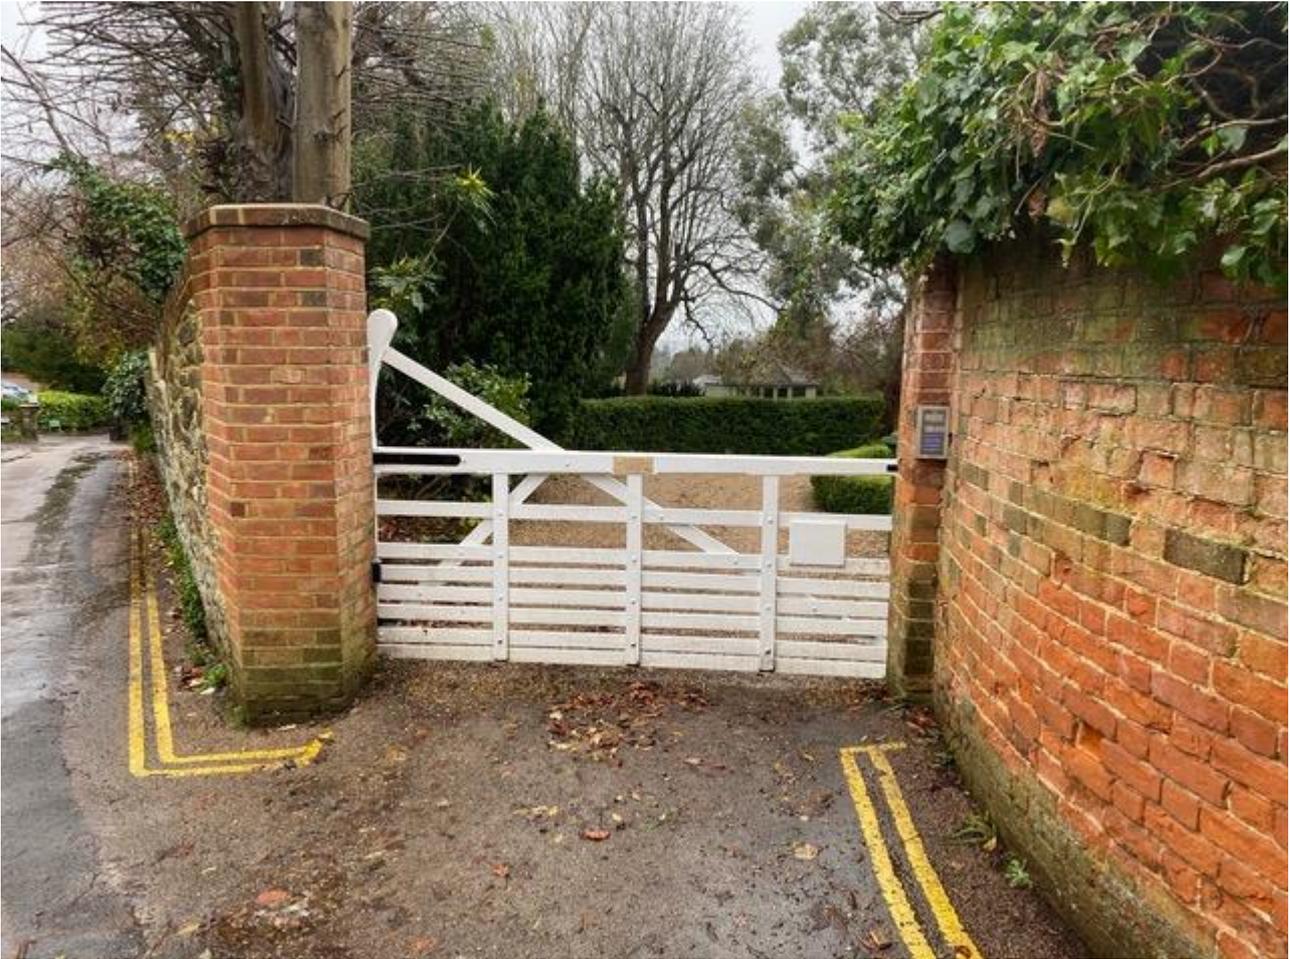
Figure 15 - Entrance gate on the south side of the garden, looking west (December 2020).

- 4.8** Metal gates are proposed for the southern entrance into the garden, off the lane beside the churchyard. These will restore (but not replicate) metal gates for which there is certain photographic evidence in the past (Figure 16). The return to the original character will be a material improvement, given that metal gates are historically appropriate for this particular opening. They will be more in context with the character of the adjacent churchyard, and will be better suited than the inappropriate timber five bar gate currently in position, which appears to be too wide for the opening (Figure 15). The Council's view on the matter during pre-application discussions was as follows:

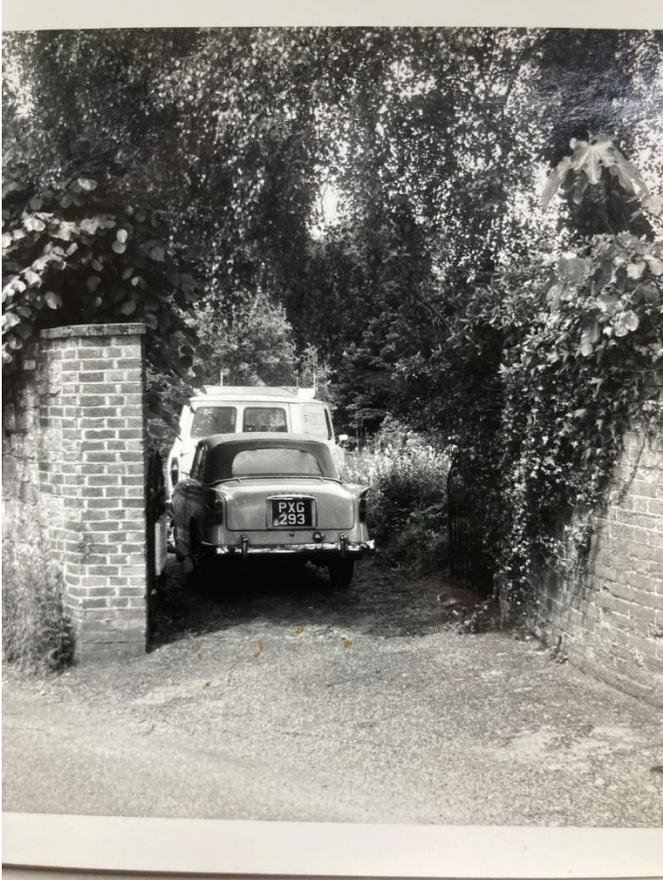
Figure 16 - Mid-20th century photograph of the south gate into the garden, showing that it had metal gates at that time (see expanded detail of the right hand gate).
