**Traffic Report - Proposed New Access at Stone Barn**  
**Finborough Road, Great Finborough**

Prepared: Ian Booth – Consultant Engineer

Date: 20<sup>th</sup> May 2021, updated 20<sup>th</sup> July 2021

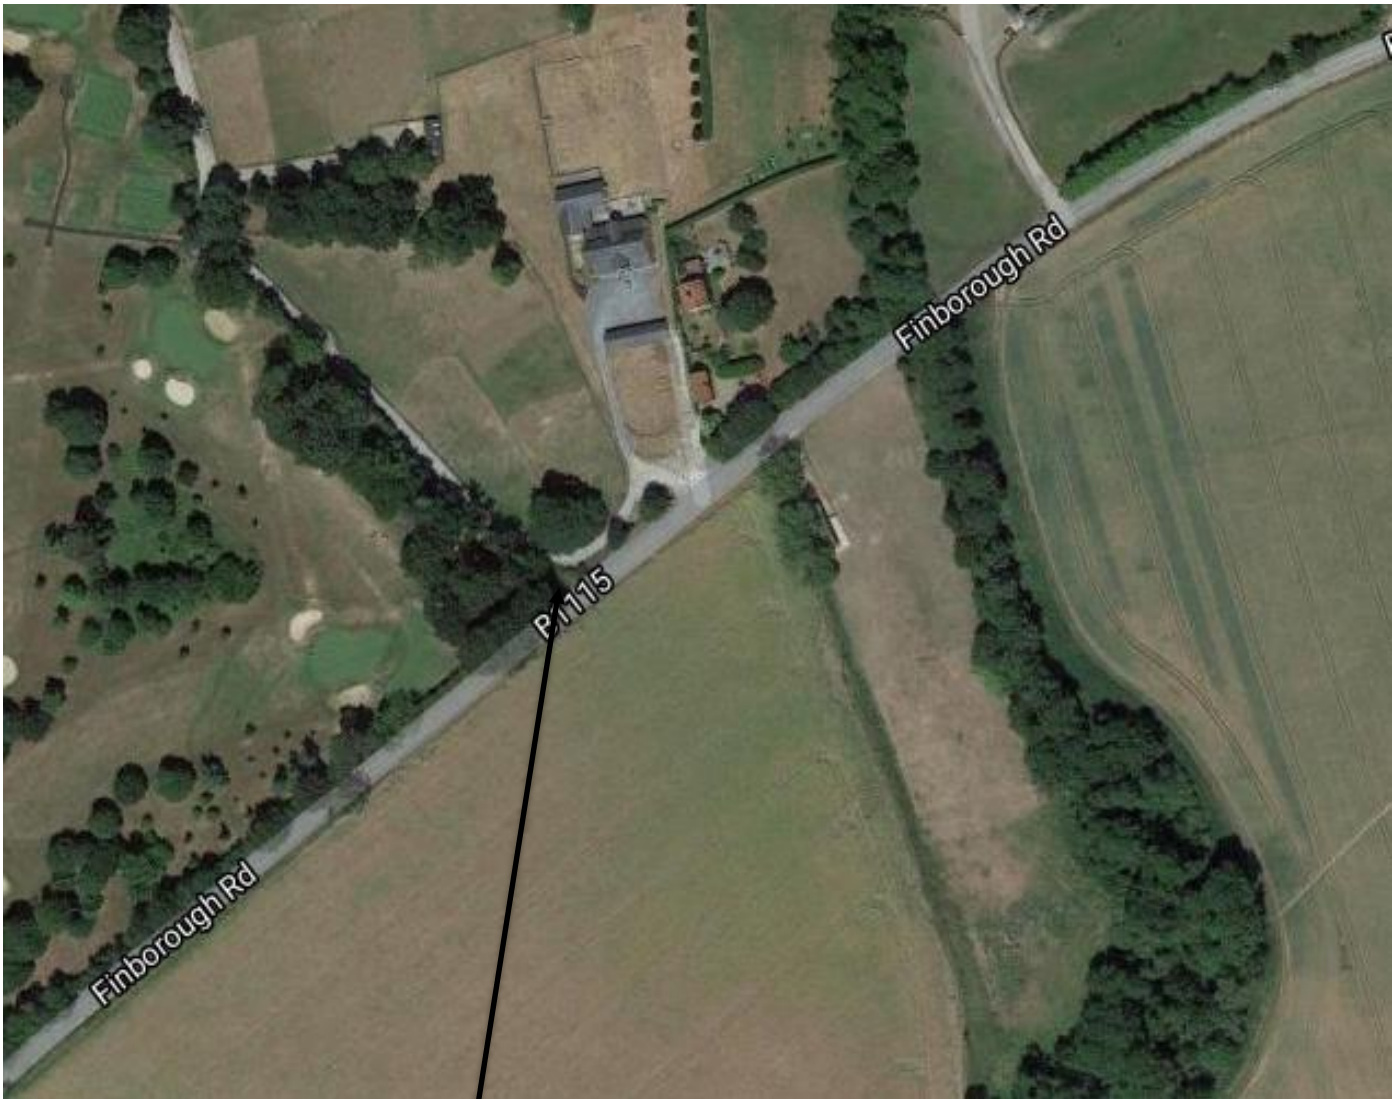
**Appendix 1 – Aerial photograph**

Proposed new access location

- 2.1 Stone Barn is located along the B1115 Finborough Road in Great Finborough. There is an existing gateway in place which provides access to Stone Barn, stables and Stables Cottage. The applicant owns the access and the track that runs to the cottage and stables and Appendix 1 gives an aerial view of the area.

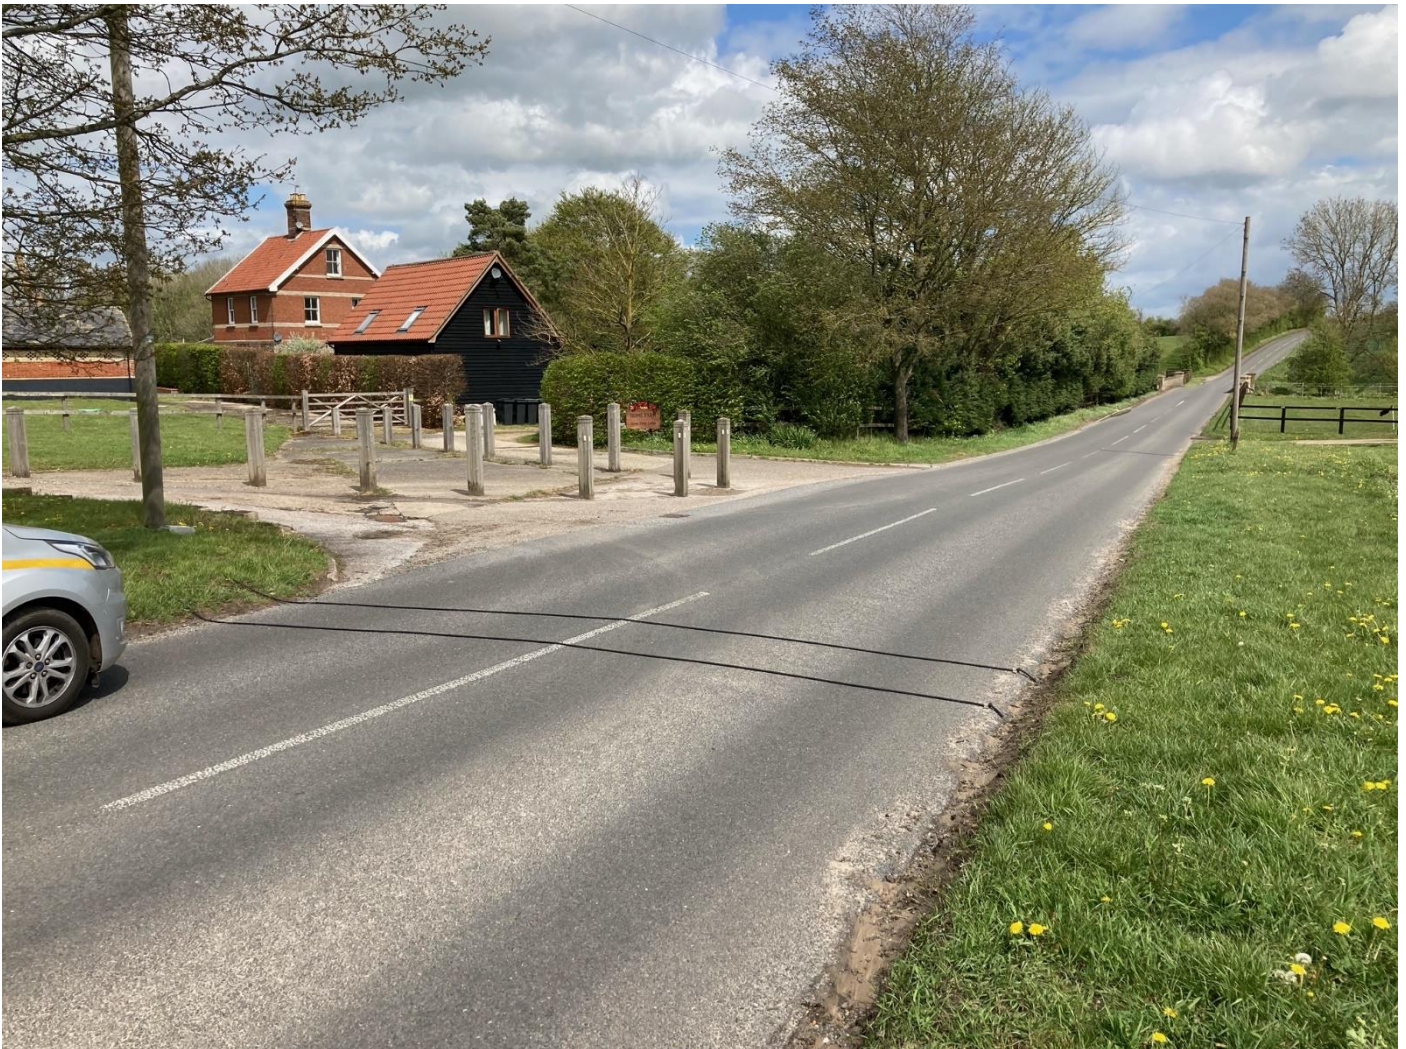
Photograph of traffic loop

Traffic loop placed across the B1115 Finborough Road

- 2.8 In order to support the application and establish vehicle speeds an automated traffic loop was placed across Finborough Road for one week from the 11th May 2021. The results of the survey are shown in Appendix 2.

- 2.9 The 85-percentile speed of the vehicles recorded was 50.8 mph, which is the equivalent of 82 kph, and much less than the national speed limit in the area. The average speed of vehicles using the area was recorded at only 43.8 mph.
