SILICATE MASONRY SYSTEM

earthborn ECOPRO SILICATE MASONRY SYSTEM

Earthborn Ecopro Silicate Masonry System is suitable for use on any porous mineral substrate, chemically bonding to form a durable, water and weather resistant barrier, whilst allowing the wall to breathe.

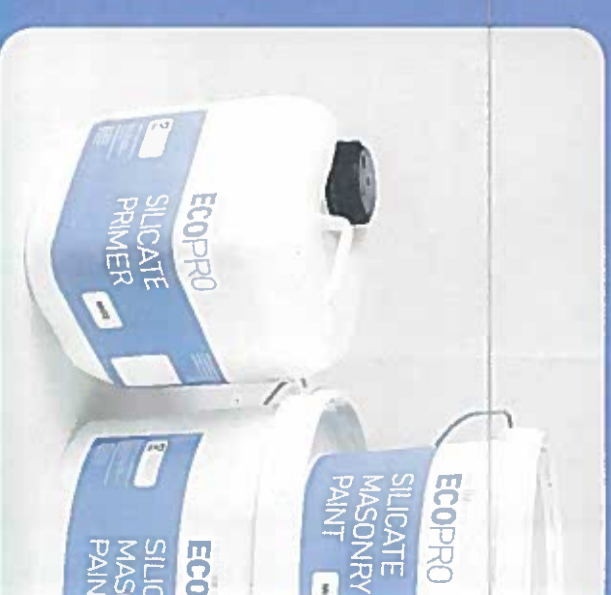
The West Lodge

PADDINGTON CEMETRY

The listed Victorian lodge had previously been poorly repaired using conventional cement and non-breathable paint

Old paint was removed and the property sympathetically restored

Earthborn's Ecopro Silicate System in the colour 'Portland' was applied, blending the original building with its red brick extension and allowing the walls to breathe

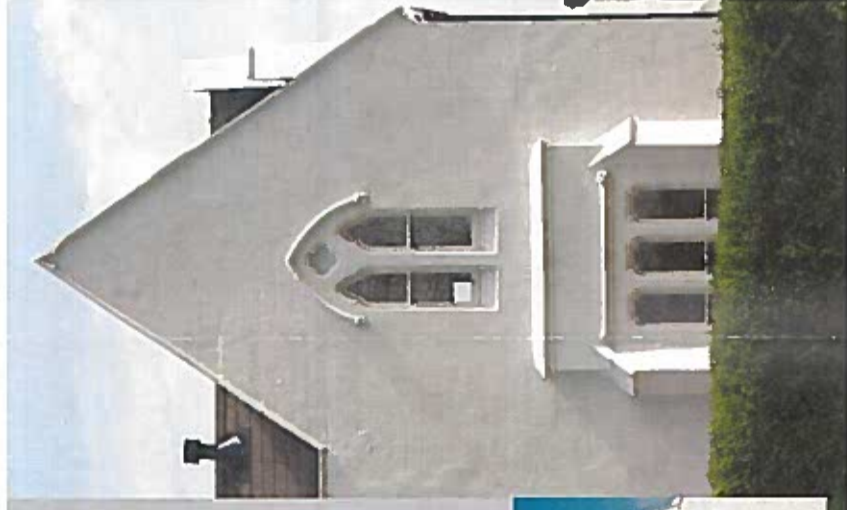
Stone Cottage

THE COTSWOLDS

Early 1800s Cotswold stone cottage

The owners have restored it using lime and breathable Earthborn Ecopro Silicate Masonry Paint in the colour 'Buttermilk'

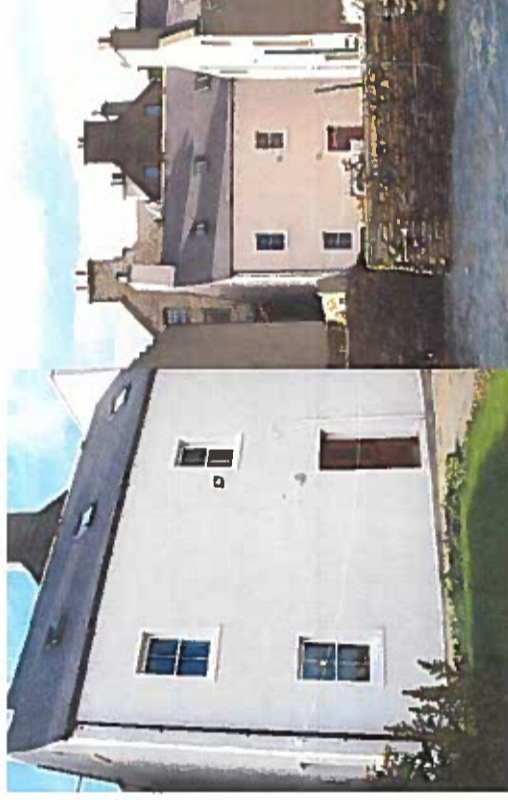
Merchant's House

STROMNESS, ORKNEY

Former merchant's house situated in the conservation area of Stromness

The property is coated with harling, a traditional Scottish render made from aggregate and lime

Walls were cleaned and residual paintwork removed before applying the Ecopro Silicate Masonry System in a bespoke colour

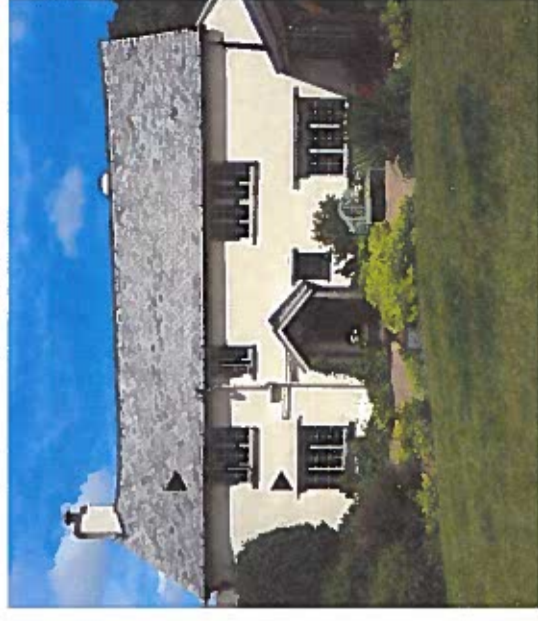
Haxton Cottage

WILTSHIRE

Traditional cottage constructed using a mix of materials including chalk cobb, brick and flint but the property suffered a range of problems caused by inappropriate repairs

Cement render and non breathable masonry paint were removed and replaced with lime and breathable Ecopro Silicate Masonry Paint in the colour 'Pebble'

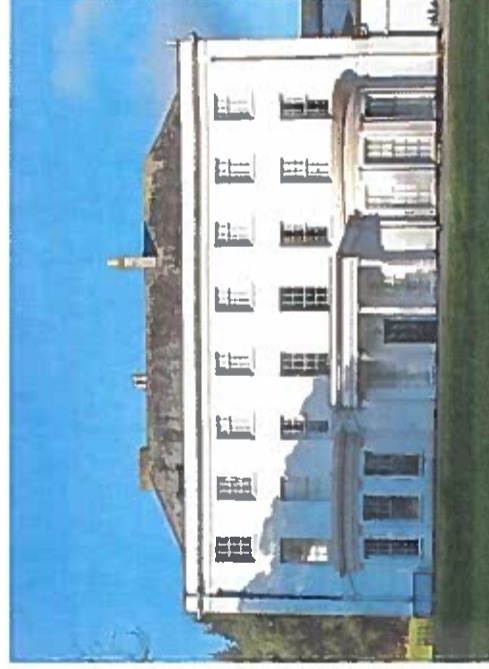
Somerset House

SOMERSET

Period property rendered with natural hydraulic lime then painted with the breathable Ecopro Silicate Masonry System
