Repair and Alterations to Existing Front Door

L008 Proposed Front Door Alte 4th August 2021 scale 1:20 Proposed Change of Use for 12 Stourport on Severn, DY13 8UV daren.hall@btopenworld.com

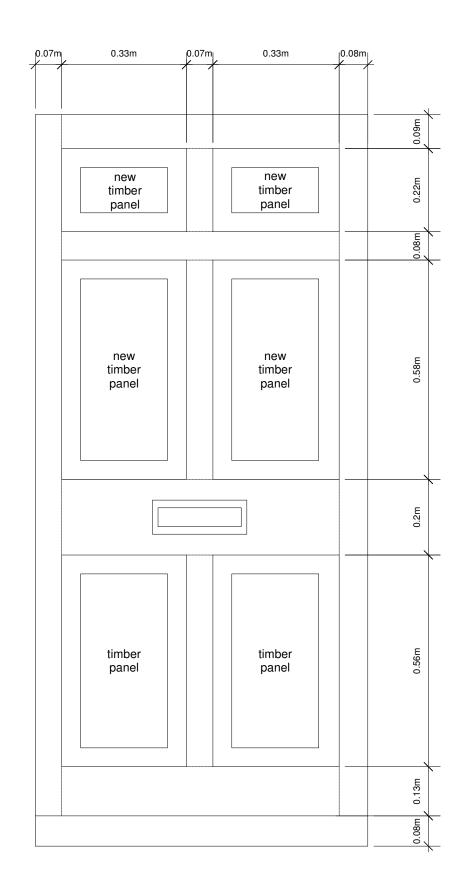
Proposed Front Door Alterations Scale 1:20

Existing Front Door to be removed from doorway and temporary plywood and timber stud partition erected to provide secure enclosure. Existing 4no glazed units to be removed and replaced with 4no timber panels, profile and thickness to match 2no existing. Door to be stripped, filled and recoated in dark blue gloss paint (colour to match existing) and rehung in its original location.
