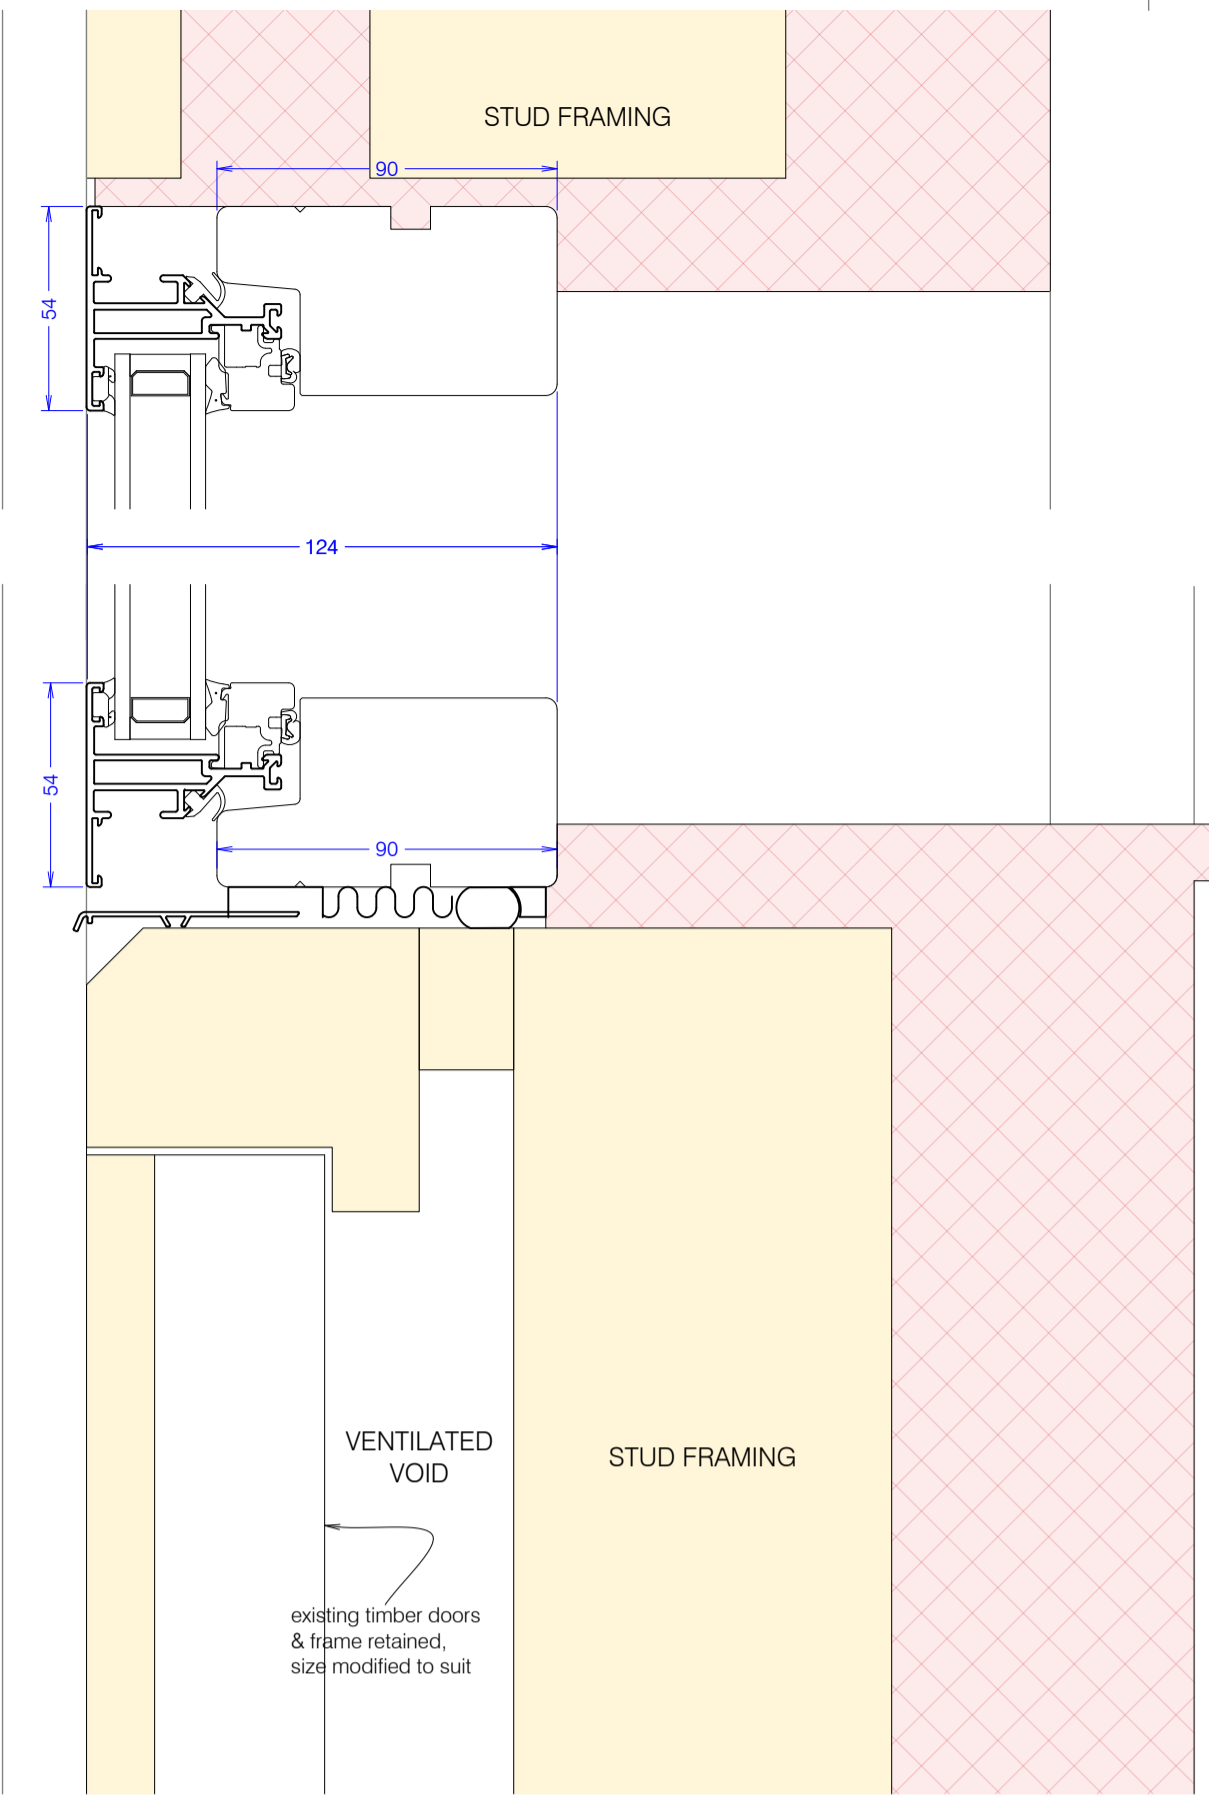
**vertical section
BARN DOOR TOPLIGHT WINDOWS**
1:2
