Project and Project No:	HABERDASHER'S SCHOOL
Title:	EXISTING TERRACE STEPS 03-04 - REPAIRS

Drawing No:	9756-1 P(0)1002
Date:	May 2021
Scale:	1:500, 1:20 1:50@A3
Revision:	-
Drawn:	NCB
Checked:	GQ

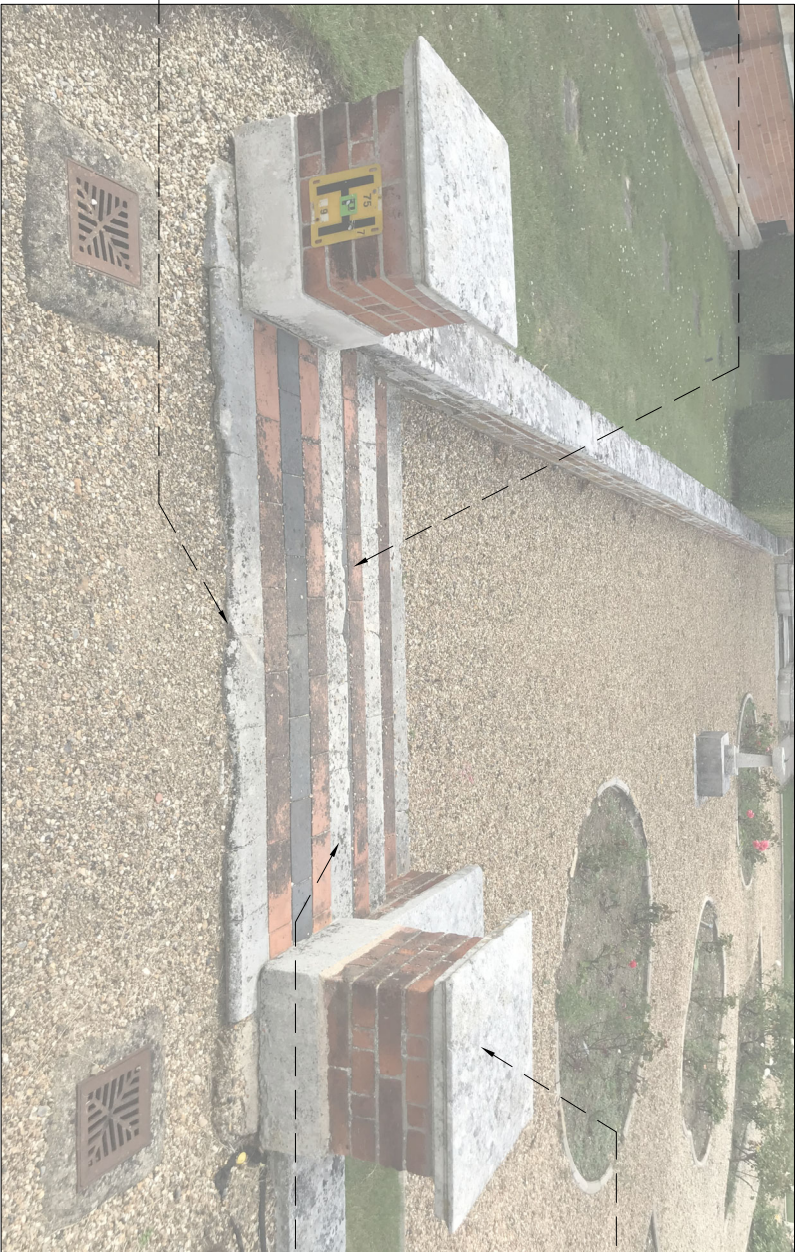
EXISTING TERRACE STEPS NO.03- PHOTO WITH REPAIR NOTES

Existing engineering brick treads are generally in good condition and are to be retained as existing and repointed

Existing brick piers and stone dressings in generally good condition. To be retained as existing

Existing limestone nosings generally in reasonable condition. To be retained as existing with localised repointing

Gravel to be renewed to align with level of limestone nosings to provide support and prevent further damage and chipping to stone

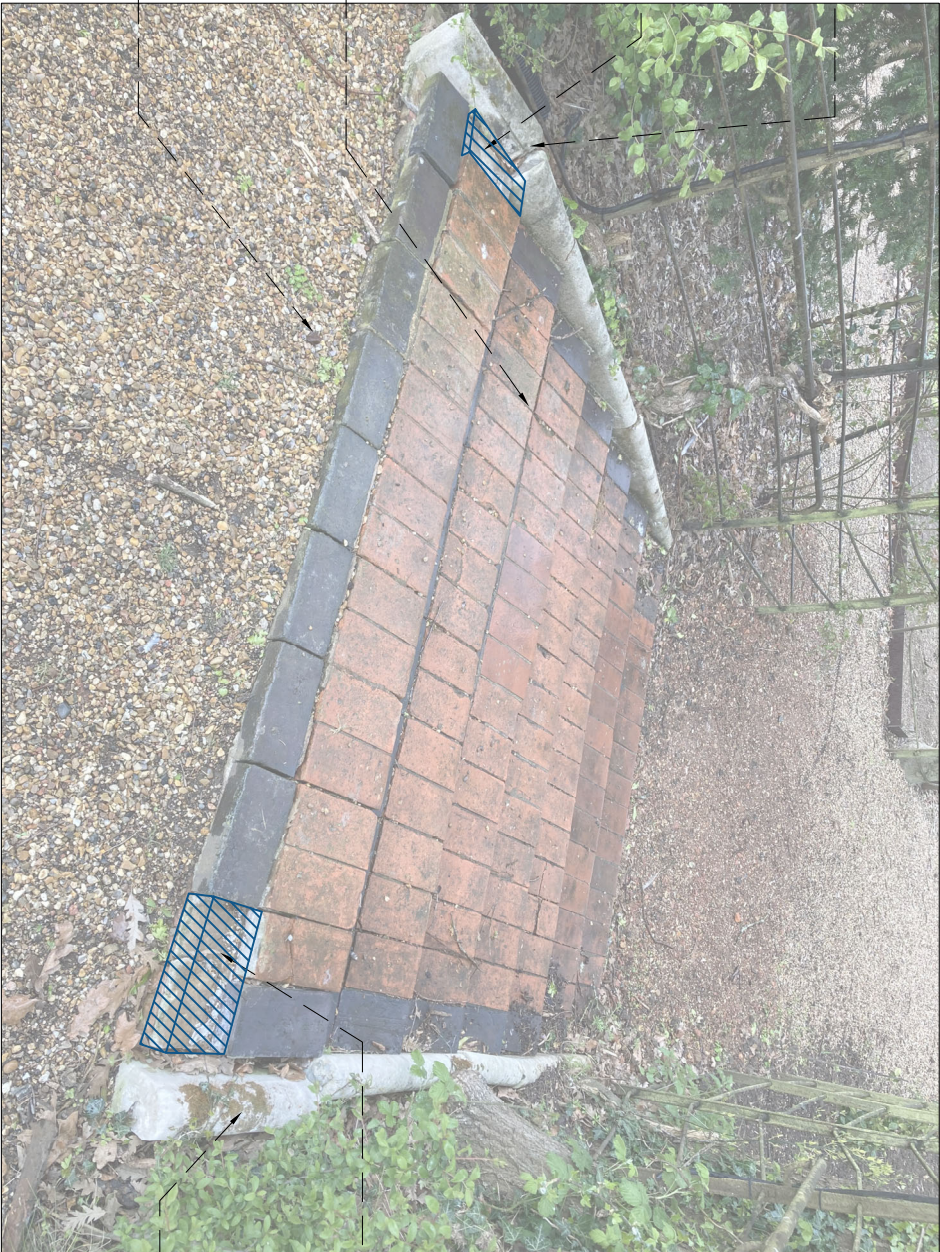
EXISTING TERRACE STEPS NO.04- PHOTO WITH REPAIR NOTES

Existing engineering brick treads are generally in good condition and are to be retained and repointed

Existing limestone kerb unit retained, straightened and repointed

New blue engineering brick to replace missing unit

Gravel to be renewed to align with level of paver bricks to provide support and prevent bricks being chipped

Existing limestone kerb retained, straightened and repointed
